Clear Creek		co-0820-r-001	Sedimentation Risk Index <b>42</b>																																																																		
<u>Common:</u> 3.7mi N of Florala <u>Drainage:</u> Yellow River <u>GPS:</u> 31.0566075, -86.341810698 <u>Land owner:</u> Rayonier Forest Resources LP		<u>County:</u> Covington <u>State:</u> Alabama <u>PLSS (T-R-S):</u> 1N-17E-15 <u>Parcel No.:</u> 1 <u>Road Name:</u> Tram Rd

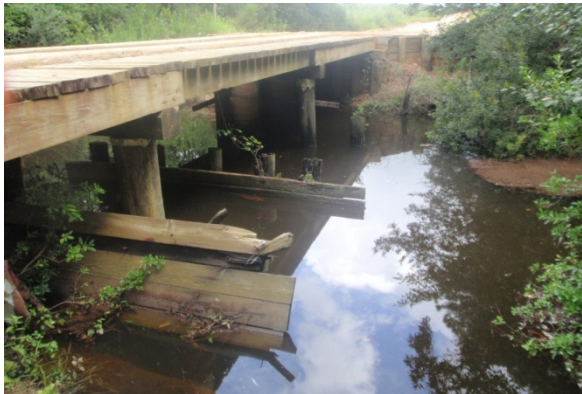
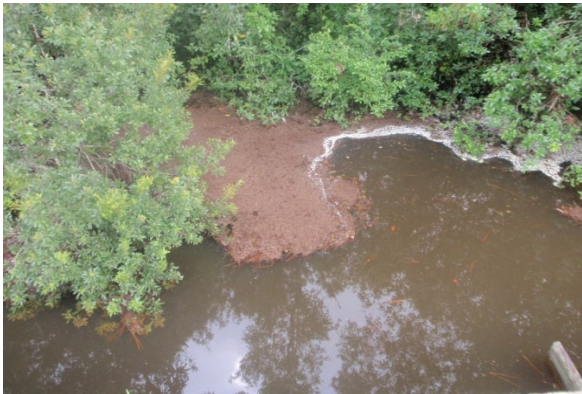
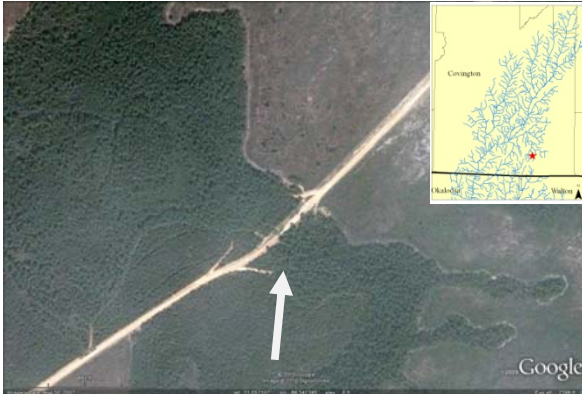
Crossing Structure: US		US																																																																			
<table border="1"> <thead> <tr> <th>Risk Factor</th> <th>Ranking</th> <th>Score</th> </tr> </thead> <tbody> <tr><td>US Channel Morph</td><td>DA</td><td>3</td></tr> <tr><td>DS Channel Morph</td><td>DA</td><td>3</td></tr> <tr><td>DS Bank Alteration</td><td>MINOR/PARTIAL</td><td>3</td></tr> <tr><td>Upstream Skew Angle</td><td>&lt;5°</td><td>5</td></tr> <tr><td>Crossing fill condition</td><td>Good/Vegetated</td><td>5</td></tr> <tr><td>Inlet/Outlet Condition</td><td>No Impairment</td><td>5</td></tr> <tr><td>Road Approach Material</td><td>All Sand/Clay</td><td>3</td></tr> <tr><td>Potential Eroded Volume Mean</td><td>&gt;40 y<sup>3</sup></td><td>1</td></tr> <tr><td>Approach Slope Mean</td><td>&lt;2%</td><td>5</td></tr> <tr><td>Soil K Factor</td><td>&lt;0.20</td><td>5</td></tr> <tr><td>Upstream Rt Outlet</td><td>Bare soil</td><td>0</td></tr> <tr><td>Upstream Lt Outlet</td><td>Bare soil</td><td>0</td></tr> <tr><td>Upstream Rt Ditch</td><td>Bare soil</td><td>0</td></tr> <tr><td>Upstream Lt Ditch</td><td>Bare soil</td><td>0</td></tr> <tr><td>Downstream Rt Outlet</td><td>Bare soil</td><td>0</td></tr> <tr><td>Downstream Lt Outlet</td><td>Bare soil</td><td>0</td></tr> <tr><td>Downstream Rt Ditch</td><td>Vegetated</td><td>1</td></tr> <tr><td>Downstream Lt Ditch</td><td>Bare soil</td><td>0</td></tr> <tr><td>Outlet Total</td><td>Unimproved Outlet System</td><td>1</td></tr> <tr><td>Ditches Total</td><td>Partially Improved Drainage System</td><td>3</td></tr> <tr><td><b>SRI Total</b></td><td><b>Medium Risk</b></td><td><b>42</b></td></tr> </tbody> </table>		Risk Factor	Ranking	Score	US Channel Morph	DA	3	DS Channel Morph	DA	3	DS Bank Alteration	MINOR/PARTIAL	3	Upstream Skew Angle	<5°	5	Crossing fill condition	Good/Vegetated	5	Inlet/Outlet Condition	No Impairment	5	Road Approach Material	All Sand/Clay	3	Potential Eroded Volume Mean	>40 y <sup>3</sup>	1	Approach Slope Mean	<2%	5	Soil K Factor	<0.20	5	Upstream Rt Outlet	Bare soil	0	Upstream Lt Outlet	Bare soil	0	Upstream Rt Ditch	Bare soil	0	Upstream Lt Ditch	Bare soil	0	Downstream Rt Outlet	Bare soil	0	Downstream Lt Outlet	Bare soil	0	Downstream Rt Ditch	Vegetated	1	Downstream Lt Ditch	Bare soil	0	Outlet Total	Unimproved Outlet System	1	Ditches Total	Partially Improved Drainage System	3	<b>SRI Total</b>	<b>Medium Risk</b>	<b>42</b>

Notes: Old bridge in channel
