Unnamed tributary		co-0904-r-003	Sedimentation Risk Index 38																																																																		
<u>Common:</u> 5.2mi SE of Andalusia <u>Drainage:</u> Five Runs Creek <i>GPS:</i> 31.247880453, -86.429983593 <u>Land owner:</u> Dixon Family Partnership LP		<u>County:</u> Covington <i>State:</i> Alabama <u>PLSS (T-R-S):</u> 3N-16E-10 <u>Parcel No.:</u> 1 <u>Road Name:</u> Head Farm Rd

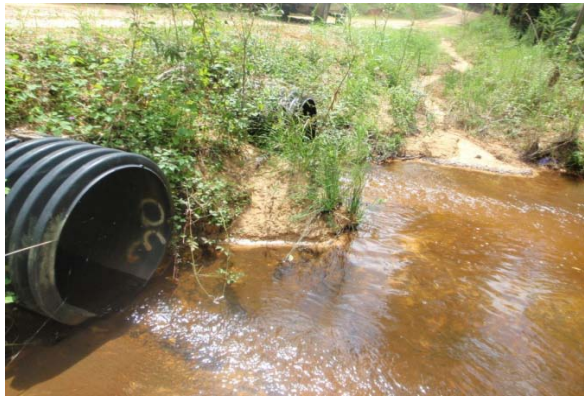
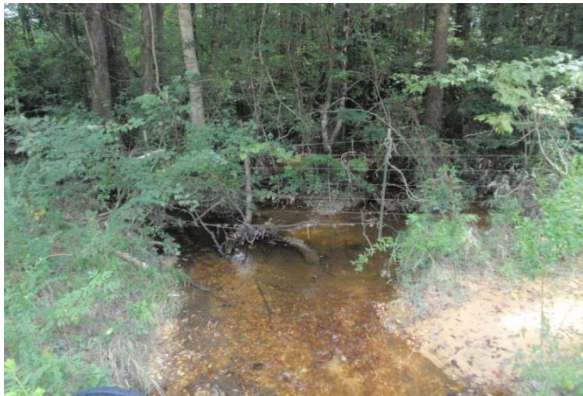
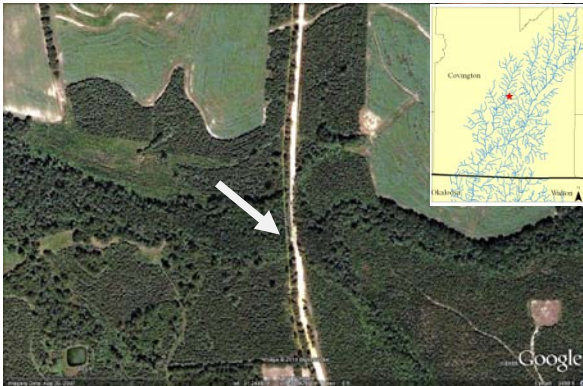
Crossing Structure: DS		US																																																																			
<table border="1"> <thead> <tr> <th>Risk Factor</th> <th>Ranking</th> <th>Score</th> </tr> </thead> <tbody> <tr><td>US Channel Morph</td><td>DA</td><td>3</td></tr> <tr><td>DS Channel Morph</td><td>C</td><td>5</td></tr> <tr><td>DS Bank Alteration</td><td>HIGH</td><td>1</td></tr> <tr><td>Upstream Skew Angle</td><td>5-30°</td><td>3</td></tr> <tr><td>Crossing fill condition</td><td>Poor/Bare soil</td><td>1</td></tr> <tr><td>Inlet/Outlet Condition</td><td>No Impairment</td><td>5</td></tr> <tr><td>Road Approach Material</td><td>All Sand/Clay</td><td>3</td></tr> <tr><td>Potential Eroded Volume Mean</td><td><21 y³</td><td>5</td></tr> <tr><td>Approach Slope Mean</td><td>2.1-4%</td><td>3</td></tr> <tr><td>Soil K Factor</td><td><0.20</td><td>5</td></tr> <tr><td>Upstream Rt Outlet</td><td>Bare soil</td><td>0</td></tr> <tr><td>Upstream Lt Outlet</td><td>Vegetated</td><td>1</td></tr> <tr><td>Upstream Rt Ditch</td><td>Bare soil</td><td>0</td></tr> <tr><td>Upstream Lt Ditch</td><td>Bare soil</td><td>0</td></tr> <tr><td>Downstream Rt Outlet</td><td>Bare soil</td><td>0</td></tr> <tr><td>Downstream Lt Outlet</td><td>Bare soil</td><td>0</td></tr> <tr><td>Downstream Rt Ditch</td><td>Bare soil</td><td>0</td></tr> <tr><td>Downstream Lt Ditch</td><td>Bare soil</td><td>0</td></tr> <tr><td>Outlet Total</td><td>Partially Improved Outlet System</td><td>3</td></tr> <tr><td>Ditches Total</td><td>Unimproved Drainage System</td><td>1</td></tr> <tr><td>SRI Total</td><td>Medium Risk</td><td>38</td></tr> </tbody> </table>		Risk Factor	Ranking	Score	US Channel Morph	DA	3	DS Channel Morph	C	5	DS Bank Alteration	HIGH	1	Upstream Skew Angle	5-30°	3	Crossing fill condition	Poor/Bare soil	1	Inlet/Outlet Condition	No Impairment	5	Road Approach Material	All Sand/Clay	3	Potential Eroded Volume Mean	<21 y ³	5	Approach Slope Mean	2.1-4%	3	Soil K Factor	<0.20	5	Upstream Rt Outlet	Bare soil	0	Upstream Lt Outlet	Vegetated	1	Upstream Rt Ditch	Bare soil	0	Upstream Lt Ditch	Bare soil	0	Downstream Rt Outlet	Bare soil	0	Downstream Lt Outlet	Bare soil	0	Downstream Rt Ditch	Bare soil	0	Downstream Lt Ditch	Bare soil	0	Outlet Total	Partially Improved Outlet System	3	Ditches Total	Unimproved Drainage System	1	SRI Total	Medium Risk	38

Notes: Fence across US
