Crain Pond		ok-0318-r-002	Sedimentation Risk Index 42																																																																		
<u>Common:</u> 6.3mi SW of Crestview <u>Drainage:</u> Shoal River <u>GPS:</u> 30.681965, -86.622201 <u>Land owner:</u> US Government- Eglin AFB		<u>County:</u> Okaloosa <u>State:</u> Florida <u>PLSS(T-R-S):</u> 2N-24-11 <u>Parcel No.:</u> 1 <u>Road Name:</u> Rattlesnake Bluff Rd

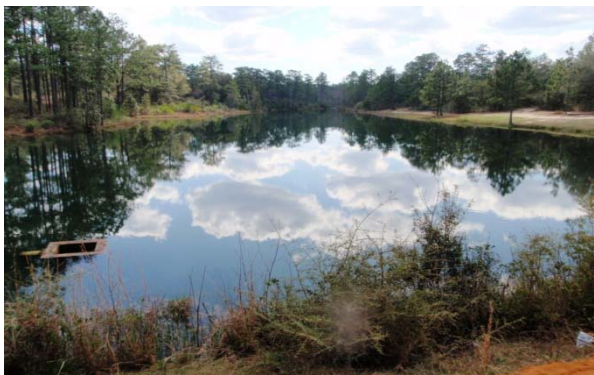
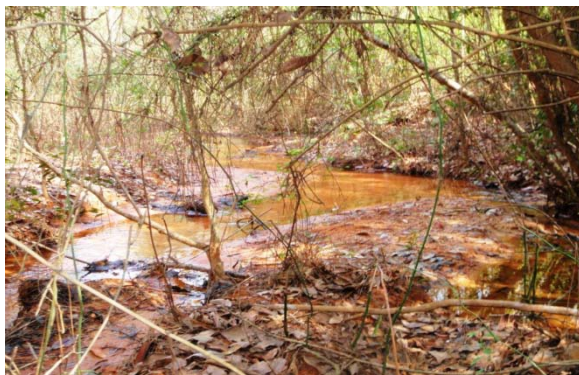
Crossing Structure- US		DS																																																																			
<table border="1"> <thead> <tr> <th>Risk Factor</th> <th>Ranking</th> <th>Score</th> </tr> </thead> <tbody> <tr><td>US Channel Morph</td><td>PONDED</td><td>1</td></tr> <tr><td>DS Channel Morph</td><td>C</td><td>5</td></tr> <tr><td>DS Bank Alteration</td><td>MINOR/PARTIAL</td><td>3</td></tr> <tr><td>Upstream Skew Angle</td><td>5-30°</td><td>3</td></tr> <tr><td>Crossing fill condition</td><td>Good/Vegetated</td><td>5</td></tr> <tr><td>Inlet/Outlet Condition</td><td>No Impairment</td><td>5</td></tr> <tr><td>Road Approach Material</td><td>All Sand/Clay</td><td>3</td></tr> <tr><td>Potential Eroded Volume Mean</td><td>>40 y³</td><td>1</td></tr> <tr><td>Approach Slope Mean</td><td><2%</td><td>5</td></tr> <tr><td>Soil K Factor</td><td><0.20</td><td>5</td></tr> <tr><td>Upstream Rt Outlet</td><td>Vegetated</td><td>1</td></tr> <tr><td>Upstream Lt Outlet</td><td>Vegetated</td><td>1</td></tr> <tr><td>Upstream Rt Ditch</td><td>Bare soil</td><td>0</td></tr> <tr><td>Upstream Lt Ditch</td><td>Bare soil</td><td>0</td></tr> <tr><td>Downstream Rt Outlet</td><td>Vegetated</td><td>1</td></tr> <tr><td>Downstream Lt Outlet</td><td>Vegetated</td><td>1</td></tr> <tr><td>Downstream Rt Ditch</td><td>Bare soil</td><td>0</td></tr> <tr><td>Downstream Lt Ditch</td><td>Bare soil</td><td>0</td></tr> <tr><td>Outlet Total</td><td>Improved Outlet System</td><td>5</td></tr> <tr><td>Ditches Total</td><td>Unimproved Drainage System</td><td>1</td></tr> <tr><td>SRI Total</td><td>Medium Risk</td><td>42</td></tr> </tbody> </table>		Risk Factor	Ranking	Score	US Channel Morph	PONDED	1	DS Channel Morph	C	5	DS Bank Alteration	MINOR/PARTIAL	3	Upstream Skew Angle	5-30°	3	Crossing fill condition	Good/Vegetated	5	Inlet/Outlet Condition	No Impairment	5	Road Approach Material	All Sand/Clay	3	Potential Eroded Volume Mean	>40 y ³	1	Approach Slope Mean	<2%	5	Soil K Factor	<0.20	5	Upstream Rt Outlet	Vegetated	1	Upstream Lt Outlet	Vegetated	1	Upstream Rt Ditch	Bare soil	0	Upstream Lt Ditch	Bare soil	0	Downstream Rt Outlet	Vegetated	1	Downstream Lt Outlet	Vegetated	1	Downstream Rt Ditch	Bare soil	0	Downstream Lt Ditch	Bare soil	0	Outlet Total	Improved Outlet System	5	Ditches Total	Unimproved Drainage System	1	SRI Total	Medium Risk	42

Notes: Reservoir drain/stand pipe US, unable to locate DS drainage structure.
