Clear Creek		ok-1005-r-002	Sedimentation Risk Index 38																																																																		
<u>Common:</u> 7.2mi NE of Crestview <u>Drainage:</u> Poverty Creek <u>GPS:</u> 30.812152272, -86.463812135 <u>Land owner:</u> Clear Creek Investments-US, Thomas & Shirley Akers-DS		<u>County:</u> Okaloosa <u>State:</u> Florida <u>PLSS(T-R-S):</u> 4N-22-29 <u>Parcel No.:</u> 1.1370/1.0900 <u>Road Name:</u> Clear Creek Dam Rd

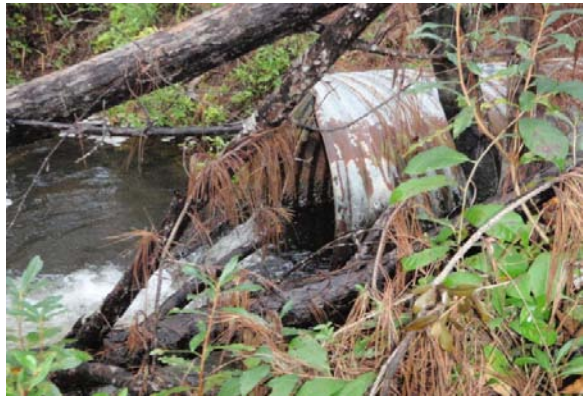
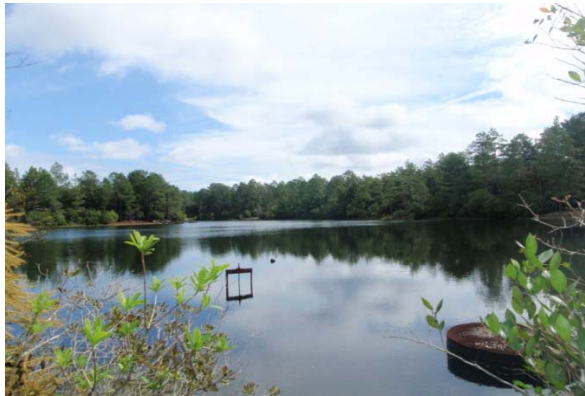
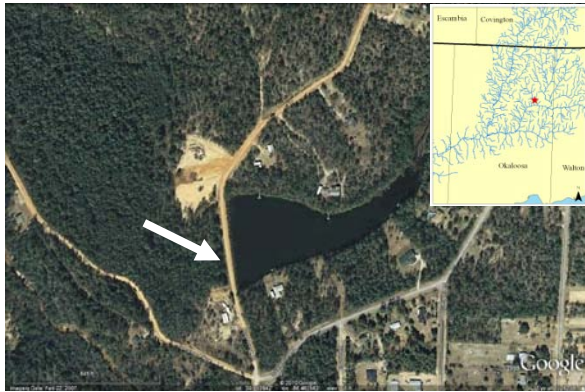
Crossing Structure: DS		US																																																																			
<table border="1"> <thead> <tr> <th>Risk Factor</th> <th>Ranking</th> <th>Score</th> </tr> </thead> <tbody> <tr><td>US Channel Morph</td><td>PONDED</td><td>1</td></tr> <tr><td>DS Channel Morph</td><td>C</td><td>5</td></tr> <tr><td>DS Bank Alteration</td><td>HIGH</td><td>1</td></tr> <tr><td>Upstream Skew Angle</td><td><5°</td><td>5</td></tr> <tr><td>Crossing fill condition</td><td>Good/Vegetated</td><td>5</td></tr> <tr><td>Inlet/Outlet Condition</td><td>No Impairment</td><td>5</td></tr> <tr><td>Road Approach Material</td><td>All Sand/Clay</td><td>3</td></tr> <tr><td>Potential Eroded Volume Mean</td><td>>40 y³</td><td>1</td></tr> <tr><td>Approach Slope Mean</td><td>2.1-4%</td><td>3</td></tr> <tr><td>Soil K Factor</td><td><0.20</td><td>5</td></tr> <tr><td>Upstream Rt Outlet</td><td>Other</td><td>0</td></tr> <tr><td>Upstream Lt Outlet</td><td>Other</td><td>0</td></tr> <tr><td>Upstream Rt Ditch</td><td>Bare soil</td><td>0</td></tr> <tr><td>Upstream Lt Ditch</td><td>Bare soil</td><td>0</td></tr> <tr><td>Downstream Rt Outlet</td><td>Vegetated</td><td>1</td></tr> <tr><td>Downstream Lt Outlet</td><td>Vegetated</td><td>1</td></tr> <tr><td>Downstream Rt Ditch</td><td>Bare soil</td><td>0</td></tr> <tr><td>Downstream Lt Ditch</td><td>Bare soil</td><td>0</td></tr> <tr><td>Outlet Total</td><td>Partially Improved Outlet System</td><td>3</td></tr> <tr><td>Ditches Total</td><td>Unimproved Drainage System</td><td>1</td></tr> <tr><td>SRI Total</td><td>Medium Risk</td><td>38</td></tr> </tbody> </table>		Risk Factor	Ranking	Score	US Channel Morph	PONDED	1	DS Channel Morph	C	5	DS Bank Alteration	HIGH	1	Upstream Skew Angle	<5°	5	Crossing fill condition	Good/Vegetated	5	Inlet/Outlet Condition	No Impairment	5	Road Approach Material	All Sand/Clay	3	Potential Eroded Volume Mean	>40 y ³	1	Approach Slope Mean	2.1-4%	3	Soil K Factor	<0.20	5	Upstream Rt Outlet	Other	0	Upstream Lt Outlet	Other	0	Upstream Rt Ditch	Bare soil	0	Upstream Lt Ditch	Bare soil	0	Downstream Rt Outlet	Vegetated	1	Downstream Lt Outlet	Vegetated	1	Downstream Rt Ditch	Bare soil	0	Downstream Lt Ditch	Bare soil	0	Outlet Total	Partially Improved Outlet System	3	Ditches Total	Unimproved Drainage System	1	SRI Total	Medium Risk	38

Notes: DS drop off. Water control structure.
