Hollis Creek		co-0907-r-001	Sedimentation Risk Index 36																																																																		
<u>Common:</u> 7.1mi W of Opp <u>Drainage:</u> Yellow River <u>GPS:</u> 31.296459097, -86.375007419 <u>Land owner:</u> Vera Worley & Norma King Heris -US, Stan Lanzo -DS		<u>County:</u> Covington <u>State:</u> Alabama <u>PLSS (T-R-S):</u> 4N-17E-20 <u>Parcel No.:</u> 5; 5.01 <u>Road Name:</u> Houston Crossing

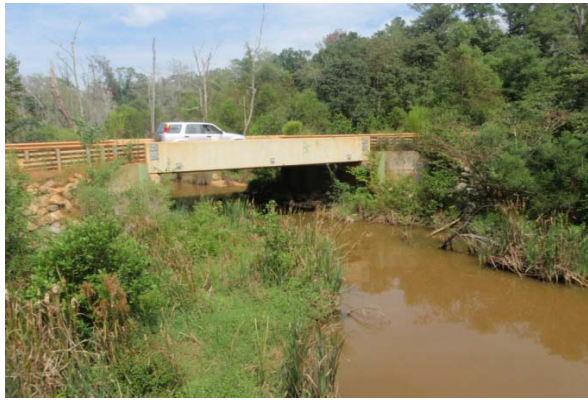
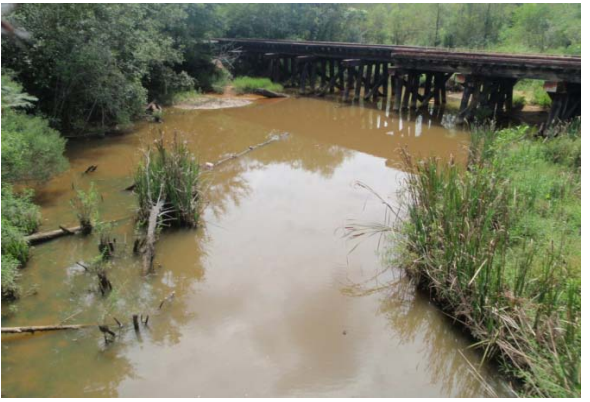
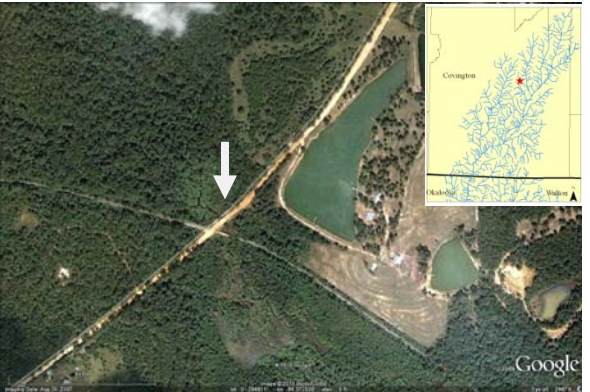
Crossing Structure: DS		DS																																																																			
<table border="1"> <thead> <tr> <th>Risk Factor</th> <th>Ranking</th> <th>Score</th> </tr> </thead> <tbody> <tr><td>US Channel Morph</td><td>DA</td><td>3</td></tr> <tr><td>DS Channel Morph</td><td>DA</td><td>3</td></tr> <tr><td>DS Bank Alteration</td><td>HIGH</td><td>1</td></tr> <tr><td>Upstream Skew Angle</td><td><5°</td><td>5</td></tr> <tr><td>Crossing fill condition</td><td>Good/Vegetated</td><td>5</td></tr> <tr><td>Inlet/Outlet Condition</td><td>Sed Islands/Scouring</td><td>3</td></tr> <tr><td>Road Approach Material</td><td>All Sand/Clay</td><td>3</td></tr> <tr><td>Potential Eroded Volume Mean</td><td>>40 y³</td><td>1</td></tr> <tr><td>Approach Slope Mean</td><td>2.1-4%</td><td>3</td></tr> <tr><td>Soil K Factor</td><td><0.20</td><td>5</td></tr> <tr><td>Upstream Rt Outlet</td><td>Bare soil</td><td>0</td></tr> <tr><td>Upstream Lt Outlet</td><td>Rip Rap</td><td>1</td></tr> <tr><td>Upstream Rt Ditch</td><td>Bare soil</td><td>0</td></tr> <tr><td>Upstream Lt Ditch</td><td>Bare soil</td><td>0</td></tr> <tr><td>Downstream Rt Outlet</td><td>Vegetated</td><td>1</td></tr> <tr><td>Downstream Lt Outlet</td><td>Bare soil</td><td>0</td></tr> <tr><td>Downstream Rt Ditch</td><td>Bare soil</td><td>0</td></tr> <tr><td>Downstream Lt Ditch</td><td>Bare soil</td><td>0</td></tr> <tr><td>Outlet Total</td><td>Partially Improved Outlet System</td><td>3</td></tr> <tr><td>Ditches Total</td><td>Unimproved Drainage System</td><td>1</td></tr> <tr><td>SRI Total</td><td>High Risk</td><td>36</td></tr> </tbody> </table>		Risk Factor	Ranking	Score	US Channel Morph	DA	3	DS Channel Morph	DA	3	DS Bank Alteration	HIGH	1	Upstream Skew Angle	<5°	5	Crossing fill condition	Good/Vegetated	5	Inlet/Outlet Condition	Sed Islands/Scouring	3	Road Approach Material	All Sand/Clay	3	Potential Eroded Volume Mean	>40 y ³	1	Approach Slope Mean	2.1-4%	3	Soil K Factor	<0.20	5	Upstream Rt Outlet	Bare soil	0	Upstream Lt Outlet	Rip Rap	1	Upstream Rt Ditch	Bare soil	0	Upstream Lt Ditch	Bare soil	0	Downstream Rt Outlet	Vegetated	1	Downstream Lt Outlet	Bare soil	0	Downstream Rt Ditch	Bare soil	0	Downstream Lt Ditch	Bare soil	0	Outlet Total	Partially Improved Outlet System	3	Ditches Total	Unimproved Drainage System	1	SRI Total	High Risk	36

Notes: Railroad crossing directly DS
