Unnamed tributary		co-0810-r-012		Sedimentation Risk Index 42																																																																			
<u>Common:</u> 12.6mi NW of Florala <u>Drainage:</u> Gum Creek <u>GPS:</u> 31.128961, -86.483664 <u>Land owner:</u> USA-Conecuh Nat. Forest		<u>County:</u> Covington <u>PLSS (T-R-S):</u> 2N-16E-19 <u>Parcel No.:</u> 1 <u>Road Name:</u> Shiloh Cemetery Rd		<u>State:</u> Alabama

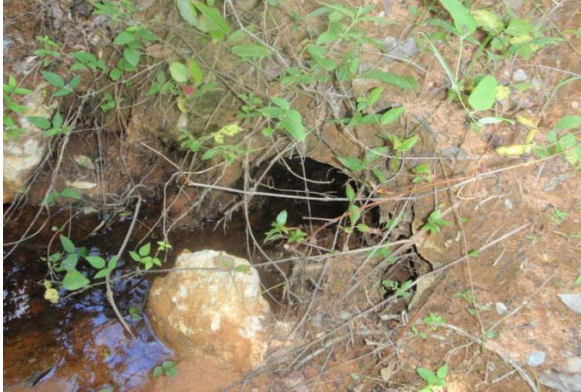
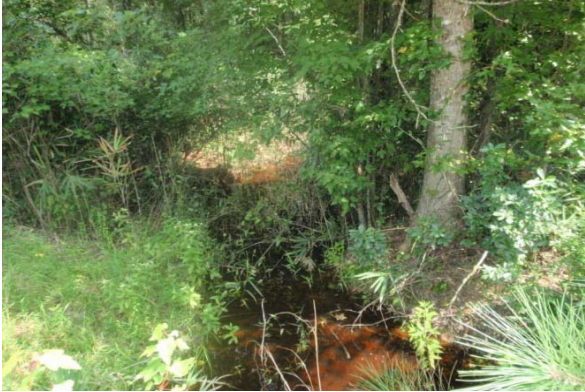
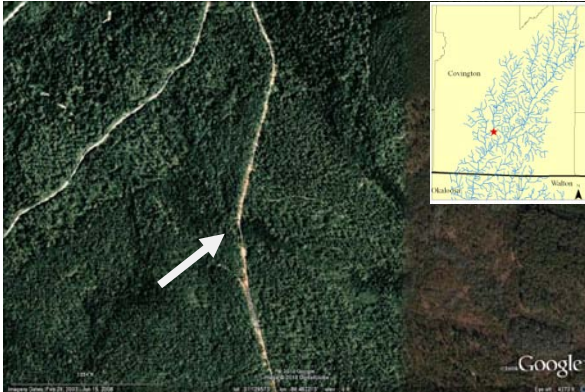
Crossing Structure: DS		US																																																																					
<table border="1"> <thead> <tr> <th>Risk Factor</th> <th>Ranking</th> <th>Score</th> </tr> </thead> <tbody> <tr><td>US Channel Morph</td><td>DA</td><td>3</td></tr> <tr><td>DS Channel Morph</td><td>DA</td><td>3</td></tr> <tr><td>DS Bank Alteration</td><td>MINOR/PARTIAL</td><td>3</td></tr> <tr><td>Upstream Skew Angle</td><td>5-30°</td><td>3</td></tr> <tr><td>Crossing fill condition</td><td>Fair/Rip Rap</td><td>3</td></tr> <tr><td>Inlet/Outlet Condition</td><td>No Impairment</td><td>5</td></tr> <tr><td>Road Approach Material</td><td>All Sand/Clay</td><td>3</td></tr> <tr><td>Potential Eroded Volume Mean</td><td><21 y³</td><td>5</td></tr> <tr><td>Approach Slope Mean</td><td>2.1-4%</td><td>3</td></tr> <tr><td>Soil K Factor</td><td><0.20</td><td>5</td></tr> <tr><td>Upstream Rt Outlet</td><td>Vegetated</td><td>1</td></tr> <tr><td>Upstream Lt Outlet</td><td>Vegetated</td><td>1</td></tr> <tr><td>Upstream Rt Ditch</td><td>Bare soil</td><td>0</td></tr> <tr><td>Upstream Lt Ditch</td><td>Bare soil</td><td>0</td></tr> <tr><td>Downstream Rt Outlet</td><td>Vegetated</td><td>1</td></tr> <tr><td>Downstream Lt Outlet</td><td>Vegetated</td><td>1</td></tr> <tr><td>Downstream Rt Ditch</td><td>Bare soil</td><td>0</td></tr> <tr><td>Downstream Lt Ditch</td><td>Bare soil</td><td>0</td></tr> <tr><td>Outlet Total</td><td>Improved Outlet System</td><td>5</td></tr> <tr><td>Ditches Total</td><td>Unimproved Drainage System</td><td>1</td></tr> <tr><td>SRI Total</td><td>Medium Risk</td><td>42</td></tr> </tbody> </table>		Risk Factor	Ranking	Score	US Channel Morph	DA	3	DS Channel Morph	DA	3	DS Bank Alteration	MINOR/PARTIAL	3	Upstream Skew Angle	5-30°	3	Crossing fill condition	Fair/Rip Rap	3	Inlet/Outlet Condition	No Impairment	5	Road Approach Material	All Sand/Clay	3	Potential Eroded Volume Mean	<21 y ³	5	Approach Slope Mean	2.1-4%	3	Soil K Factor	<0.20	5	Upstream Rt Outlet	Vegetated	1	Upstream Lt Outlet	Vegetated	1	Upstream Rt Ditch	Bare soil	0	Upstream Lt Ditch	Bare soil	0	Downstream Rt Outlet	Vegetated	1	Downstream Lt Outlet	Vegetated	1	Downstream Rt Ditch	Bare soil	0	Downstream Lt Ditch	Bare soil	0	Outlet Total	Improved Outlet System	5	Ditches Total	Unimproved Drainage System	1	SRI Total	Medium Risk	42

Risk Factor	Ranking	Score																																																																					
US Channel Morph	DA	3																																																																					
DS Channel Morph	DA	3																																																																					
DS Bank Alteration	MINOR/PARTIAL	3																																																																					
Upstream Skew Angle	5-30°	3																																																																					
Crossing fill condition	Fair/Rip Rap	3																																																																					
Inlet/Outlet Condition	No Impairment	5																																																																					
Road Approach Material	All Sand/Clay	3																																																																					
Potential Eroded Volume Mean	<21 y ³	5

Approach Slope Mean	2.1-4%	3																																																																					
Soil K Factor	<0.20	5																																																																					
Upstream Rt Outlet	Vegetated	1																																																																					
Upstream Lt Outlet	Vegetated	1																																																																					
Upstream Rt Ditch	Bare soil	0																																																																					
Upstream Lt Ditch	Bare soil	0																																																																					
Downstream Rt Outlet	Vegetated	1																																																																					
Downstream Lt Outlet	Vegetated	1																																																																					
Downstream Rt Ditch	Bare soil	0																																																																					
Downstream Lt Ditch	Bare soil	0

Outlet Total	Improved Outlet System	5																																																																					
Ditches Total	Unimproved Drainage System	1																																																																					
SRI Total	Medium Risk	42																																																																					
Additional Site Features <u>Crossing Type and Quantity:</u> Culvert, 1 <u>Crossing Materials:</u> PVC <u>Soil Types:</u> BoC,CdC,LuB,RaA,TrD <u>Rt Approach Prism Fill:</u> 0.5in <u>Lt Approach Prism Fill:</u> 0.1in		<table border="1"> <thead> <tr> <th>Feature</th> <th>Within Range</th> <th>Descriptive Field</th> </tr> </thead> <tbody> <tr> <td>303(d)</td> <td>No</td> <td>N/A</td> </tr> <tr> <td>Wetland Species</td> <td>No</td> <td>N/A</td> </tr> <tr> <td>Rare and Imperiled</td> <td>No</td> <td>N/A</td> </tr> <tr> <td>Land Use/Cover</td> <td>Yes</td> <td>N/A/ EAST GULF COASTAL PLAIN SOUTHERN MESIC SLOPE FOREST</td> </tr> <tr> <td>Candidate Mussels</td> <td>No</td> <td>N/A</td> </tr> <tr> <td>Sturgeon C.H.</td> <td>No</td> <td>N/A</td> </tr> </tbody> </table>				Feature	Within Range	Descriptive Field	303(d)	No	N/A	Wetland Species	No	N/A	Rare and Imperiled	No	N/A	Land Use/Cover	Yes	N/A/ EAST GULF COASTAL PLAIN SOUTHERN MESIC SLOPE FOREST	Candidate Mussels	No	N/A	Sturgeon C.H.	No	N/A
