Unnamed tributary		wa-0707-r-006	Sedimentation Risk Index <b>30</b>																																																																		
<u>Common:</u> 2.9mi NE of Mossy Head <u>Drainage:</u> Adams Mill Creek <i>GPS:</i> 30.784486, -86.304017 <u>Land owner:</u> Wax Aero Acres LLC- US, Mildred & James Courtney- DS		<u>County:</u> Walton <i>State:</i> Florida <u>PLSS(T-R-S):</u> 3N-21-01 <u>Parcel No.:</u> 2; 1 <u>Road Name:</u> Adams Branch Rd

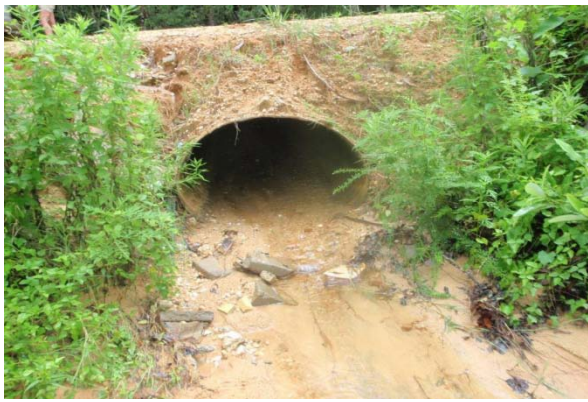
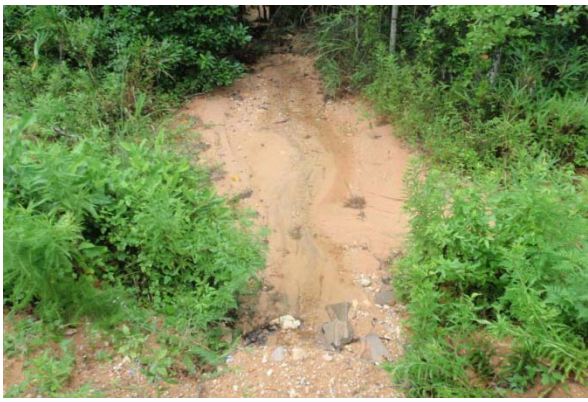
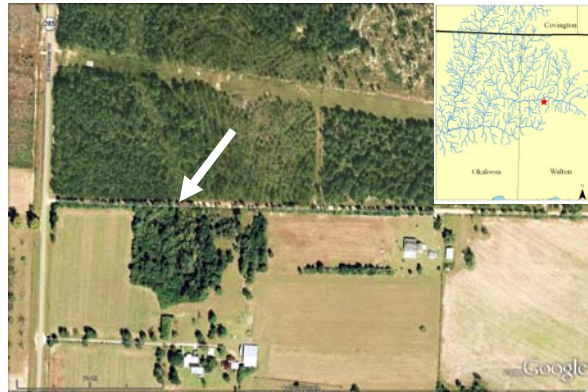
Crossing Structure: DS		DS																																																																			
<table border="1"> <thead> <tr> <th>Risk Factor</th> <th>Ranking</th> <th>Score</th> </tr> </thead> <tbody> <tr><td>US Channel Morph</td><td>D</td><td>1</td></tr> <tr><td>DS Channel Morph</td><td>D</td><td>1</td></tr> <tr><td>DS Bank Alteration</td><td>HIGH</td><td>1</td></tr> <tr><td>Upstream Skew Angle</td><td>&lt;5°</td><td>5</td></tr> <tr><td>Crossing fill condition</td><td>Poor/Bare soil</td><td>1</td></tr> <tr><td>Inlet/Outlet Condition</td><td>Sed Islands/Scouring</td><td>3</td></tr> <tr><td>Road Approach Material</td><td>All Sand/Clay</td><td>3</td></tr> <tr><td>Potential Eroded Volume Mean</td><td>&lt;21 y<sup>3</sup></td><td>5</td></tr> <tr><td>Approach Slope Mean</td><td>&gt;4%</td><td>1</td></tr> <tr><td>Soil K Factor</td><td>&lt;0.20</td><td>5</td></tr> <tr><td>Upstream Rt Outlet</td><td>Bare soil</td><td>0</td></tr> <tr><td>Upstream Lt Outlet</td><td>Bare soil</td><td>0</td></tr> <tr><td>Upstream Rt Ditch</td><td>Bare soil</td><td>0</td></tr> <tr><td>Upstream Lt Ditch</td><td>Bare soil</td><td>0</td></tr> <tr><td>Downstream Rt Outlet</td><td>Vegetated</td><td>1</td></tr> <tr><td>Downstream Lt Outlet</td><td>Vegetated</td><td>1</td></tr> <tr><td>Downstream Rt Ditch</td><td>Bare soil</td><td>0</td></tr> <tr><td>Downstream Lt Ditch</td><td>Bare soil</td><td>0</td></tr> <tr><td>Outlet Total</td><td>Partially Improved Outlet System</td><td>3</td></tr> <tr><td>Ditches Total</td><td>Unimproved Drainage System</td><td>1</td></tr> <tr><td><b>SRI Total</b></td><td><b>High Risk</b></td><td><b>30</b></td></tr> </tbody> </table>		Risk Factor	Ranking	Score	US Channel Morph	D	1	DS Channel Morph	D	1	DS Bank Alteration	HIGH	1	Upstream Skew Angle	<5°	5	Crossing fill condition	Poor/Bare soil	1	Inlet/Outlet Condition	Sed Islands/Scouring	3	Road Approach Material	All Sand/Clay	3	Potential Eroded Volume Mean	<21 y <sup>3</sup>	5	Approach Slope Mean	>4%	1	Soil K Factor	<0.20	5	Upstream Rt Outlet	Bare soil	0	Upstream Lt Outlet	Bare soil	0	Upstream Rt Ditch	Bare soil	0	Upstream Lt Ditch	Bare soil	0	Downstream Rt Outlet	Vegetated	1	Downstream Lt Outlet	Vegetated	1	Downstream Rt Ditch	Bare soil	0	Downstream Lt Ditch	Bare soil	0	Outlet Total	Partially Improved Outlet System	3	Ditches Total	Unimproved Drainage System	1	<b>SRI Total</b>	<b>High Risk</b>	<b>30</b>
