Unnamed tributary		co-0901-r-017	Sedimentation Risk Index 50																																																																		
<u>Common:</u> 11.0mi NW of Florala <u>Drainage:</u> Yellow River <i>GPS:</i> 31.157421325, -86.381592263 <u>Land owner:</u> T. Ivey Powell & Sons Inc		<u>County:</u> Covington <u>PLSS (T-R-S):</u> 2N-17E-7 <u>Parcel No.:</u> 3 <u>Road Name:</u> Cravey Bridge Rd	<u>State:</u> Alabama

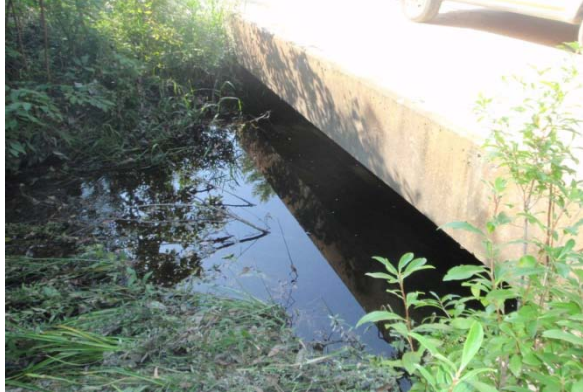
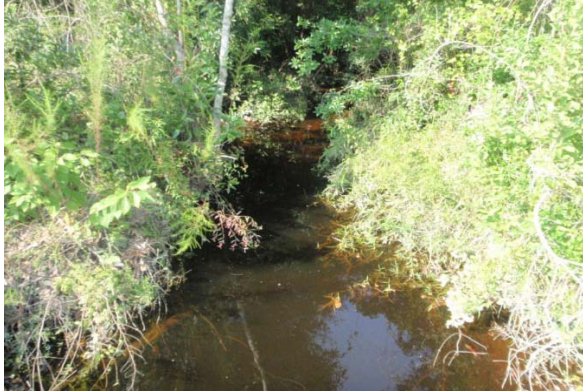
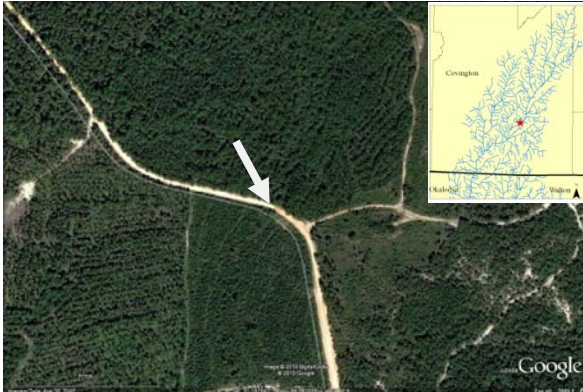
Crossing Structure: DS		US																																																																			
<table border="1"> <thead> <tr> <th>Risk Factor</th> <th>Ranking</th> <th>Score</th> </tr> </thead> <tbody> <tr><td>US Channel Morph</td><td>DA</td><td>3</td></tr> <tr><td>DS Channel Morph</td><td>E</td><td>5</td></tr> <tr><td>DS Bank Alteration</td><td>MINOR/PARTIAL</td><td>3</td></tr> <tr><td>Upstream Skew Angle</td><td><5°</td><td>5</td></tr> <tr><td>Crossing fill condition</td><td>Good/Vegetated</td><td>5</td></tr> <tr><td>Inlet/Outlet Condition</td><td>No Impairment</td><td>5</td></tr> <tr><td>Road Approach Material</td><td>All Sand/Clay</td><td>3</td></tr> <tr><td>Potential Eroded Volume Mean</td><td><21 y³</td><td>5</td></tr> <tr><td>Approach Slope Mean</td><td><2%</td><td>5</td></tr> <tr><td>Soil K Factor</td><td><0.20</td><td>5</td></tr> <tr><td>Upstream Rt Outlet</td><td>Vegetated</td><td>1</td></tr> <tr><td>Upstream Lt Outlet</td><td>Vegetated</td><td>1</td></tr> <tr><td>Upstream Rt Ditch</td><td>Bare soil</td><td>0</td></tr> <tr><td>Upstream Lt Ditch</td><td>Bare soil</td><td>0</td></tr> <tr><td>Downstream Rt Outlet</td><td>Vegetated</td><td>1</td></tr> <tr><td>Downstream Lt Outlet</td><td>Vegetated</td><td>1</td></tr> <tr><td>Downstream Rt Ditch</td><td>Bare soil</td><td>0</td></tr> <tr><td>Downstream Lt Ditch</td><td>Bare soil</td><td>0</td></tr> <tr><td>Outlet Total</td><td>Improved Outlet System</td><td>5</td></tr> <tr><td>Ditches Total</td><td>Unimproved Drainage System</td><td>1</td></tr> <tr><td>SRI Total</td><td>Low Risk</td><td>50</td></tr> </tbody> </table>		Risk Factor	Ranking	Score	US Channel Morph	DA	3	DS Channel Morph	E	5	DS Bank Alteration	MINOR/PARTIAL	3	Upstream Skew Angle	<5°	5	Crossing fill condition	Good/Vegetated	5	Inlet/Outlet Condition	No Impairment	5	Road Approach Material	All Sand/Clay	3	Potential Eroded Volume Mean	<21 y ³	5	Approach Slope Mean	<2%	5	Soil K Factor	<0.20	5	Upstream Rt Outlet	Vegetated	1	Upstream Lt Outlet	Vegetated	1	Upstream Rt Ditch	Bare soil	0	Upstream Lt Ditch	Bare soil	0	Downstream Rt Outlet	Vegetated	1	Downstream Lt Outlet	Vegetated	1	Downstream Rt Ditch	Bare soil	0	Downstream Lt Ditch	Bare soil	0	Outlet Total	Improved Outlet System	5	Ditches Total	Unimproved Drainage System	1	SRI Total	Low Risk	50

Notes: Poorly maintained rd.
