Unnamed tributary		co-0810-r-005	Sedimentation Risk Index 36																																																																		
<u>Common:</u> 9.0mi N of Laurel Hill <u>Drainage:</u> Yellow River <u>GPS:</u> 31.092025, -86.500908 <u>Land owner:</u> USA- Conecuh Nat. Forest		<u>County:</u> Covington <u>State:</u> Alabama <u>PLSS (T-R-S):</u> 2N-15E-36 <u>Parcel No.:</u> 4 <u>Road Name:</u> Bass Rd

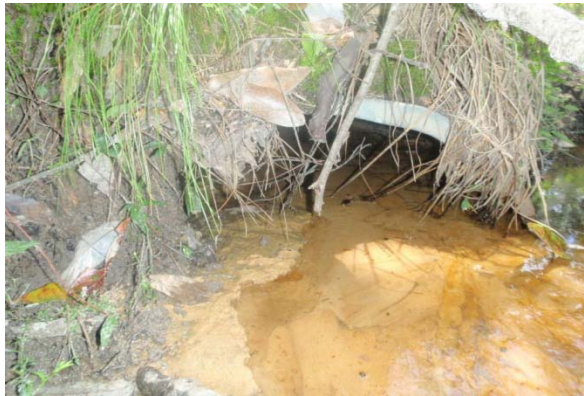
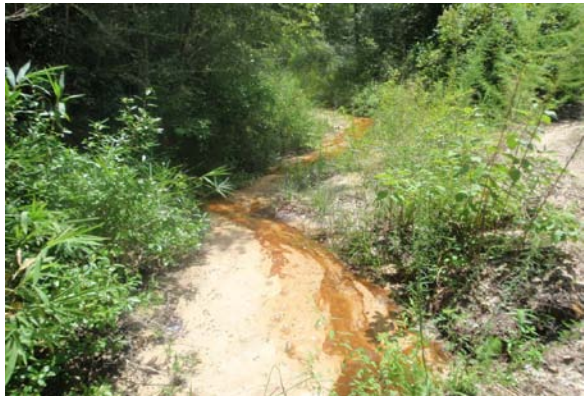
Crossing Structure: US		DS																																																																			
<table border="1"> <thead> <tr> <th>Risk Factor</th> <th>Ranking</th> <th>Score</th> </tr> </thead> <tbody> <tr><td>US Channel Morph</td><td>DA</td><td>3</td></tr> <tr><td>DS Channel Morph</td><td>DA</td><td>3</td></tr> <tr><td>DS Bank Alteration</td><td>MINOR/PARTIAL</td><td>3</td></tr> <tr><td>Upstream Skew Angle</td><td>>30°</td><td>1</td></tr> <tr><td>Crossing fill condition</td><td>Poor/Bare soil</td><td>1</td></tr> <tr><td>Inlet/Outlet Condition</td><td>Blocked</td><td>1</td></tr> <tr><td>Road Approach Material</td><td>All Sand/Clay</td><td>3</td></tr> <tr><td>Potential Eroded Volume Mean</td><td><21 y³</td><td>5</td></tr> <tr><td>Approach Slope Mean</td><td><2%</td><td>5</td></tr> <tr><td>Soil K Factor</td><td><0.20</td><td>5</td></tr> <tr><td>Upstream Rt Outlet</td><td>Vegetated</td><td>1</td></tr> <tr><td>Upstream Lt Outlet</td><td>Vegetated</td><td>1</td></tr> <tr><td>Upstream Rt Ditch</td><td>Vegetated</td><td>1</td></tr> <tr><td>Upstream Lt Ditch</td><td>Bare soil</td><td>0</td></tr> <tr><td>Downstream Rt Outlet</td><td>Bare soil</td><td>0</td></tr> <tr><td>Downstream Lt Outlet</td><td>Bare soil</td><td>0</td></tr> <tr><td>Downstream Rt Ditch</td><td>Bare soil</td><td>0</td></tr> <tr><td>Downstream Lt Ditch</td><td>Bare soil</td><td>0</td></tr> <tr><td>Outlet Total</td><td>Partially Improved Outlet System</td><td>3</td></tr> <tr><td>Ditches Total</td><td>Partially Improved Drainage System</td><td>3</td></tr> <tr><td>SRI Total</td><td>High Risk</td><td>36</td></tr> </tbody> </table>		Risk Factor	Ranking	Score	US Channel Morph	DA	3	DS Channel Morph	DA	3	DS Bank Alteration	MINOR/PARTIAL	3	Upstream Skew Angle	>30°	1	Crossing fill condition	Poor/Bare soil	1	Inlet/Outlet Condition	Blocked	1	Road Approach Material	All Sand/Clay	3	Potential Eroded Volume Mean	<21 y ³	5	Approach Slope Mean	<2%	5	Soil K Factor	<0.20	5	Upstream Rt Outlet	Vegetated	1	Upstream Lt Outlet	Vegetated	1	Upstream Rt Ditch	Vegetated	1	Upstream Lt Ditch	Bare soil	0	Downstream Rt Outlet	Bare soil	0	Downstream Lt Outlet	Bare soil	0	Downstream Rt Ditch	Bare soil	0	Downstream Lt Ditch	Bare soil	0	Outlet Total	Partially Improved Outlet System	3	Ditches Total	Partially Improved Drainage System	3	SRI Total	High Risk	36

Notes: Buried culvert.
