Blaze Branch		cr-1103-r-006	Sedimentation Risk Index 44																																																																		
<u>Common:</u> 2.18mi SW of Pine Level <u>Drainage:</u> Lightwood Knot <u>GPS:</u> 31.451029824,-86.209858693 <u>Land owner:</u> John E Bozeman		<u>County:</u> Crenshaw <u>State:</u> Alabama <u>PLSS (T-R-S):</u> 6N-18E-36 <u>Parcel No.:</u> 3 <u>Road Name:</u> Morgan Mill Creek Rd

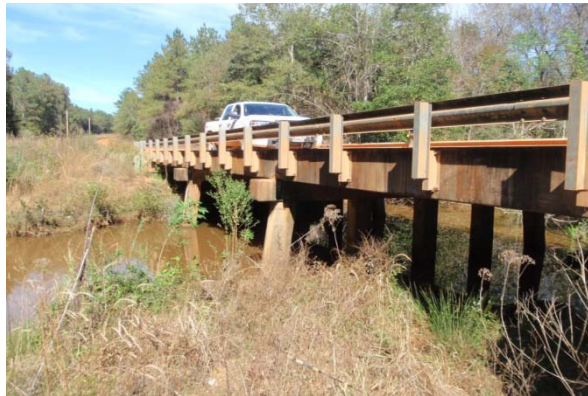
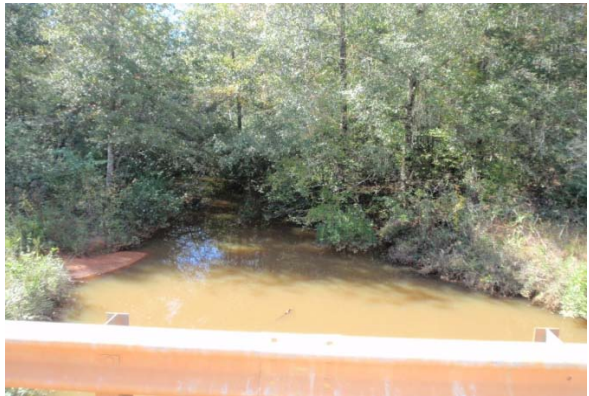
Crossing Structure: DS		DS																																																																			
<table border="1"> <thead> <tr> <th>Risk Factor</th> <th>Ranking</th> <th>Score</th> </tr> </thead> <tbody> <tr><td>US Channel Morph</td><td>DA</td><td>3</td></tr> <tr><td>DS Channel Morph</td><td>C</td><td>5</td></tr> <tr><td>DS Bank Alteration</td><td>MINOR/PARTIAL</td><td>3</td></tr> <tr><td>Upstream Skew Angle</td><td><5°</td><td>5</td></tr> <tr><td>Crossing fill condition</td><td>Good/Vegetated</td><td>5</td></tr> <tr><td>Inlet/Outlet Condition</td><td>No Impairment</td><td>5</td></tr> <tr><td>Road Approach Material</td><td>All Sand/Clay</td><td>3</td></tr> <tr><td>Potential Eroded Volume Mean</td><td>21-40 y³</td><td>3</td></tr> <tr><td>Approach Slope Mean</td><td>2.1-4%</td><td>3</td></tr> <tr><td>Soil K Factor</td><td>0.21-0.40</td><td>3</td></tr> <tr><td>Upstream Rt Outlet</td><td>Vegetated</td><td>1</td></tr> <tr><td>Upstream Lt Outlet</td><td>Vegetated</td><td>1</td></tr> <tr><td>Upstream Rt Ditch</td><td>Bare soil</td><td>0</td></tr> <tr><td>Upstream Lt Ditch</td><td>Bare soil</td><td>0</td></tr> <tr><td>Downstream Rt Outlet</td><td>Vegetated</td><td>1</td></tr> <tr><td>Downstream Lt Outlet</td><td>Vegetated</td><td>1</td></tr> <tr><td>Downstream Rt Ditch</td><td>Bare soil</td><td>0</td></tr> <tr><td>Downstream Lt Ditch</td><td>Bare soil</td><td>0</td></tr> <tr><td>Outlet Total</td><td>Improved Outlet System</td><td>5</td></tr> <tr><td>Ditches Total</td><td>Unimproved Drainage System</td><td>1</td></tr> <tr><td>SRI Total</td><td>Medium Risk</td><td>44</td></tr> </tbody> </table>				Risk Factor	Ranking	Score	US Channel Morph	DA	3	DS Channel Morph	C	5	DS Bank Alteration	MINOR/PARTIAL	3	Upstream Skew Angle	<5°	5	Crossing fill condition	Good/Vegetated	5	Inlet/Outlet Condition	No Impairment	5	Road Approach Material	All Sand/Clay	3	Potential Eroded Volume Mean	21-40 y ³	3	Approach Slope Mean	2.1-4%	3	Soil K Factor	0.21-0.40	3	Upstream Rt Outlet	Vegetated	1	Upstream Lt Outlet	Vegetated	1	Upstream Rt Ditch	Bare soil	0	Upstream Lt Ditch	Bare soil	0	Downstream Rt Outlet	Vegetated	1	Downstream Lt Outlet	Vegetated	1	Downstream Rt Ditch	Bare soil	0	Downstream Lt Ditch	Bare soil	0	Outlet Total	Improved Outlet System	5	Ditches Total	Unimproved Drainage System	1	SRI Total	Medium Risk	44

Notes: Well vegetated buffers. Bare ditches influencing score, with moderate erodible soils.
