| Unnamed tributary | | wa-0716-r-004 | Sedimentation Risk Index<br><b>36</b> |
| <u>Common:</u> | 3.8mi NE of Mossy Head | <u>County:</u> | Walton |
| | | <u>Road Name:</u> | Trout Rd |

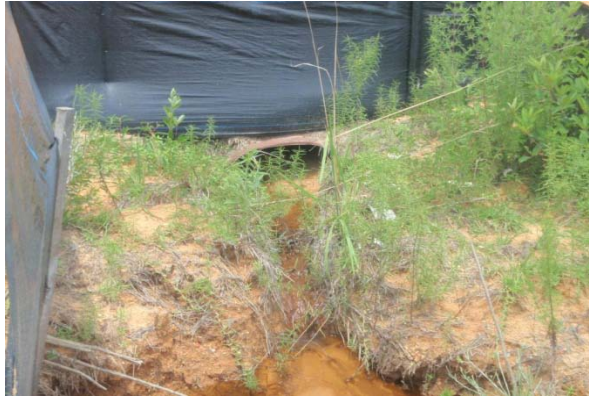
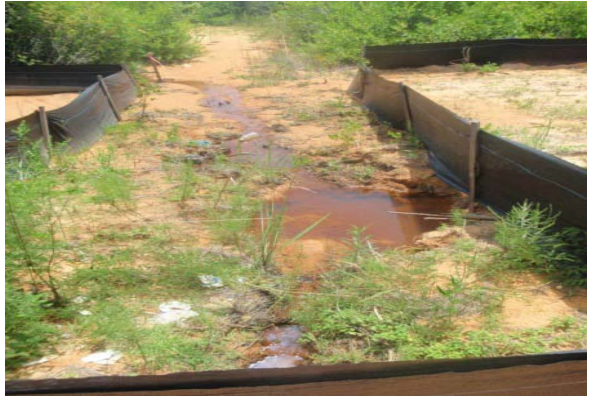
| Unnamed tributary | | wa-0716-r-004 | Sedimentation Risk Index<br><b>36</b> |
|---|---|---|---|
| Crossing Structure: DS | | DS | |

| Unnamed tributary | | wa-0716-r-004 | Sedimentation Risk Index<br><b>36</b> |
|---|---|---|---|
| Crossing fill condition | Poor/Bare soil | 1 | |
| Inlet/Outlet Condition | Sed Islands/Scouring | 3 | |
| <b>SRI Total</b> | <b>High Risk</b> | <b>36</b> | |

Notes: BMPs DS outlets

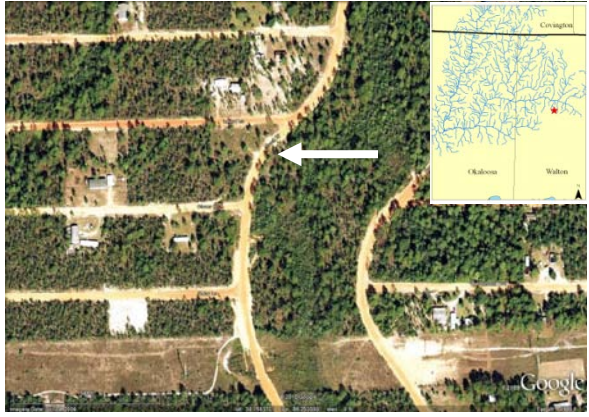
| Unnamed tributary | | wa-0716-r-004 | Sedimentation Risk Index<br><b>36</b> |
|---|---|---|---|
| <b>Additional Site Features</b><br><u>Crossing Type and Quantity:</u> Culvert, 1<br><u>Crossing Materials:</u> Metal<br><u>Soil Types:</u> 8,17,17,32<br><u>Rt Approach Prism Fill:</u> 0.5in<br><u>Lt Approach Prism Fill:</u> 0.5in | | | |
