# **SOIL MOVEMENT NEAR TOWNSHIP**

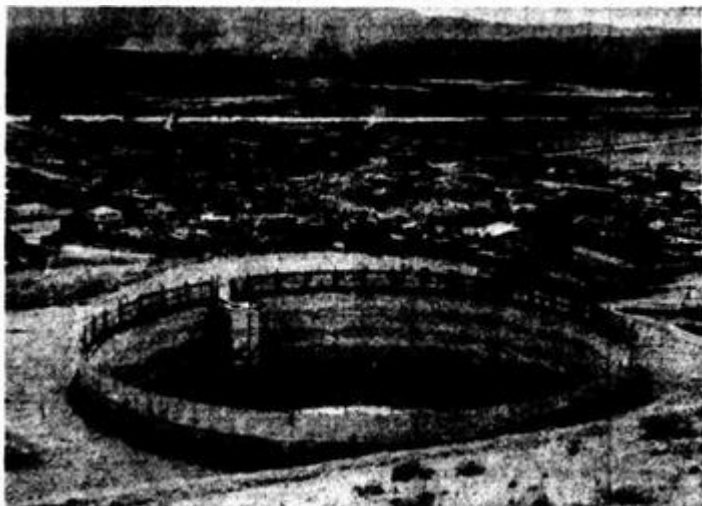
No serious concern is felt for the safety of the million-gallon water surface tank on the hillside (top photograph) nor for the houses near the foot of the hill.

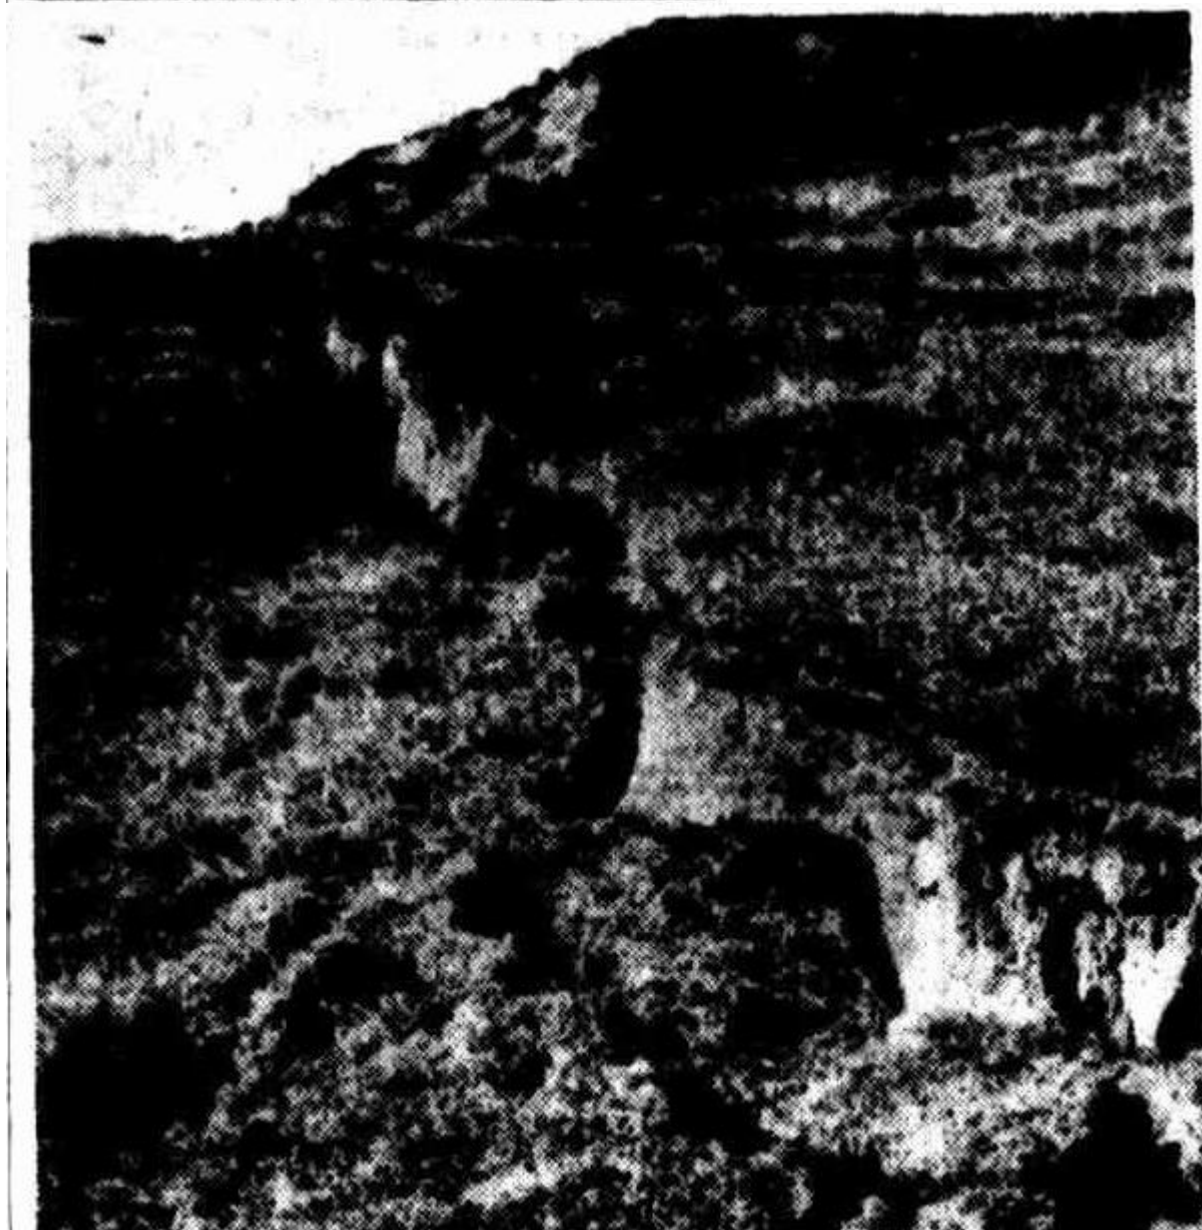
Engineers who examined the hillside yesterday said the movement, which began during the heavy June rains,

appeared to have ceased and only further heavy rains would aggravate the trouble.

The lower photograph shows fissures, some of which are 7ft deep, below the water tank, which serves Boolaroo and Teralba. The hillside has changed from a gradual slope to a series of terraces.

Authorities consulted by the Lake Macquarie Shire Council said the movement was not due to underground mining in the area.
