Impact on structural behavior due to installation of billboard

Article in *Jurnal Teknologi* · August 2017

IMPACT ON STRUCTURAL BEHAVIOR DUE TO INSTALLATION OF BILLBOARD

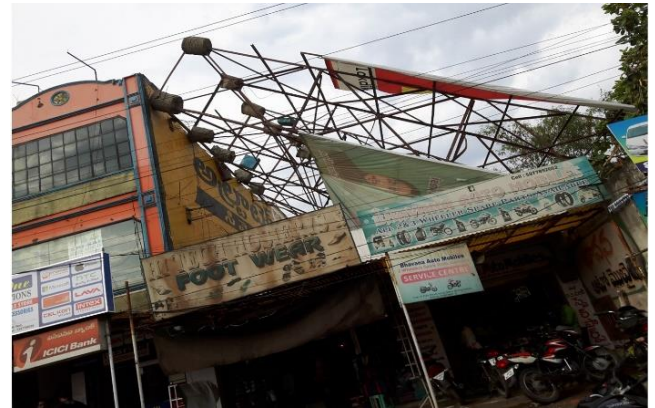
Figure 3 Damage of Billboard and partial damage of building (Raidurgam, Hyderabad, 20 May 2016)

Figures 2-5, show the recent damages of both building which suffered partial damage and complete collapse of billboards. Pictures have been taken by the authors themselves.

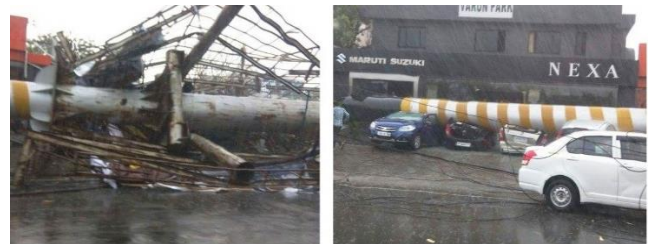
Figure 4 Damage of Billboard and partial damage of building (Jubilee Hills check post, Hyderabad, 20 May 2016)

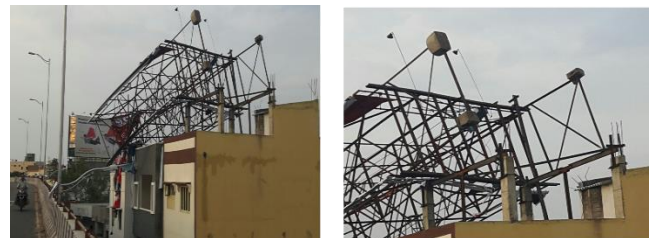
Figure 5 Damage of Billboard and partial damage of building (Tolichowki, Hyderabad, 20 May 2016)

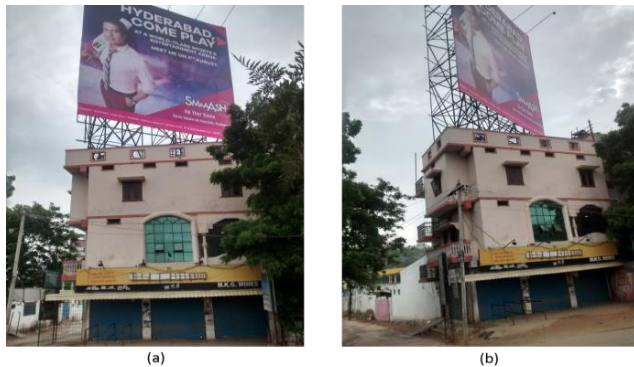
Figure 6 Existing structure considered for this study

For this study a G+2 structure with billboard located at Raidurg, Hyderabad is considered, which is shown in Figure 6 from two different views. Structural details of building are shown in Figure 8 and geometrical specifications are mentioned in Table 2, similarly details of billboard are shown in the Figure 9 and geometrical specifications of the channels used for numerical modeling are given in Table 2.

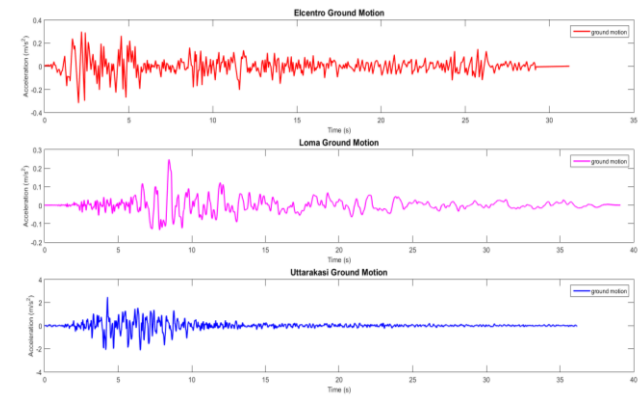
**Figure 13** Three ground motions considered for this study, a. El Centro earthquake, b. Loma Prieta earthquake and c. Uttarkashi earthquake

Linear time history analysis (THA) is carried out for three ground motions viz. **a.** 1940 El Centro earthquake ground motion which occurred in the Imperial Valley having a moment magnitude of 6.9 and maximum perceived intensity of X on the Mercalli intensity scale and first major earthquake recorded by a strong-motion seismograph [7-9]. **b.** Second earthquake ground motion considered for this study is Loma Prieta earthquake occurred in Northern California on 17th October 1989 with a moment magnitude of 6.9 on a section of San Andreas Fault system. **c.** Third ground motion is of 1991 Uttarkashi earthquake of moment magnitude 6.8 occurred within the main thrust system of Himalayas [10, 11]. All three ground motions are shown in Figure 13. To understand the response for building, billboard and for combined structure few joints have been selected. Figure 14 shows the building, billboard and combined structural with highlighted joint locations where response is taken and plotted. Three joints 6, 7 and 8 are taken for the building. Six joints 68, 69, 70, 71, 72 and 73 for billboard. And the same joints have been considered for combined structure as for building. Even though joints are same, but when structure has been combined joint numbers have been changed to 39, 57, 75, 99 and 109 which are similar to joints 68, 69, 70, 71, 72 and 73 respectively. The major assumption of the study is the joint connection between the building and billboard is assumed to be rigid. Since, this study mainly focused towards the change in behavior after installation of the billboard on a new structure or on an existing structure. Apart from joint connection, the total analysis is linear which actually give the fundamental behavior of the structure up to a limit.

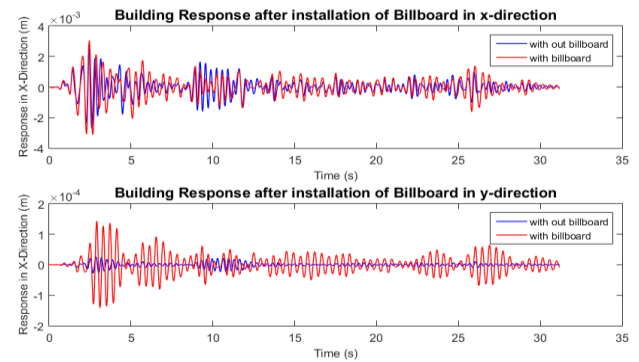
Figure 17 Comparison of response within the building at three joints shown in Figure 13 after installation of billboard for both x and y directions

Figure 17 shows the combined response of the building with and without billboard. The red color line indicates the response of the building with billboard and blue color line indicates the response of the structure of only building. From the plot, it is clear evident that the response of the structure has changed. The percentage change in x-direction is only 6 %, where as in y-direction it is 18 %. The major reason for this change is because of its stiffness.

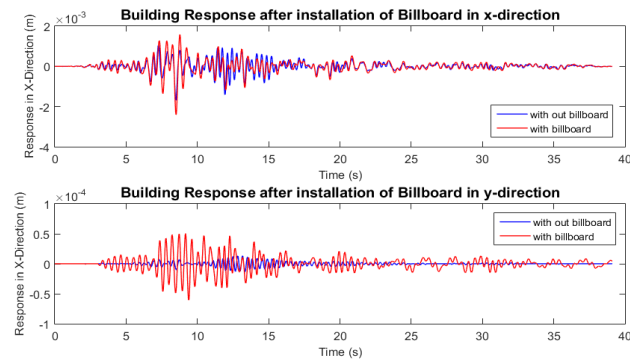
Figure 20 Comparison of response within the building at three joints shown in Figure 13 after installation of billboard for both x and y directions

Figure 20 shows the combined response of the building with and without billboard. The red color line indicates the response of the building with billboard and blue color line indicates the response of the structure of only building. From the plot, it is clear evident that the response of the structure has changed. The percentage change in x-direction is 30 %, where as in y-direction it is 79.4 %. It is a clear evident that the type of ground motion will change the total response of the structure. The percentage change of billboard response acquired for Loma Prieta is quite different from the response obtained due to El Centro earthquake. These comparisons actually show the importance of this study even for two earthquakes scenarios. One of the major reason for these two earthquake ground motions the response of the billboard is same at all the joints from bottom to top is because of its action like a soft storey. This effect is also seen in the mode shape two. Where its frequency is 1.13 Hz and time period is 0.884 seconds. Apart from that the upper part of the billboard is being rigid.

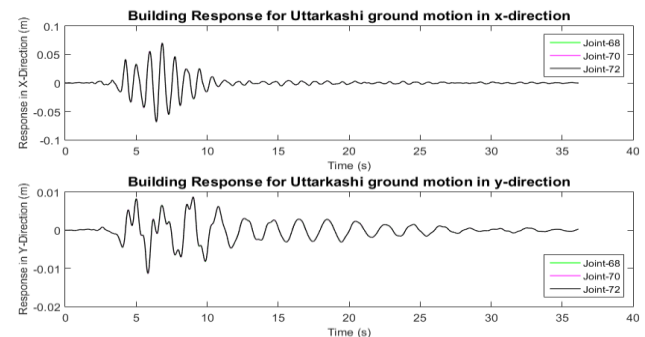
Figure 22 Comparison of response within the billboard at three joints shown in Figure 13 for both x and y directions

Figure 22 shows the response of the billboard in both the x and y directions. The maximum displacement of the billboard in x-direction is 70.34 mm and displacement in y-direction is 11.36 mm. In fact this is the highest displacement when compared to other two ground motions. If the predominant frequency of the ground motion match's with the natural frequency of the billboard, then it would increase the response of the billboard. Other reason would be the peak ground acceleration of the Uttarkashi earthquake. And Figure 23 shows the combined response of the building with and without billboard. The red color line indicates the response of the building with billboard and blue color line indicates the response of the structure of only building. The percentage change in the response of the building with billboard in x-direction is 33 %, whereas, the displacement increase on the top of the structure in y-direction with billboard is 77%.
