3-12 VISIBILITY OF REARVIEW MIRROR AND SIDE TURN SIGNAL LAMP AFTER REAR BODY INSTALLATION

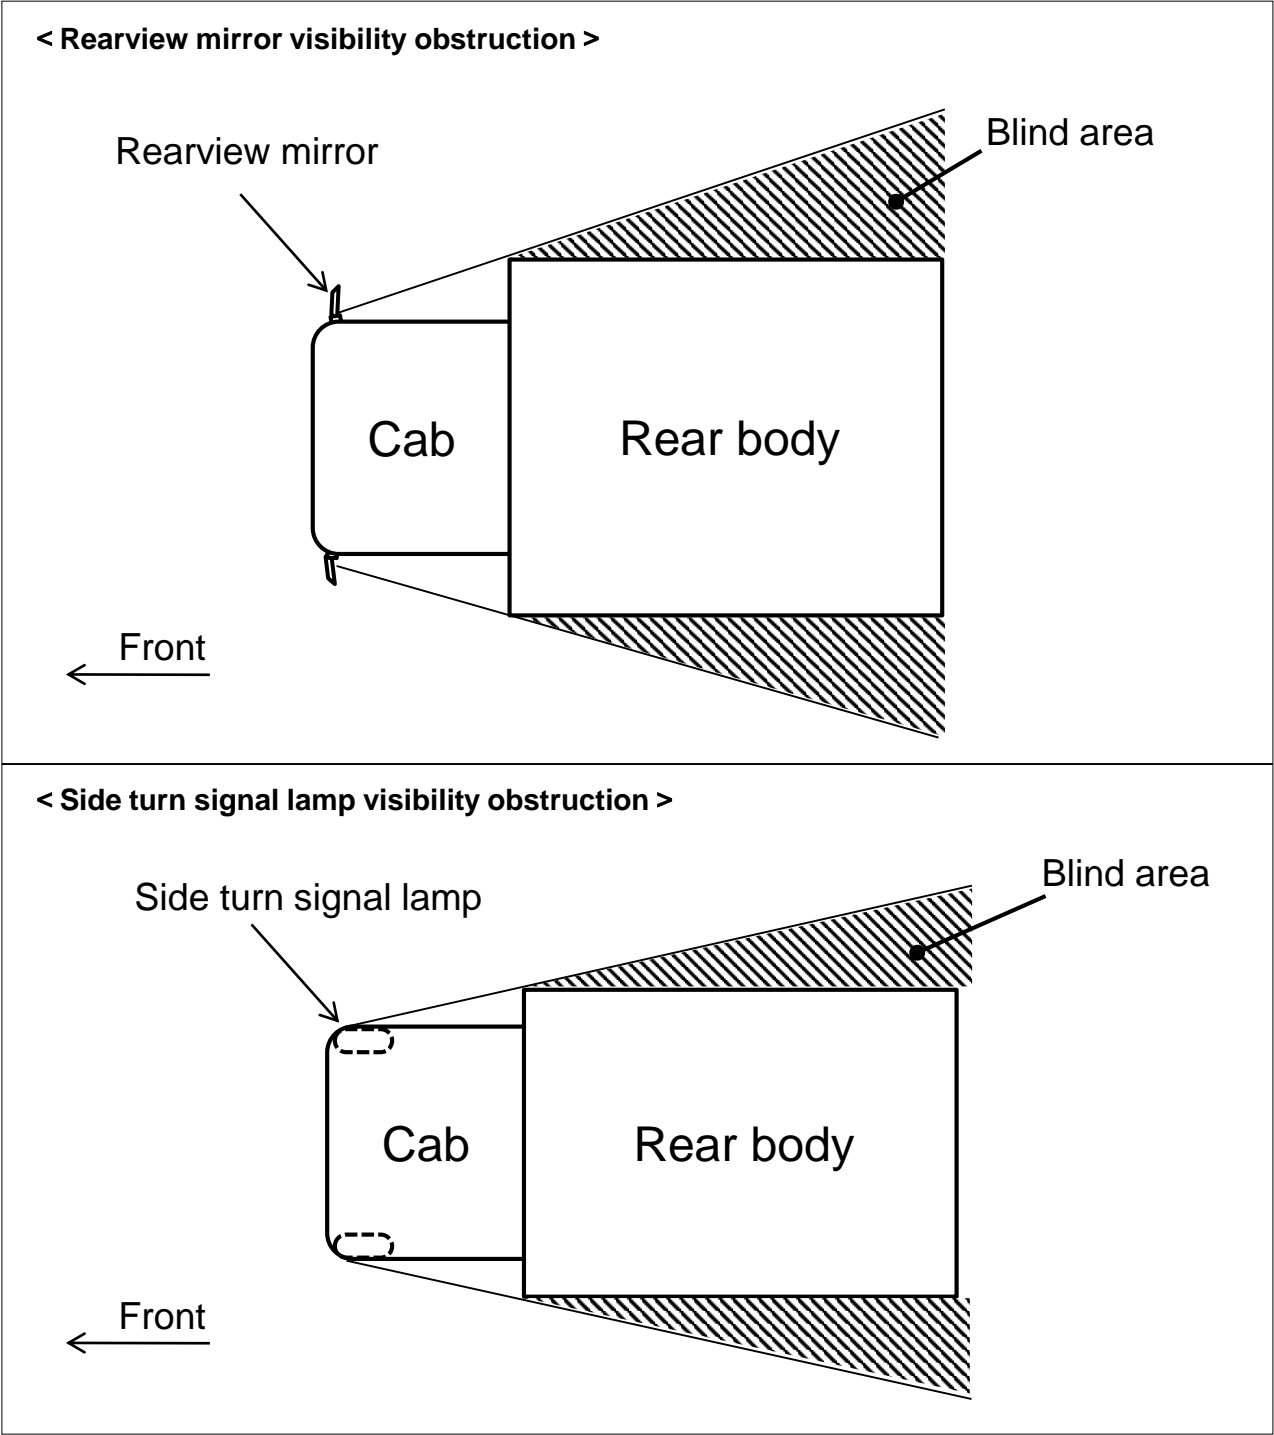
Depending on the width of the mounted rear body, visibility of the rearview mirror and side turn signal lamp may be obstructed. Body builders must ensure the visibility of the rearview mirror and the side turn signal lamp after rear body installation, and carry out a rear body installation that enables safe operation of the vehicle.

Example of visibility obstruction by rear body
