② Front end of a sub frame

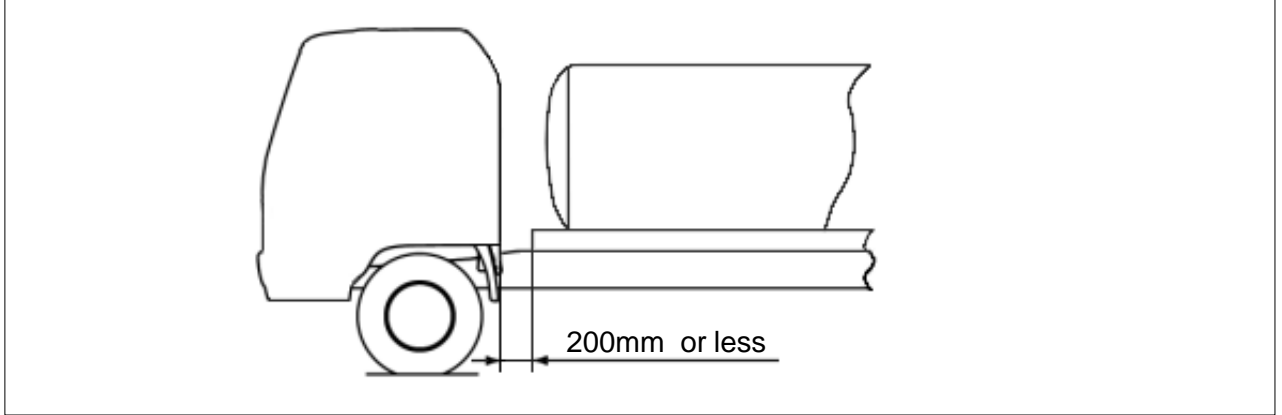
**Position of the sub frame front end**

- Mislocation of the front end of a sub frame may result in cracks in a chassis frame in that area, or deterioration in ride comfort. The distance between the rear face of cab back and the front end of a sub frame should be no longer than 200mm.
