RE-INSPECTION: 767HM01_2004

BUILDING 767
FIRST FLOOR PLAN
FLOORS AND WALLS
2003-2004 ASBESTOS RE-INSPECTION

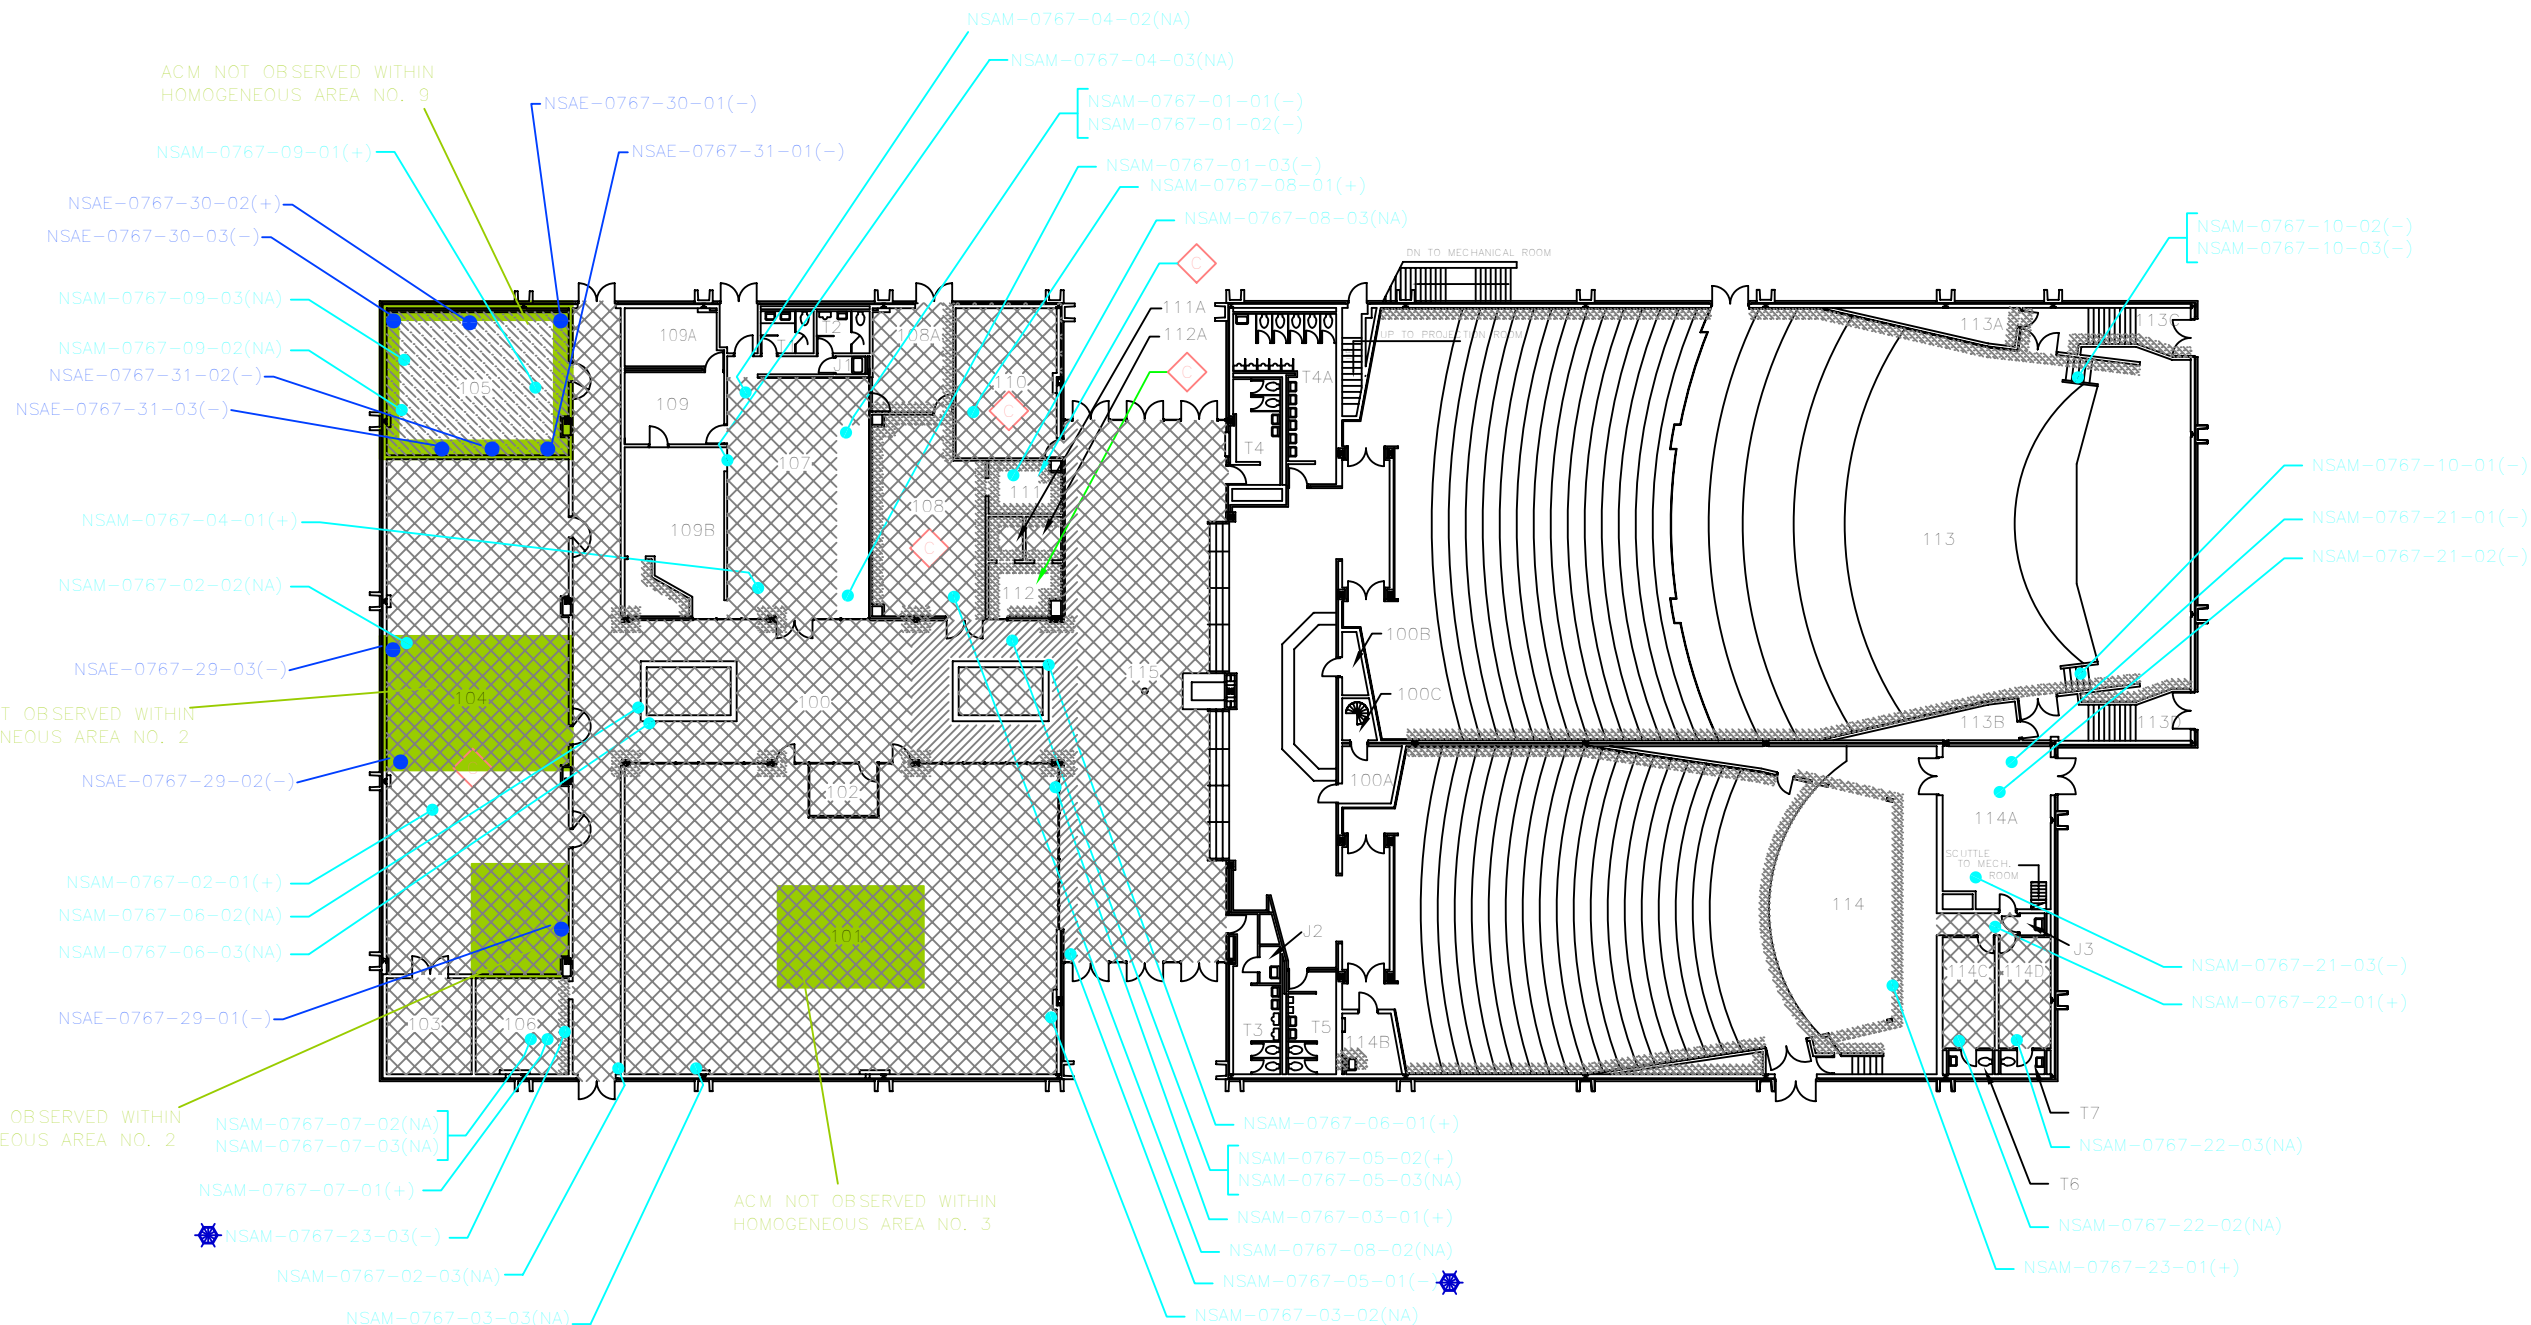
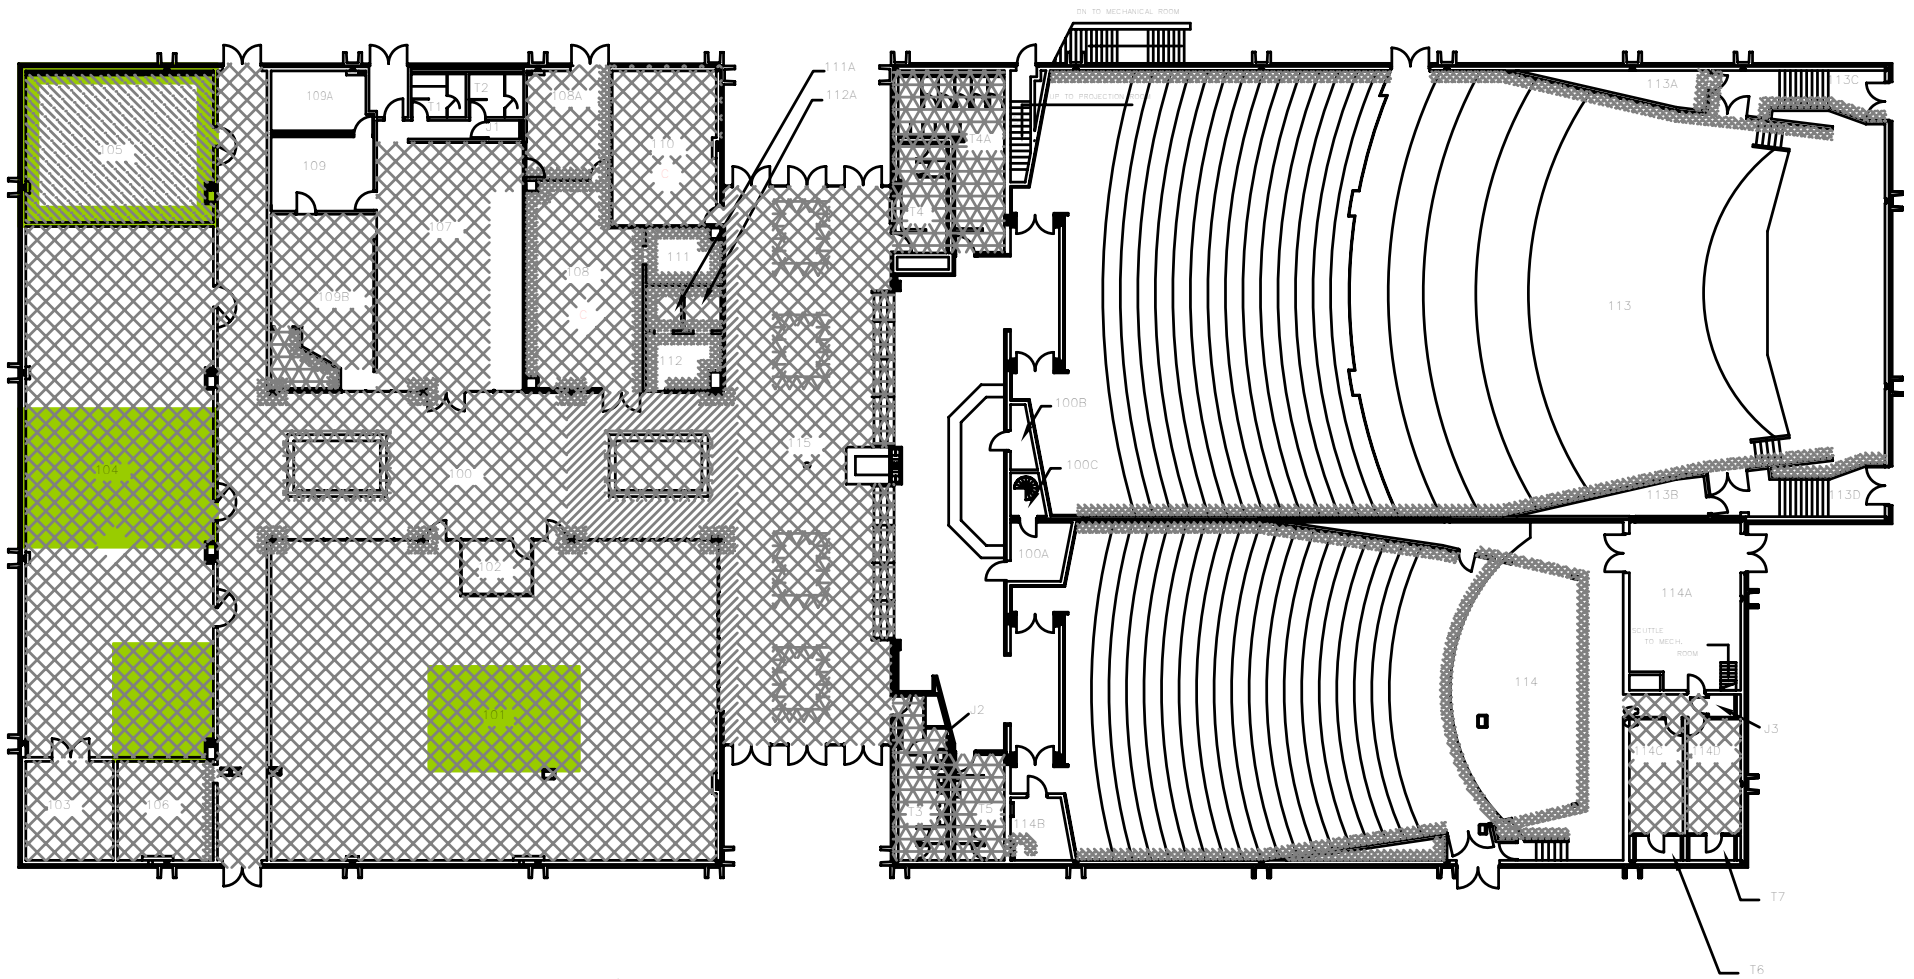
- - LOCATION OF BULK SAMPLES COLLECTED BY ENSAFE
- - ACM WAS NOT OBSERVED DURING ENSAFE'S 2003-2004 RE-INSPECTION

ASBESTOS-CONTAINING MATERIALS (ACM)
IDENTIFIED - FLOORS AND WALLS
