CODION LTD		TITLE A3000_16MB	
SIZE A3	DIMENSIONS	VARIANT [No Variations]	REVISION 1.0
DATE 2023		SHEET 1 OF 5	
FILE A3000_16MB_Glue.SchDoc		DRAWN BY

CODION LTD		TITLE A3000_16MB	
SIZE A3	DIMENSIONS	VARIANT [No Variations]	REVISION 1.0
DATE 2023		SHEET 2 OF 5	
FILE A3000_16MB.SchDoc		DRAWN BY

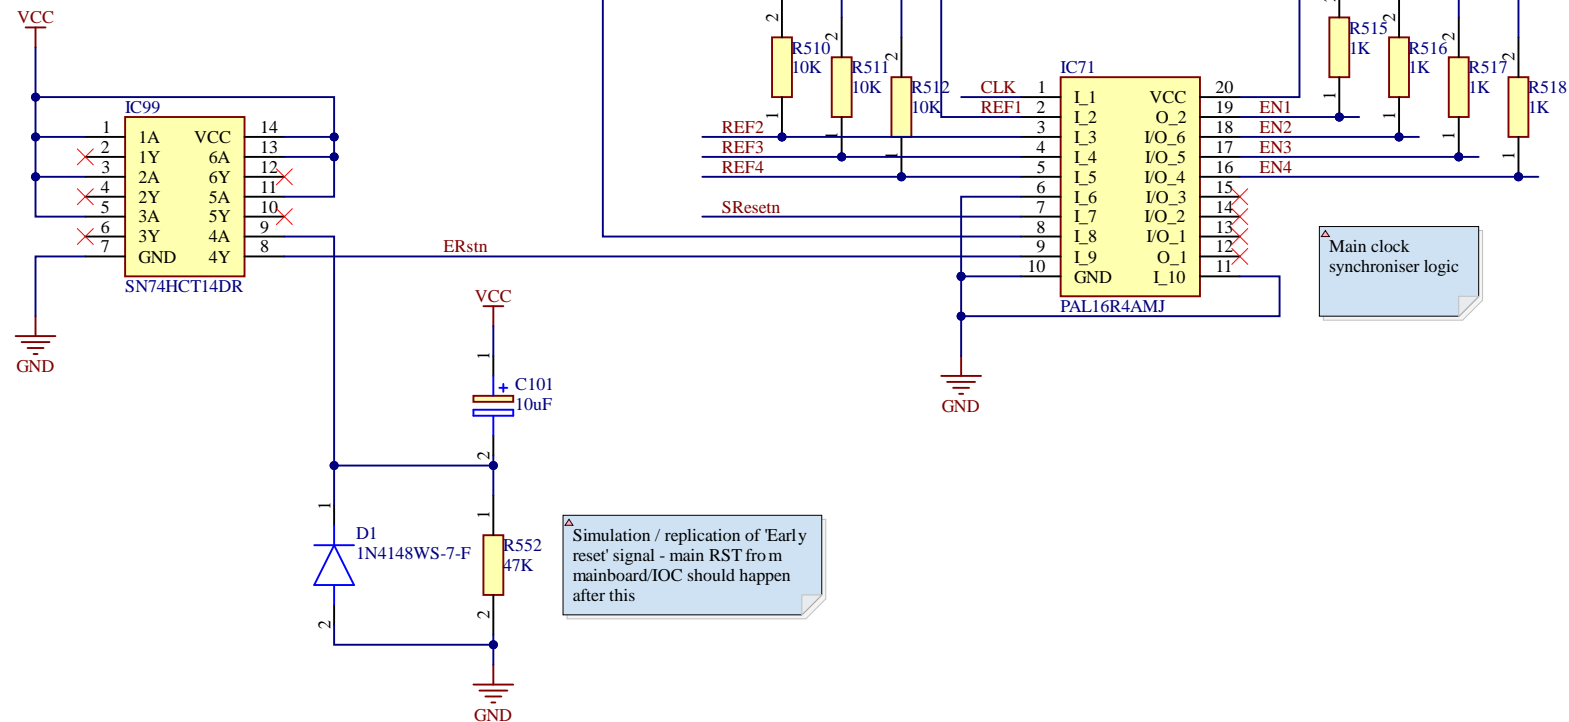
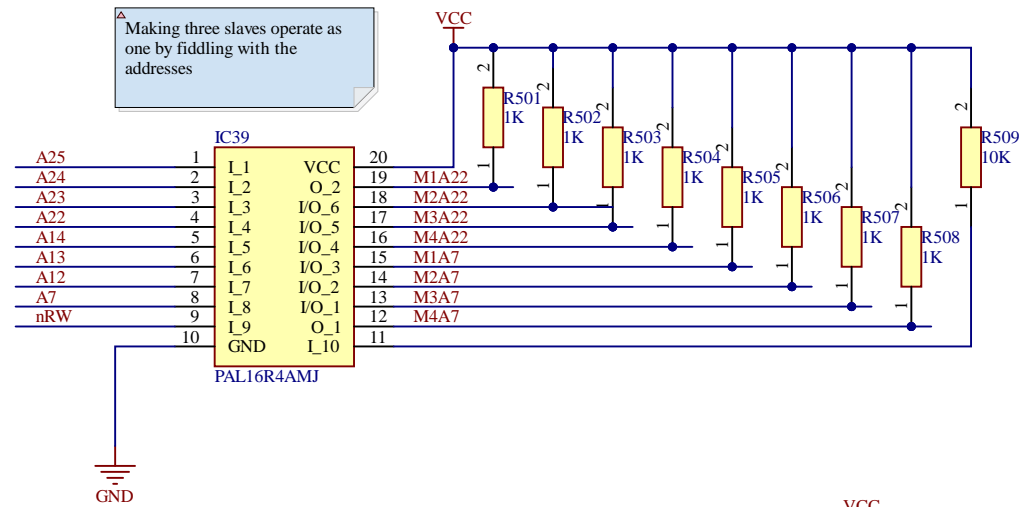
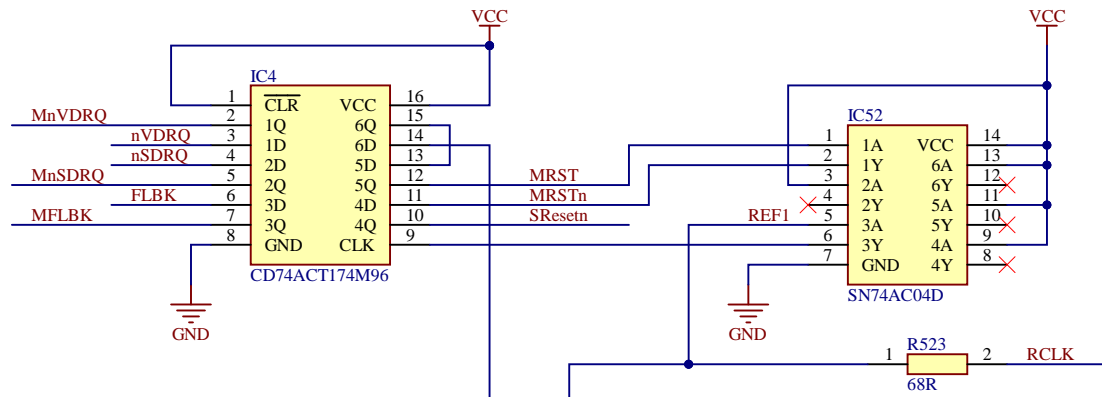
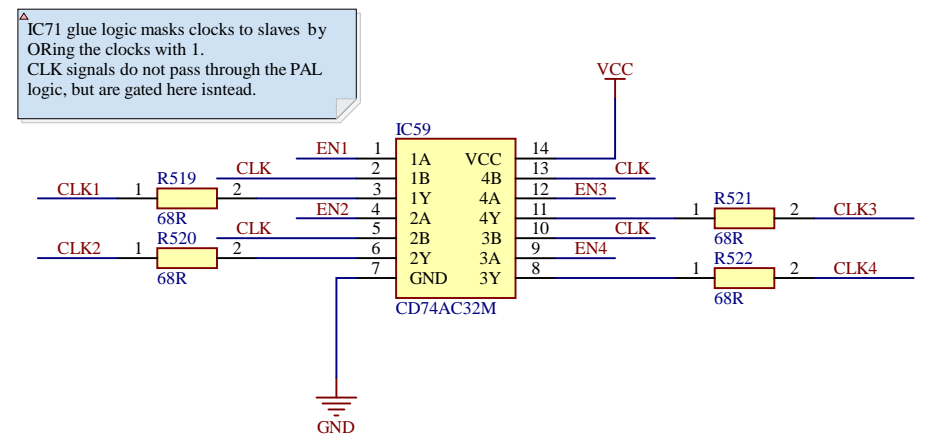
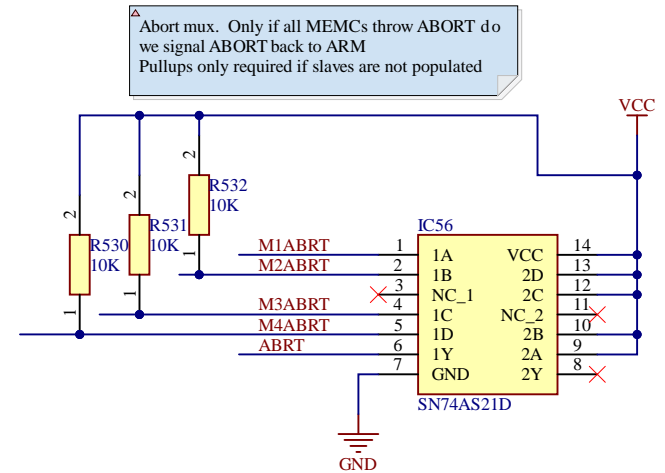
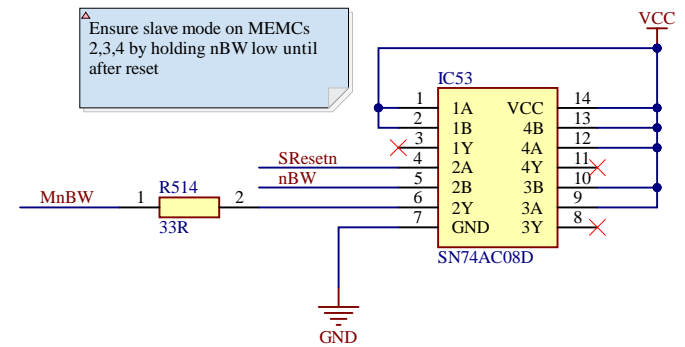
MRST is fed back down the plug for ARM. IC47 on the motherboard must have pin12 lifted so it is not driving this signal. The lifted leg should be wired to the RST_IN connector on our board instead.

Pullups for motherboard RAM may not be required as BANK pulls OE, but undriven circuits "probably bad" so fit if paranoic
