SCAFFOLDING ANKLE INJURY

No – 22.20

This Corporate Memory bulletin is issued to recall the circumstances associated with a significant accident or incident that has occurred within the past 5 years.

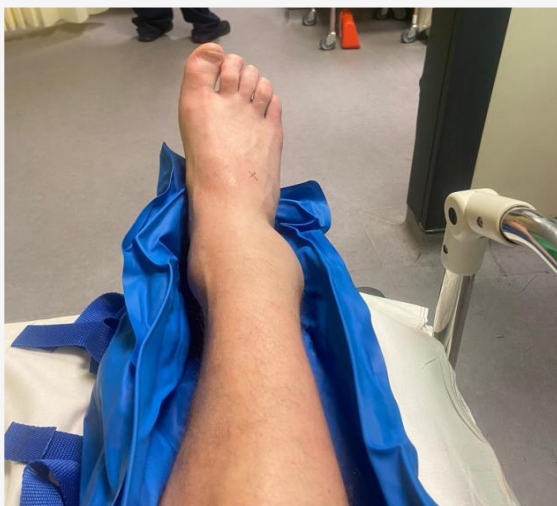
On the 15th of June 2021, a subcontractor undertaking bridge refurbishment works was walking across a scaffold deck with a bucket of fixings when their right foot came to rest in gap between two scaffolding boards.

As the person transferred their weight onto their right leg, one of the scaffold boards flexed causing the ankle of their right foot to twist suddenly due to the movement of the boards.

The investigation into this incident identified that the scaffold deck where the accident occurred had not been fully handed over for general use and therefore it should have not been accessible.

It was also identified that some of the spacings of the scaffold boards on the supporting scaffold tubes meant that there were excessive gaps in the scaffolding that needed to be filled with in-fill boards or decking.

These issues were corrected at the time.

- Any gaps in the scaffold working platform must be closed or covered with a suitable material to prevent any access hazards.
- Sites where personnel are required to work at height must include work at height rescue arrangements (for emergency situations or the retrieval of injured persons) into their site emergency and contingency plans.
