## PROBABILISTIC CORROSION RATE ESTIMATION MODEL FOR LONGITUDINAL STRENGTH MEMBERS OF BULK CARRIERS

Jeom Kee Paik,<sup>\*,†</sup> Sung Kyu Kim<sup>‡</sup> and Sang Kon Lee<sup>†</sup>

<sup>†</sup>Pusan National University, Department of Naval Architecture and Ocean Engineering, Pusan 609-735, Korea

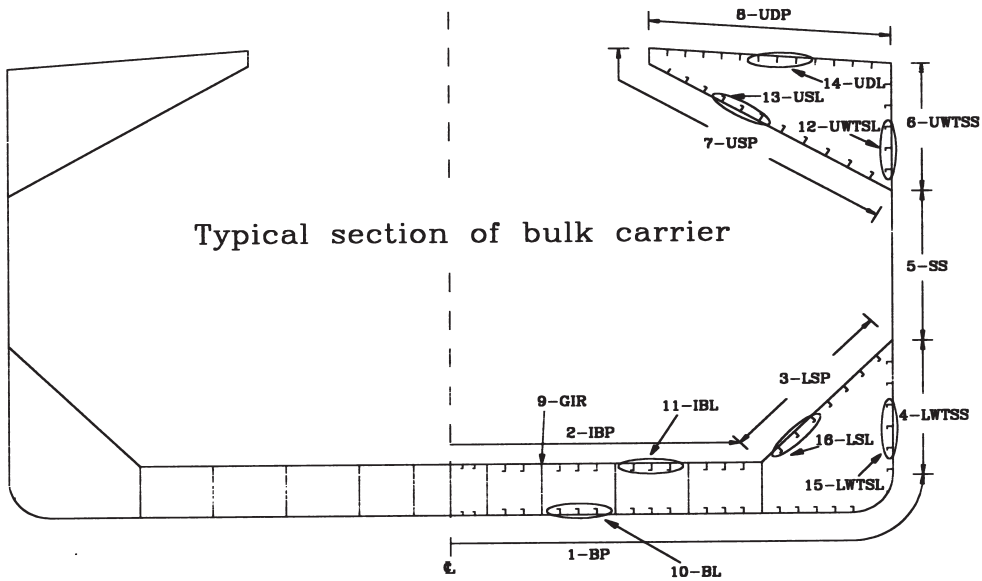
Fig. 1. Longitudinal primary members of bulk carrier.

A total of 7503 corrosion data for 44 existing bulk carriers were obtained. The corrosion data pertained to 16 types of primary structural members of bulk carriers (see Table 1 and Fig. 1). Table 2 indicates examples of the statistics of corrosion data for primary members as a function of time. The corrosion data indicated in Table 2 are based on assumption that corrosion starts 5 years after new-building. Thus, the time, for instance, 4.75 ~ 5.00 in Table 2 indicates the ship age of 9.75 ~ 10.00 years. It should also be noted that some of the data obtained might be measured for repaired members, indicating even smaller wear of corrosion. This is in fact due to lack of measurement information. As will be noted later, therefore, the analysis is made based on some or all of the corrosion data collected.

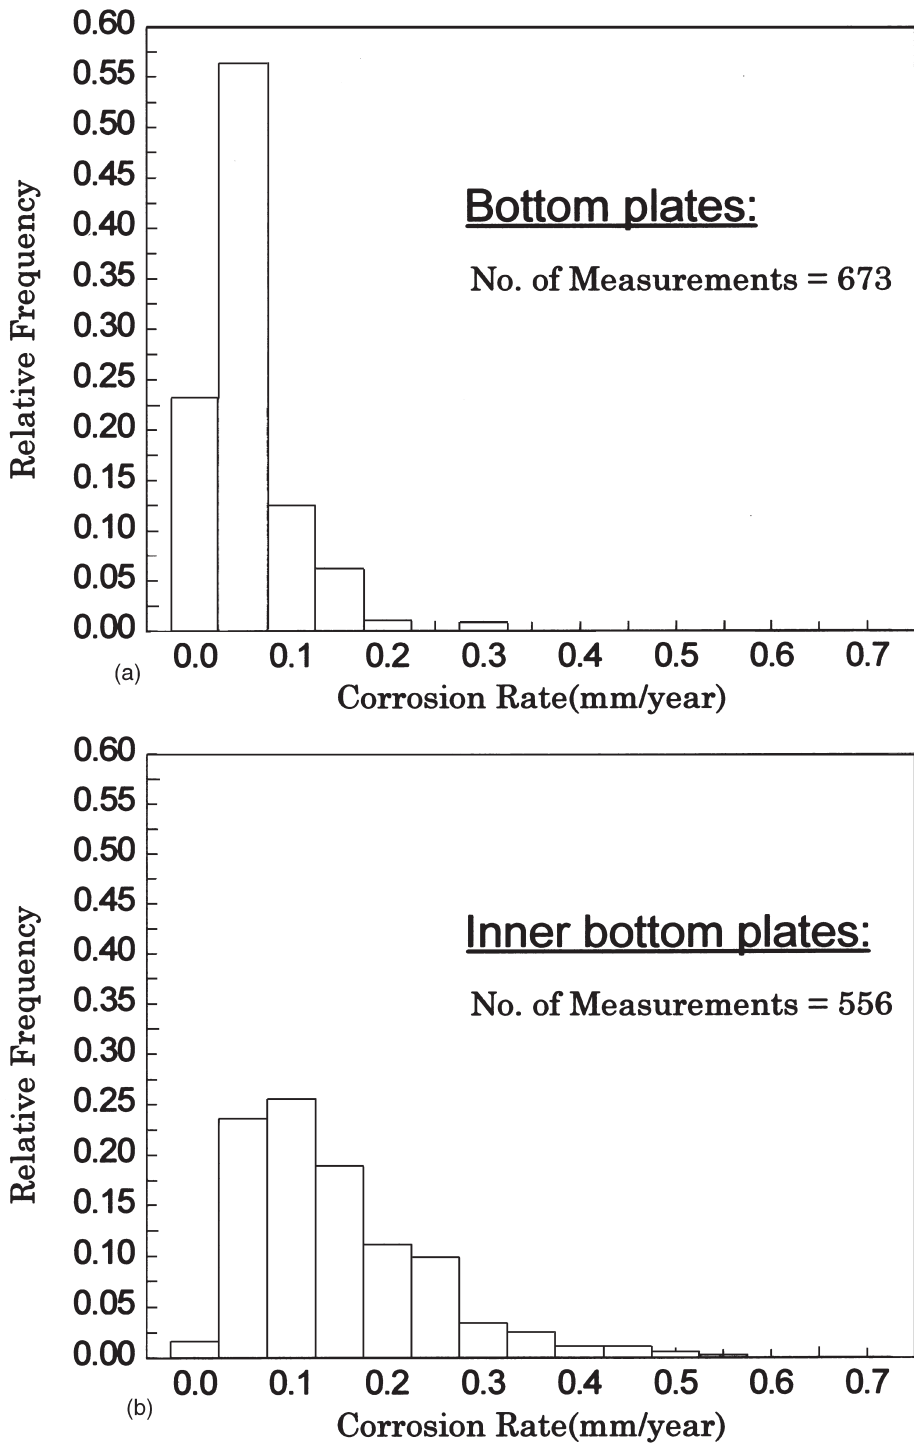
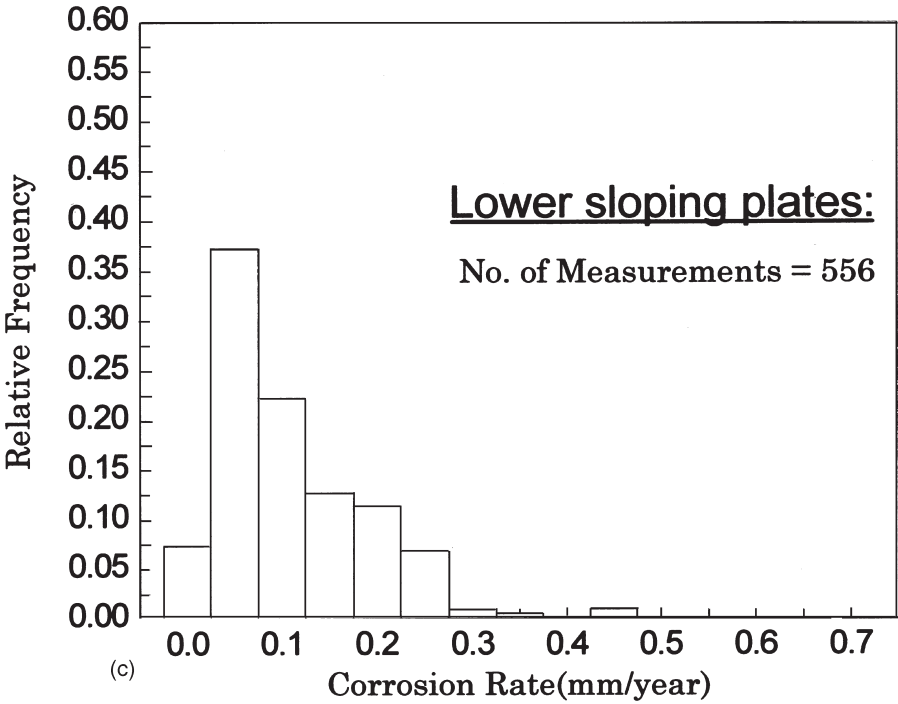
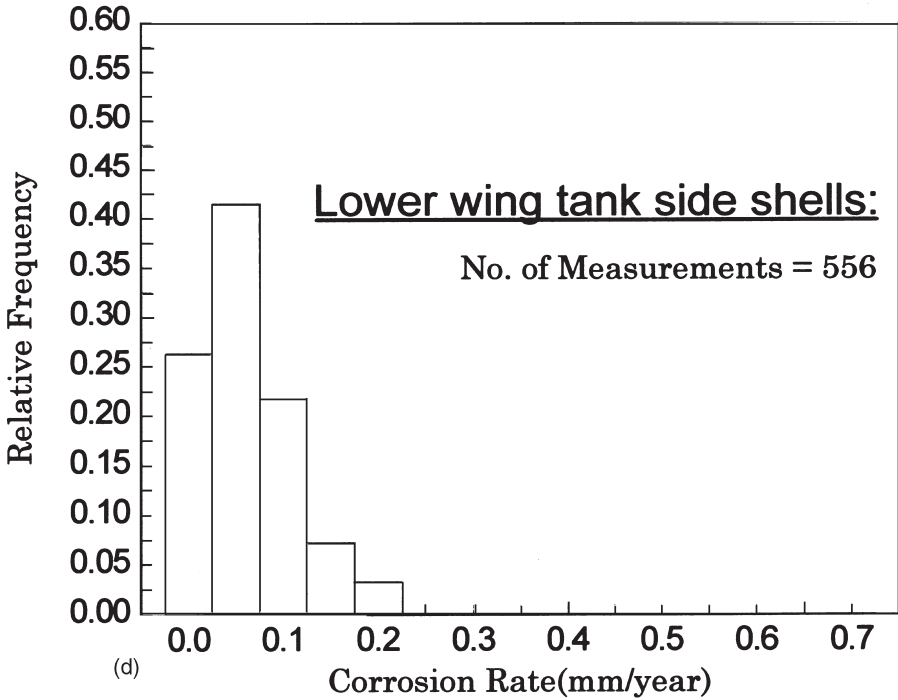
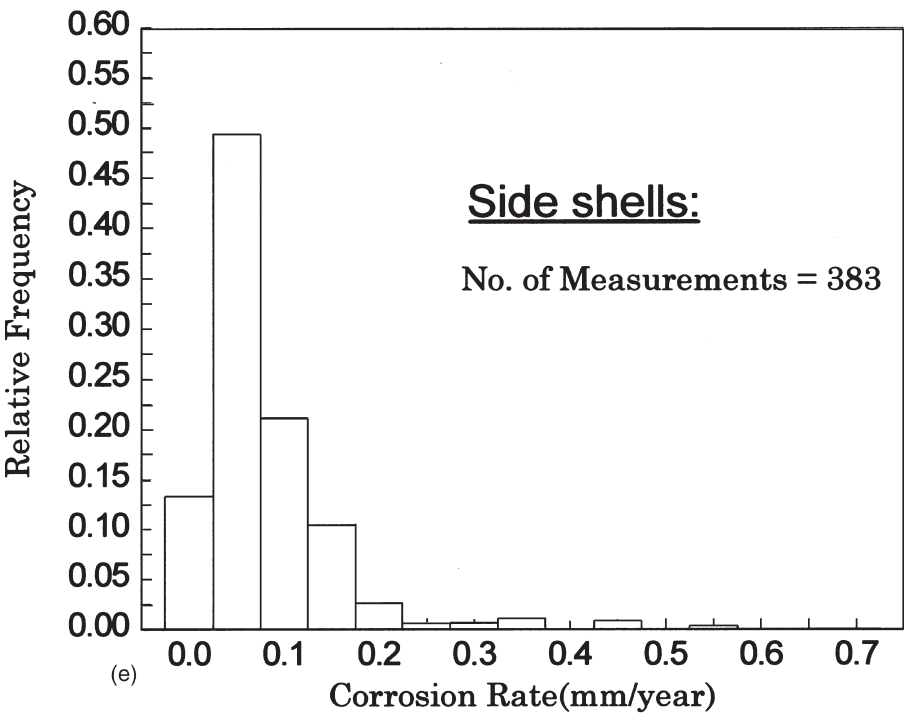
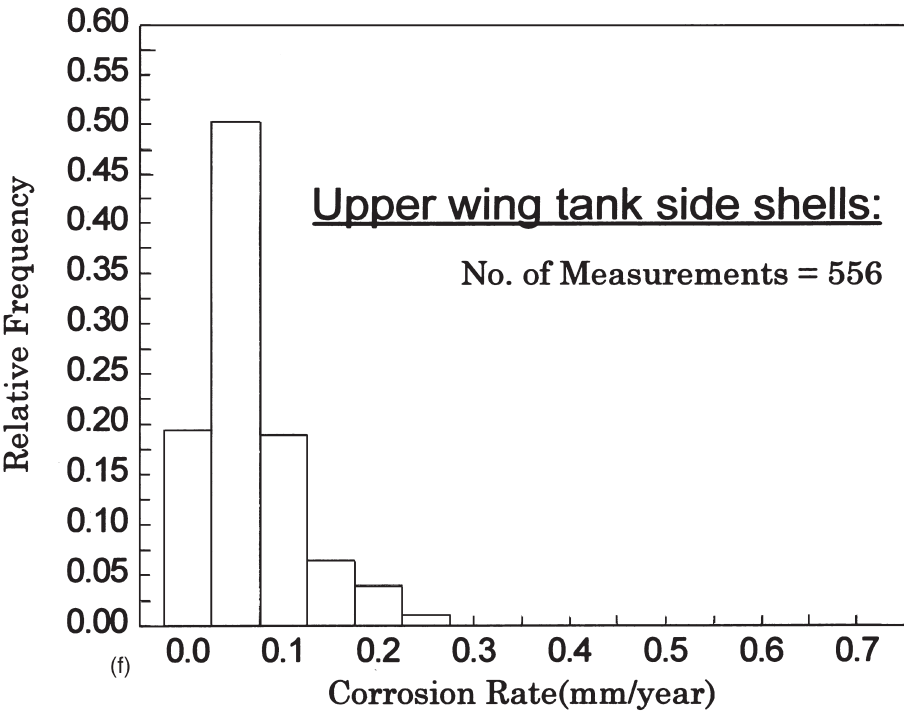
Fig. 2. Frequency distribution of corrosion rate for (a) bottom plates of bulk carriers; (b) inner bottom plates of bulk carriers; (c) lower sloping plates of bulk carriers; (d) lower wing side shells of bulk carriers; (e) side shells of bulk carriers; (f) upper wing tank side shells of bulk carrier.

From such data, Fig. 2 shows the calculated relative frequency distribution of annual corrosion rate, e.g., wear of thickness due to corrosion divided by ship age (mm/year) for each member region. It is seen that there is a large scatter in the corrosion rate data, and so a probabilistic treatment of the problem is needed.

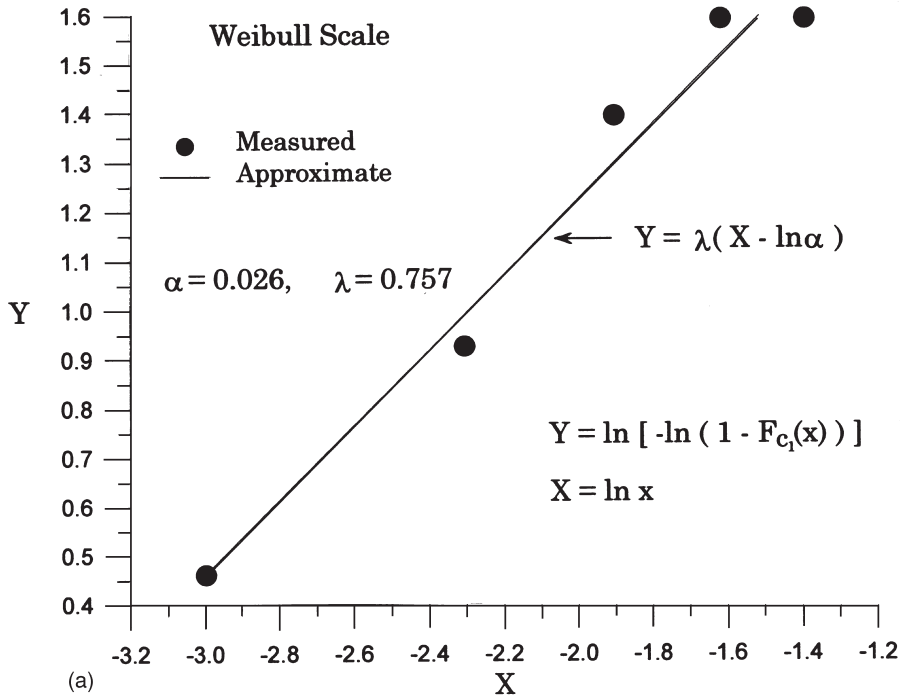
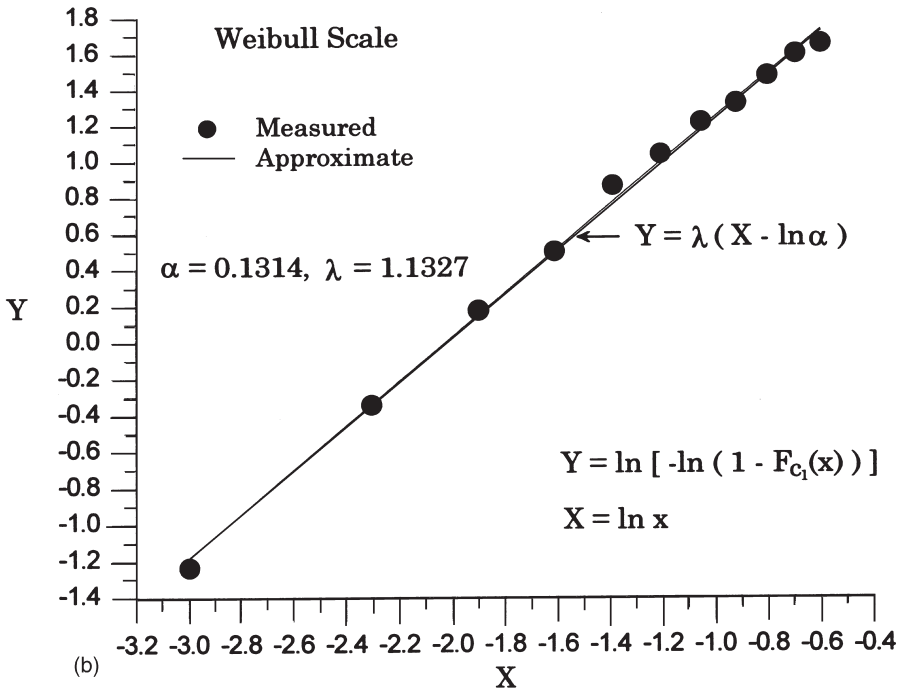
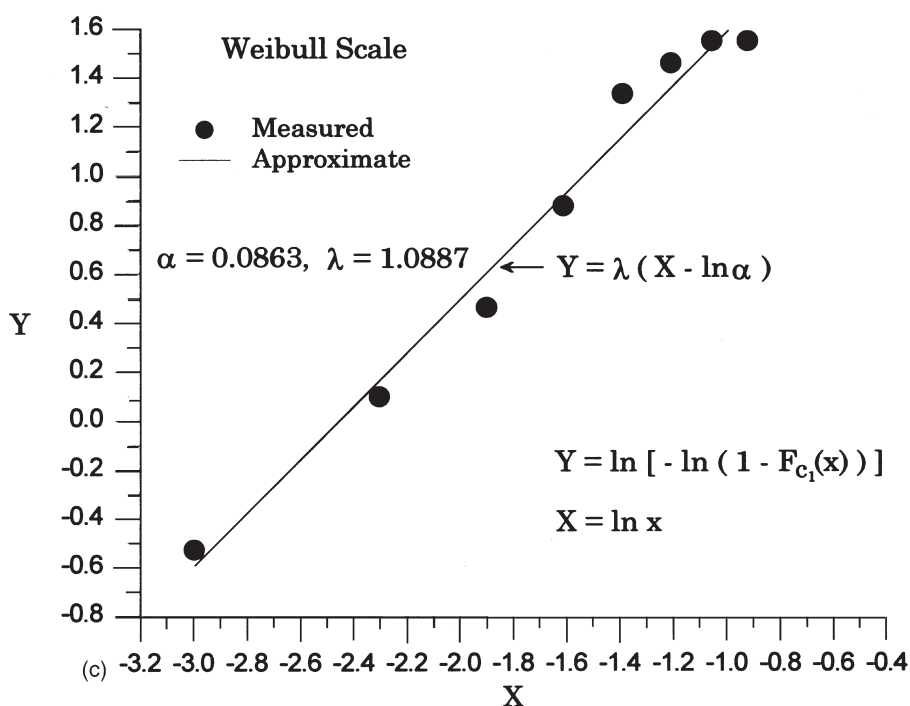
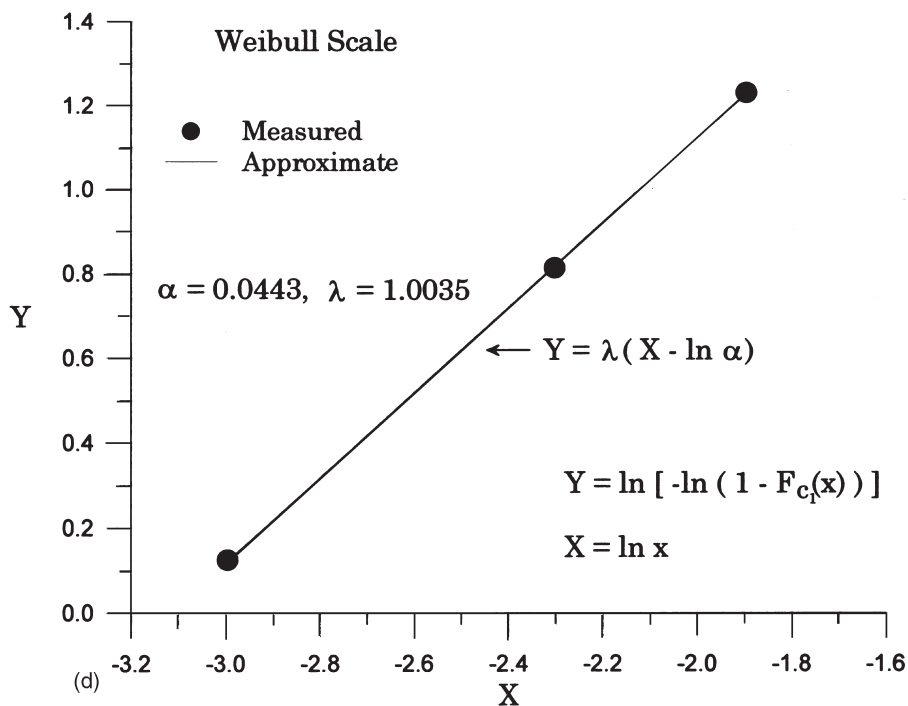
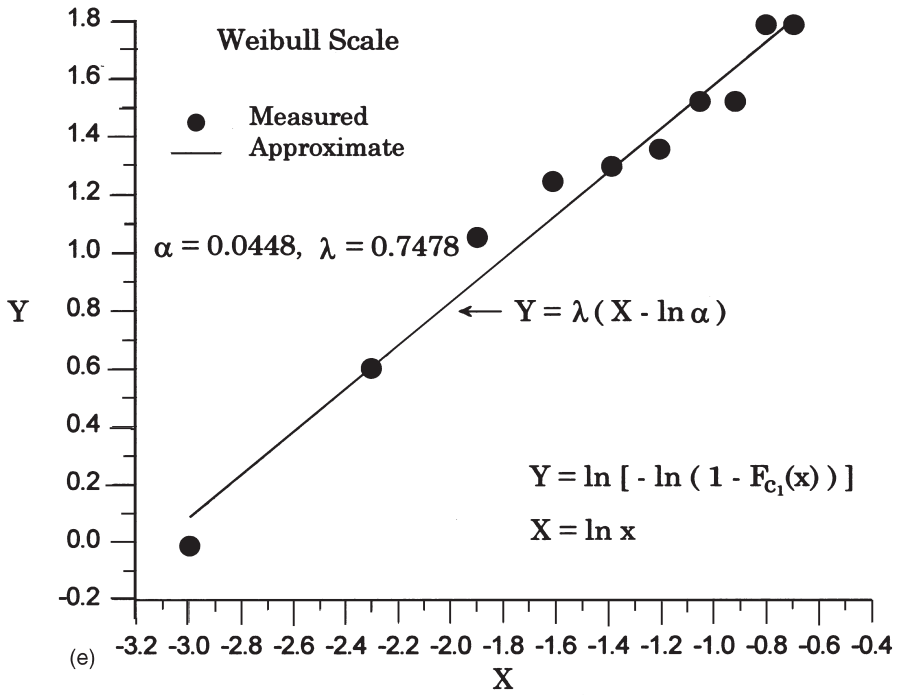
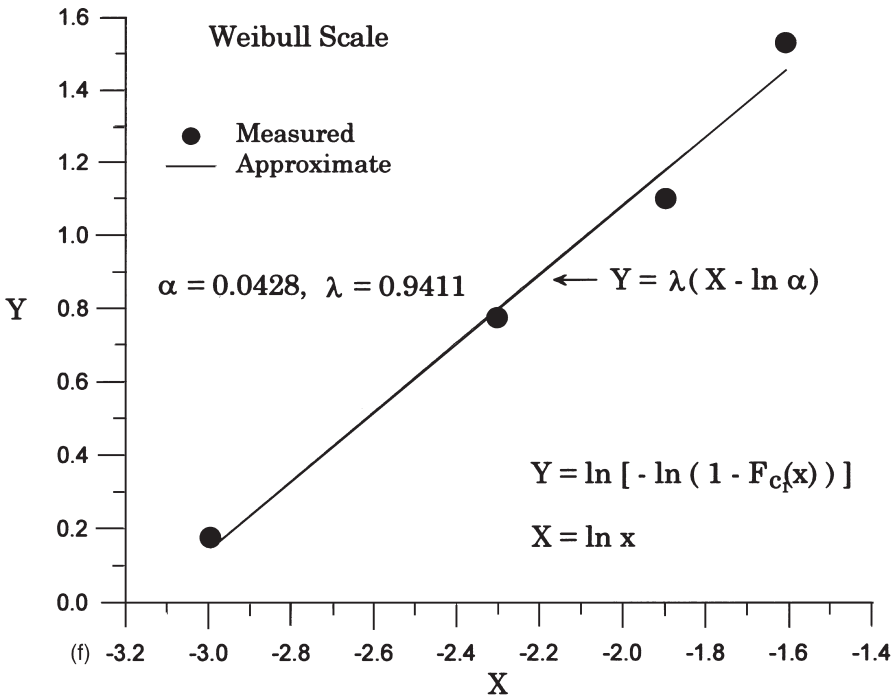
Fig. 3. Curve fitting for determining parameters  $\alpha$  and  $\lambda$  for corrosion wear depth of (a) bottom plates; (b) inner bottom plates; (c) lower sloping plates; (d) lower wing tank side shells; (e) side shells; (f) upper wing tank side shells.

Figure 3 indicates results of the curve fitting (using all data collected) to determine scale and shape parameters of the coefficient  $c_1$ , e.g.  $\alpha$  and  $\lambda$ , which is assumed to follow the Weibull function. Such curve fit calculations are made for each primary member. It is seen from Fig. 3 that the relationship between  $Y (= \ln [ - \ln (1 - F_{c_1}(x)) ]$  and  $X (= \ln x)$  could be reasonably assumed to be linear, indicating the appropriateness of the Weibull distribution. In Fig. 4, verification of the approximation is made by comparing the com-

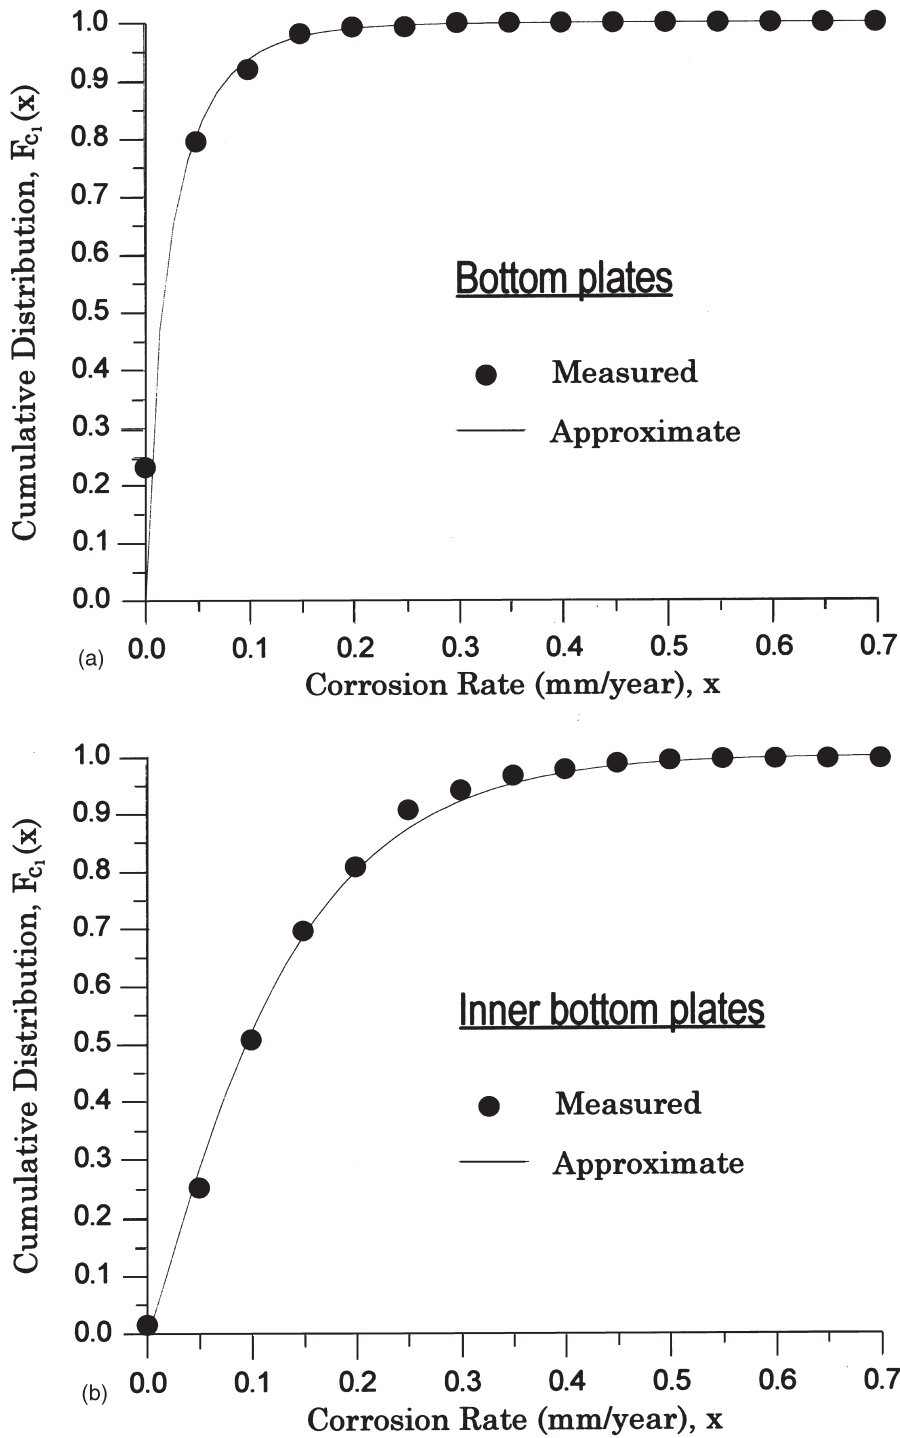
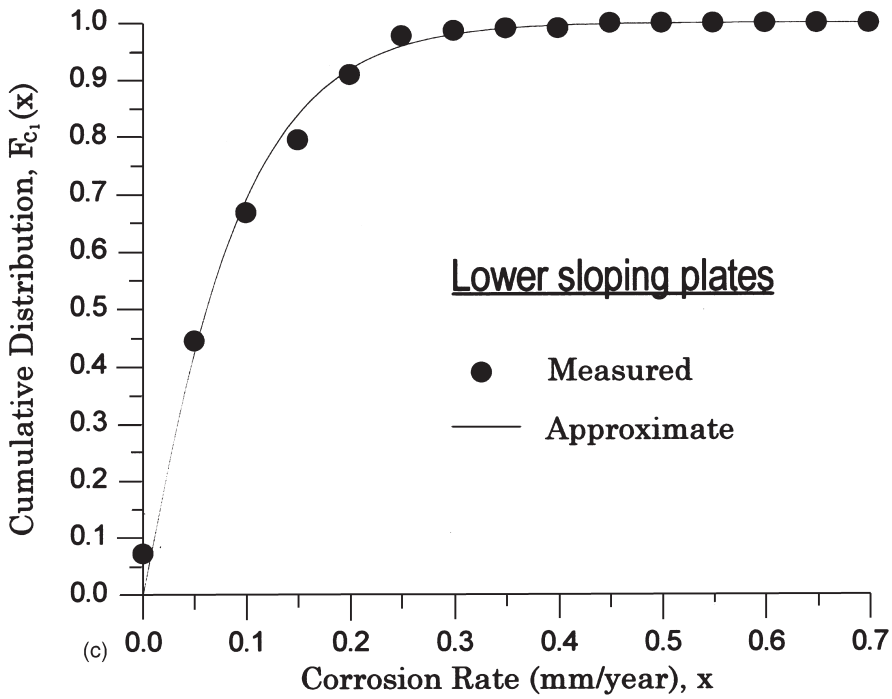
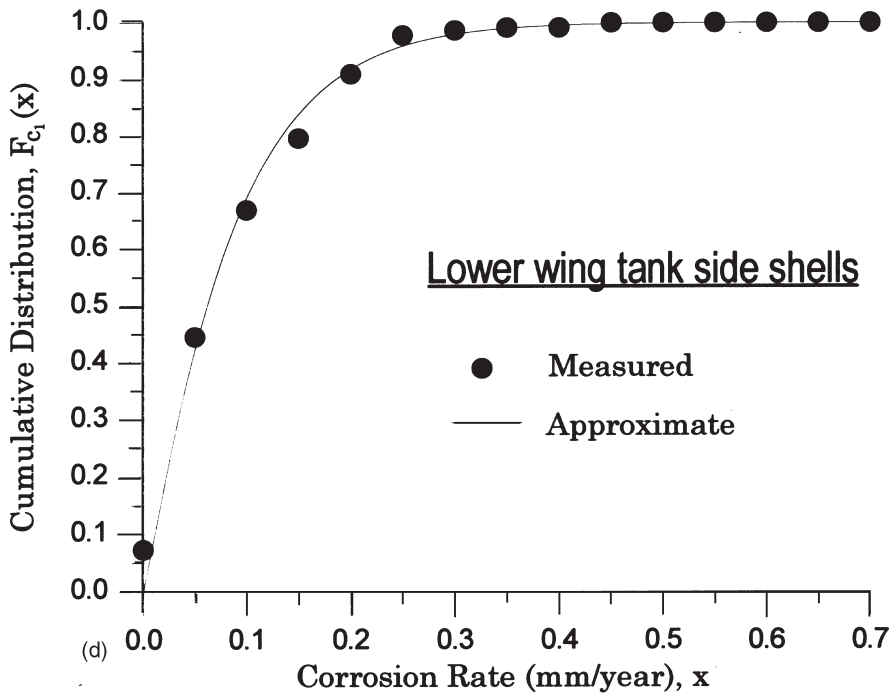
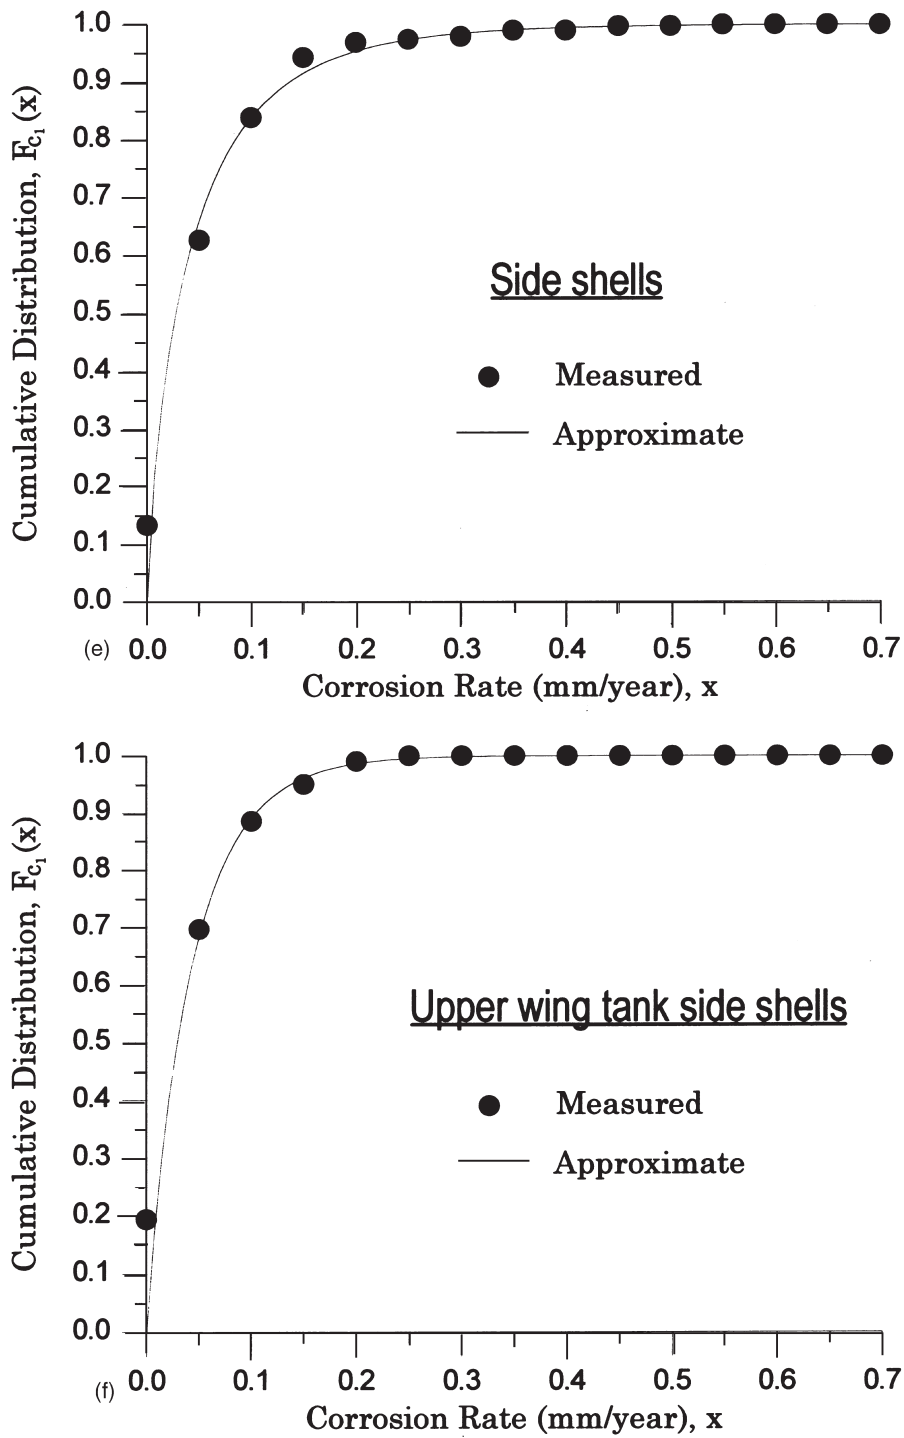
Fig. 4. Comparison of cumulative distribution between measurements and approximation for (a) bottom plates of bulk carriers; (b) inner bottom plates of bulk carriers; (c) lower sloping plates of bulk carriers; (d) lower wing tank side shells of bulk carriers; (e) side shells of bulk carriers; (f) upper wing tank side shells of bulk carriers.

puted results with measurements for each member region. Similar calculations were also performed for the data up to the ship age of 15.25 years.

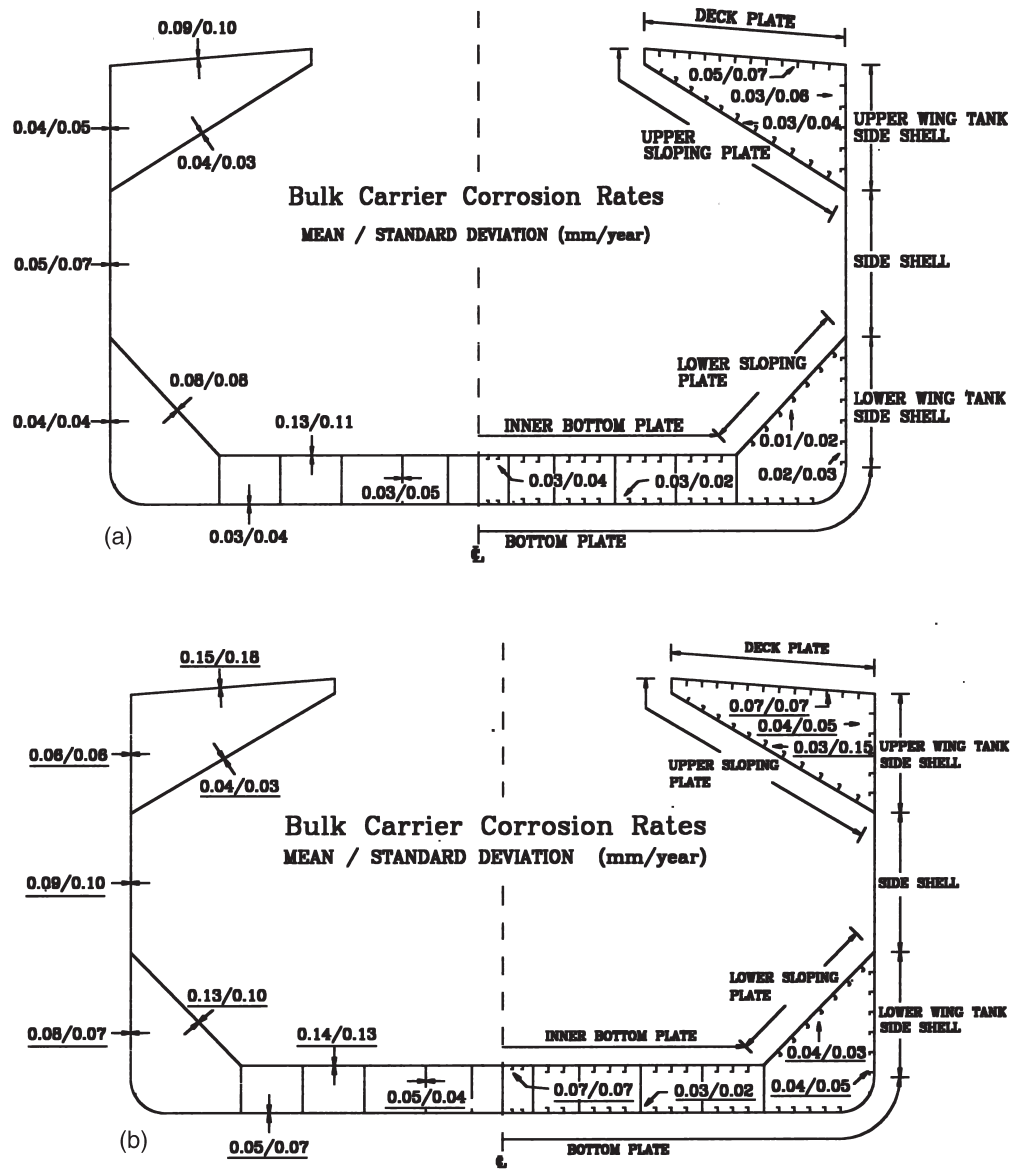
Fig. 5. Mean and standard deviation of corrosion rate for each member type in a conventional bulk carrier based on (a) all data collected, i.e. up to the ship age of 25.25 years; (b) some of the data, i.e. up to the ship age of 15.25 years.

Figure 5 and Table 3 present the computed results for mean and standard deviation of corrosion rate for each primary member type in a bulk carrier. Based on the computed results as shown in the figure, the following conclusions could be drawn:

1. The corrosion rate of boundary plating between ballast water and cargo regions, e.g. inner bottom, upper and lower sloping plate, is higher than that of bottom and bilge plates. This will be due to the fact that the former plates are exposed to both ballast and cargoes, while bottom and bilge plates are exposed to ballast water alone as the external (outer) surface is fully coated.

2. The corrosion rate of inner bottom plates is considerably high. This shows that inner bottom may be relatively rapidly corroded not only due to it being a boundary between ballast and cargoes, but also due to high mechanical wastage and accelerated local corrosion as a horizontal surface.

3. The corrosion rate of the side shell between lower wing tank and upper wing tank is slightly higher compared to the shell in way of lower wing tank and upper wing tank. This indicates that cargoes being carried may have been relatively more corrosive than the ballast water, possibly due to their higher humidity and/or temperature.

4. Deck in way of upper wing tanks show heavier corrosion when compared to the other external surfaces. This is perhaps due to frequent wet and dry cycles in the ullage areas of the top side ballast tank and also the heat of the sun.

5. Most longitudinals in the ballast tanks show quite similar corrosion rates except those at the deck. The higher corrosion rate of the deck longitudinals are presumably due to the same reasons as the deck plate, see (4) above.

6. The corrosion rate based on the data up to 15.25 years gives slightly higher values than those based on all data collected, especially in way of inner bottom and hopper plates, inner bottom longitudinals, side shell plates and deck plates. This would be due to the fact that the renewal of members due to heavy corrosion is usually made after the ship age of about 15 years. This also implies that the corrosion rate estimate model developed in this study may be not complete, and it should be further modified based on much more data of corrosion. Nevertheless, it is concluded that the model developed in the present study quite reasonably represents the actual progress of corrosion for primary members of bulk carriers.
