Roger Clark

TTGO T5 eInk display - update

10  
OCT 2018

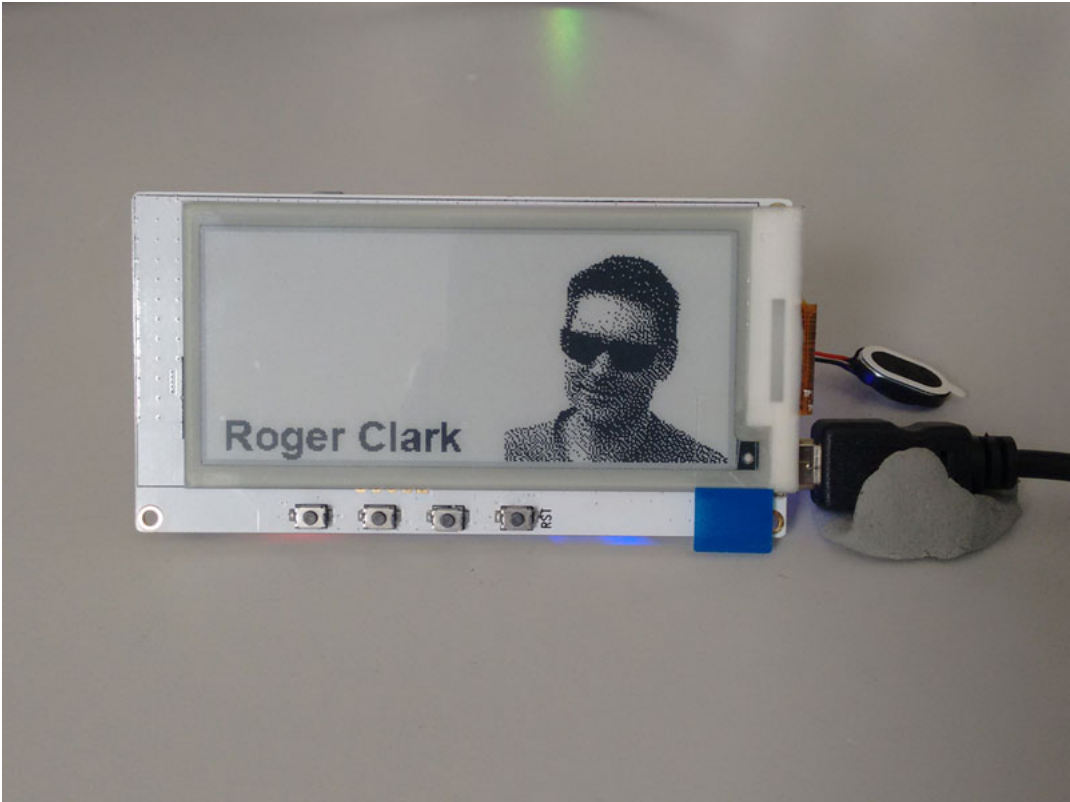
In the last few days I've been attempting to resolve a major design fault on the TTGo T5 eInk display board, where the battery management chip (IP5306) was completely turning off the power to the ESP32, and the other chips, when I put the ESP32 into deep sleep mode.

But whatever the reason, it became clear that the IP5306 is totally unsuitable for the application to which it's been put, and I took the radical decision to remove the chip from the PCB completely and use an external battery charger / protection module instead.

Once the chip had been removed, I was able to solder a wire to the pad for pin 1, which receives 5V when the board is connected to USB (or I presumed powered via the 5v pin on the header), and a wire to pin 8, which was the output (5V which I presume feeds into the EA3036 multi output buck converter), and a third wire to the ground pad in the middle of the IP5306 footprint.

I already have a stock of TP4055 based battery charger modules with built in battery protection. So I soldered the module to these 3 wires, and connected the same 2000mAh LiPo cell to the new battery charger module.
