Warranty Extension: MIL Comes On With DTCs P0301 thru P0304Supersedes 13-081, dated January 23, 2018, to revise the information highlighted in **yellow**.**AFFECTED VEHICLES**

Year	Model	Trim	VIN Range
2011–13	Odyssey	ALL	Check the iN VIN Status for Eligibility

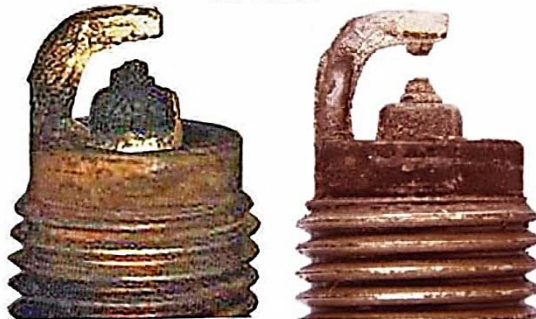
2. Remove and check the spark plug(s) on the affected cylinders (example: if P0301 is stored, check the spark plug on cylinder No. 1).

Are the spark plug(s) fouled?

GOOD

NO GOOD

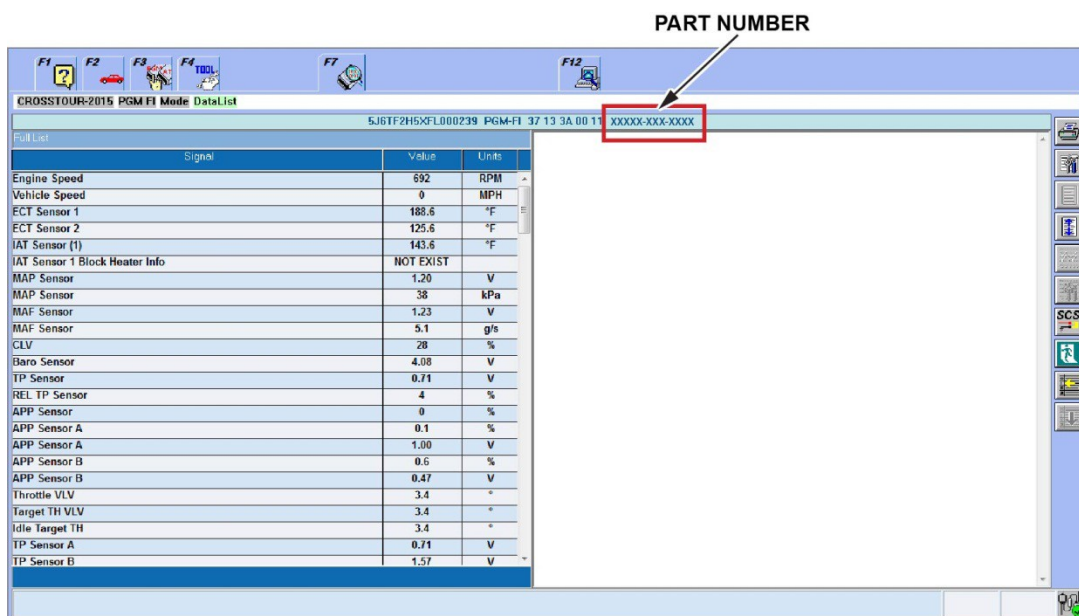
3. For 2011 Odyssey only: Check the PCM software version P/N located above the **PGM FI Data List**.

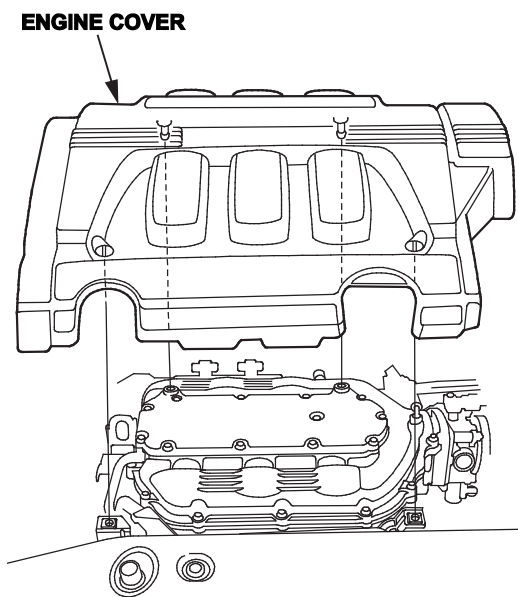
5. Remove the engine cover.

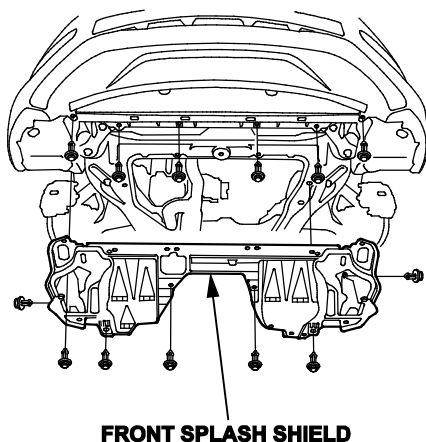
6. Remove the radiator cap.
7. Raise the vehicle.
8. Remove the front splash shield.

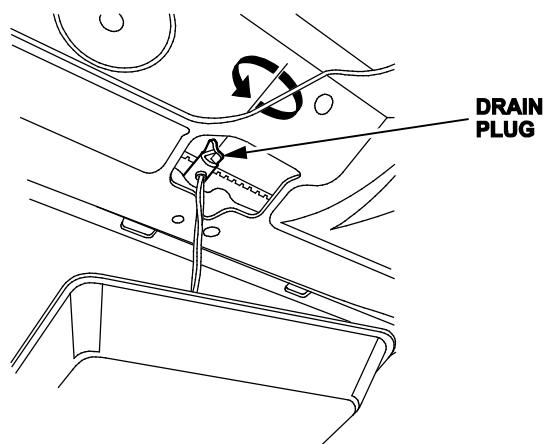
9. Drain the engine oil.
10. Loosen the drain plug on the radiator, and drain the coolant.

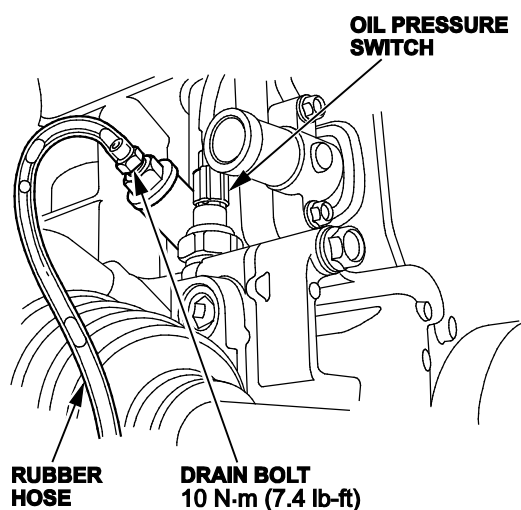
11. Install a 5/16th inner diameter rubber hose on the drain bolt located at the rear of the engine block, loosen the drain bolt, and drain all remaining coolant. Then disconnect the oil pressure switch connector.

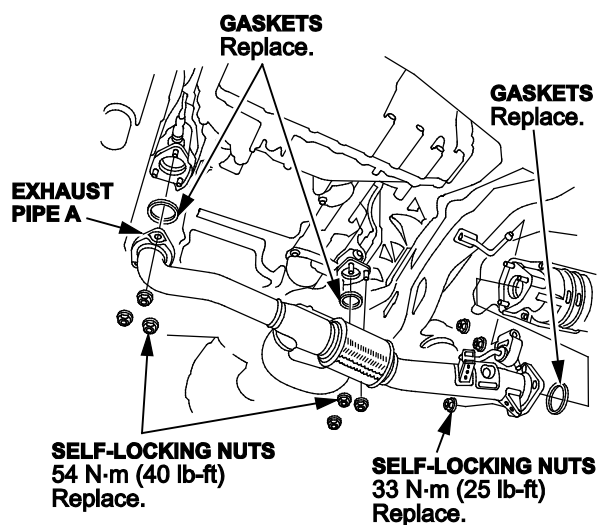
12. Remove exhaust pipe A.

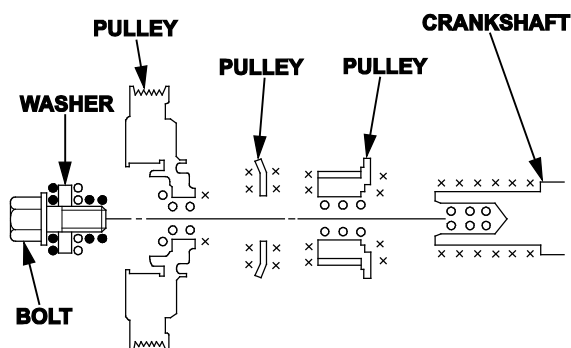
13. Depending on the diagnosis, remove the appropriate WU-TWC support bracket bolts.
14. Remove the EGR lower pipe nuts.
15. Remove the crankshaft pulley bolt but not the pulley.

NOTE: Make sure to apply new oil to the bolt flange and threads before reinstallation.

X : Remove any oil

O : Clean

● : Lubricate with new engine oil

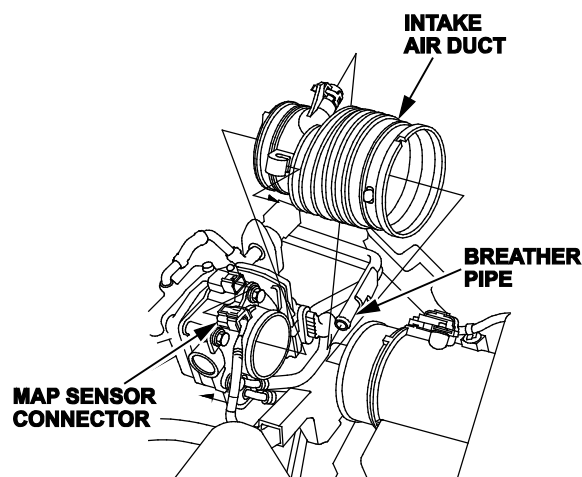
16. Lower the vehicle.
17. Disconnect the MAP sensor connector and the breather pipe, then remove the intake air duct.

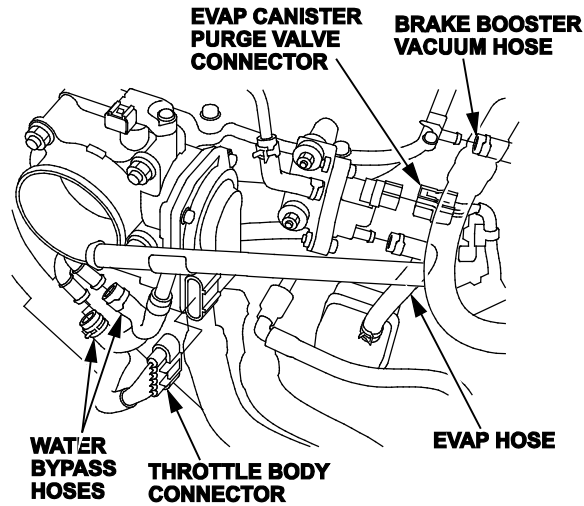
18. Disconnect the throttle body connector, the EVAP canister purge valve connector, the EVAP hose, the brake booster vacuum hose, and the vacuum hose.
19. Disconnect and plug the water bypass hoses.

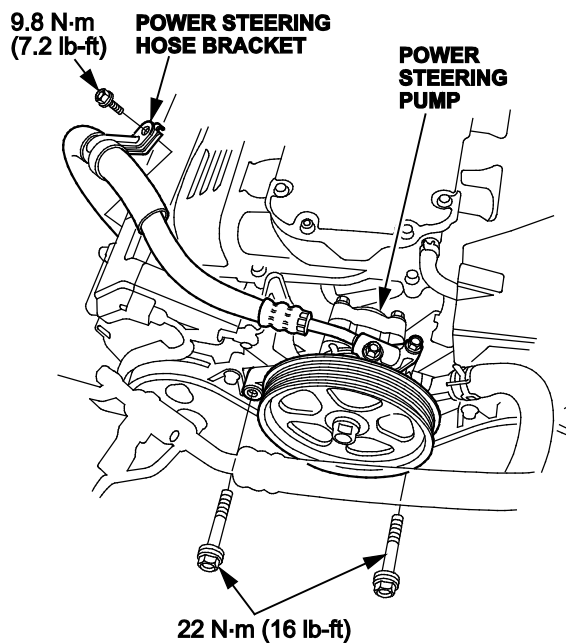
20. Remove the drive belt.
21. Remove the drive belt auto-tensioner.
22. Remove the power steering pump bolts, the power steering bracket then secure the power steering pump out of the way.

NOTE: Do not remove any of the hoses.

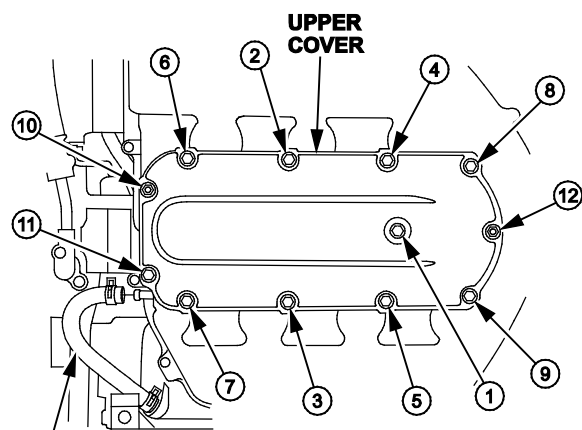
28. Remove the engine intake upper cover and PCV hose.

SPECIFIED TORQUE

6 x 1.0 mm

12 N·m (8.7 lb-ft)

PCV HOSE

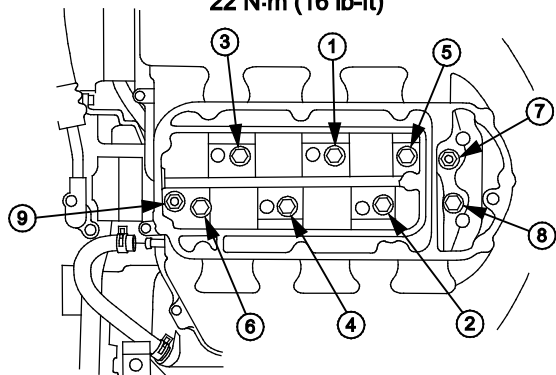
29. Remove the intake manifold bolts and nuts in three steps, then remove the intake manifold.

SPECIFIED TORQUE

22 N·m (16 lb-ft)

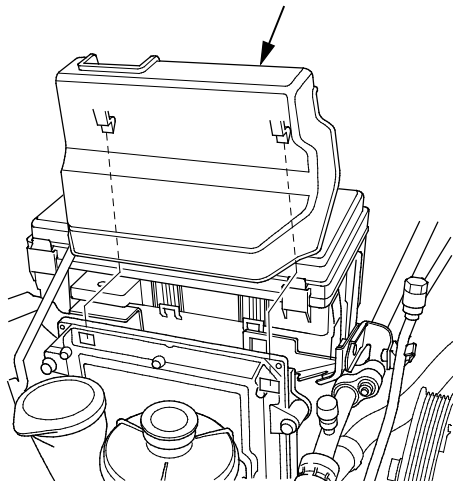
30. Remove the PCM cover.

KEIHIN SHOWN:

PCM COVER

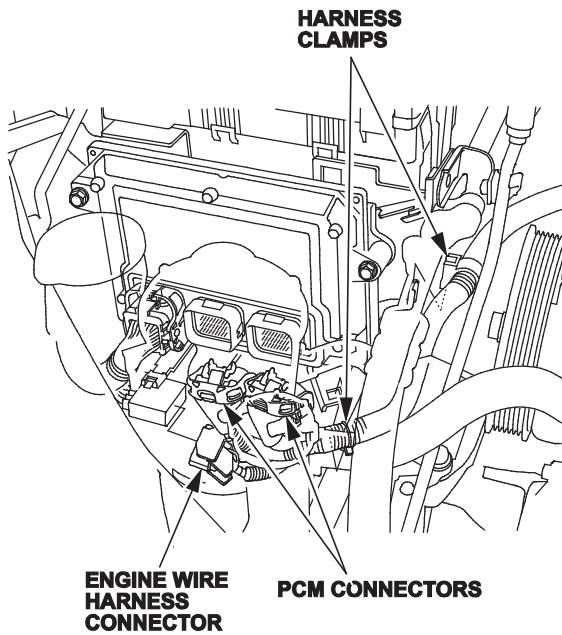
31. Remove the PCM connectors and harness clip. Remove the battery cables from the underhood fuse box.

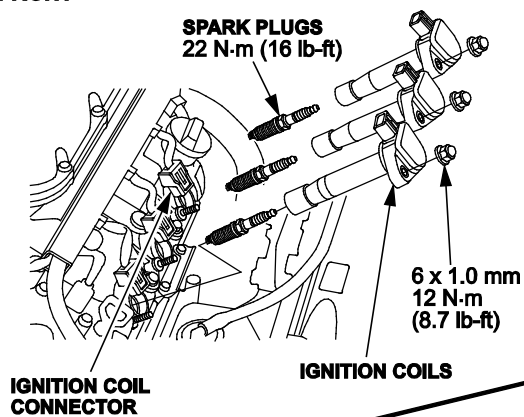
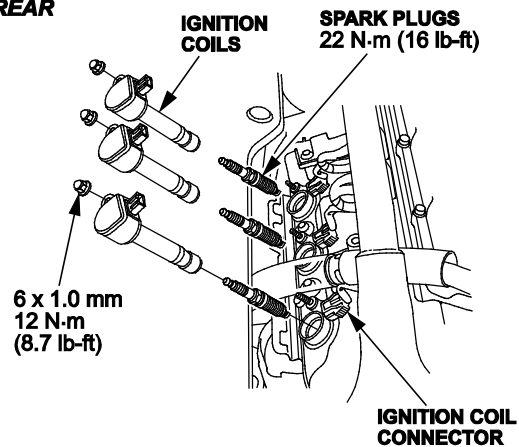
32. Remove the appropriate Ignition coils based on the diagnosis.

NOTE: Depending on the diagnosis, you will either have to remove the rear bank ignition coils or both ignition coil banks.

FRONT

REAR

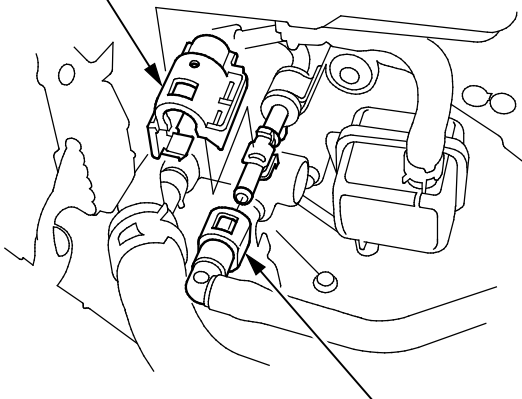
33. Depending on the diagnosis, remove some or all of the following:
- ECT sensor connector
 - Front rocker arm oil pressure switch connector
 - Rear rocker arm oil pressure switch connector
 - CMP sensor connector
 - Front A/F sensor one connector
 - Rear A/F sensor one connector
 - Front secondary HO2S connector
 - Rear secondary HO2S connector
 - Rocker arm oil control solenoid A connector (bank one)
 - Rocker arm oil control solenoid A connector (bank two)
 - Rocker arm oil control solenoid B connector (bank one)
 - Alternator connector and positive alternator cable
 - A/C clutch switch connector
 - EGR 5P valve connector
 - Engine ground
 - Knock sensor
 - Fuel injector connectors and clips
34. Remove the quick-connect fitting cover, then disconnect the fuel feed hose.

**QUICK-CONNECT
FITTING COVER**

FUEL FEED HOSE

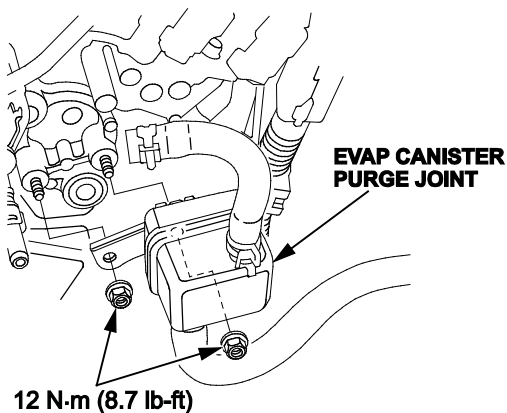
35. Remove the EVAP canister purge joint with the bracket.

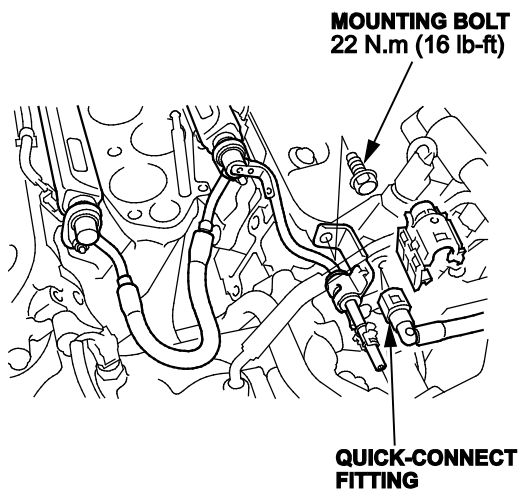
36. Remove the fuel rail connecting joint hose.

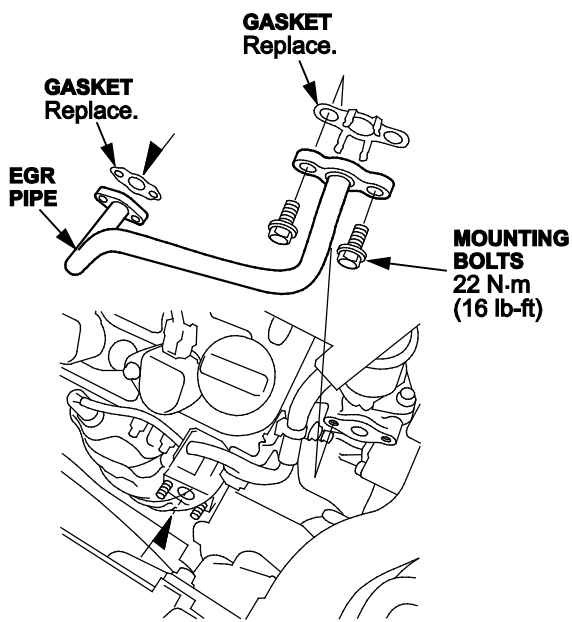
37. Remove the EGR pipe mounting bolts, then remove the EGR pipe.

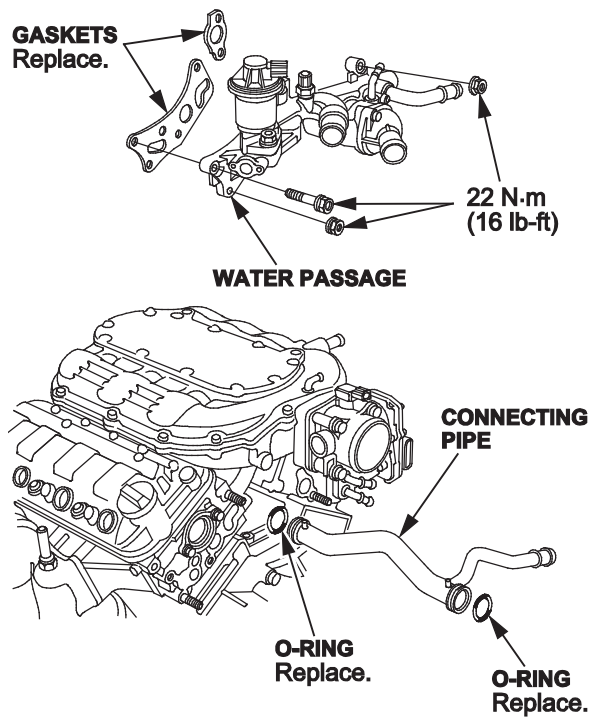
38. Separate the water passage from the heads.

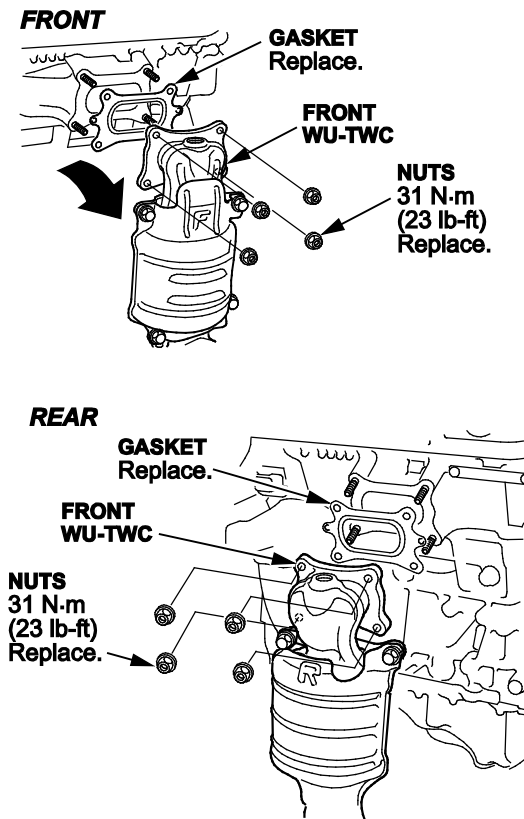
39. Remove the appropriate WU-TWC depending on diagnosis.

NOTE: Set the WU-TWC aside and cover the opening with shop towels to prevent coolant from entering.

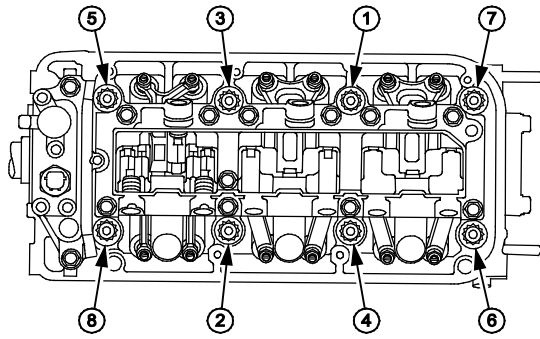
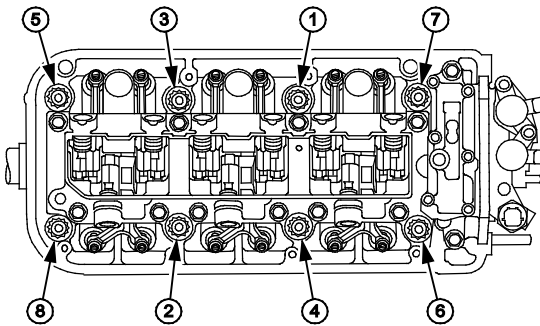
40. Remove the appropriate head with the injector base attached.

NOTE: Depending on diagnosis, you will remove the rear bank head or both heads.

FRONT

REAR

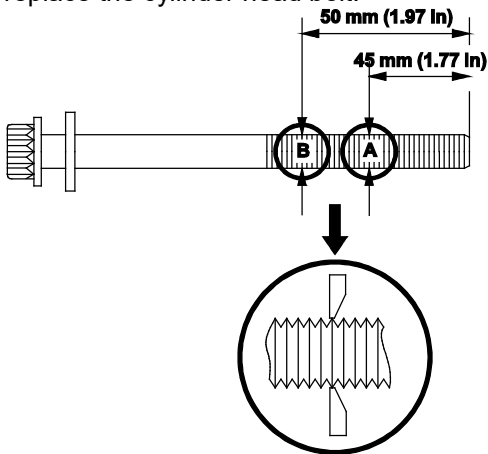
41. Measure the head bolts to determine if they need replacement. If either diameter is less than **11.3 mm (0.445 in)**, replace the cylinder head bolt.

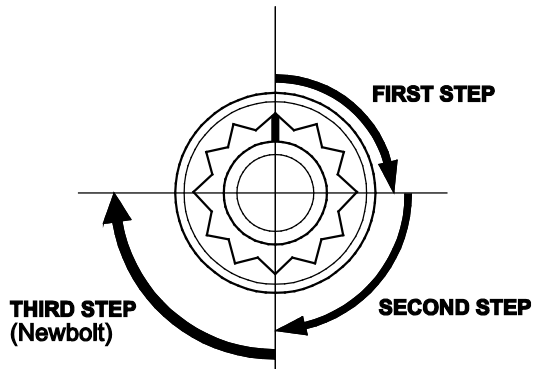
NOTE: Below are the head bolt torque specifications for reinstallation.

- First step: torque the cylinder bolts in sequence to **29 N•m (22 lb-ft)**.
- Second step: tighten in sequence an additional **90 degrees**.
- Third step: tighten in sequence an additional **90 degrees**.
- If the bolts are new, tighten an additional **90 degrees**.

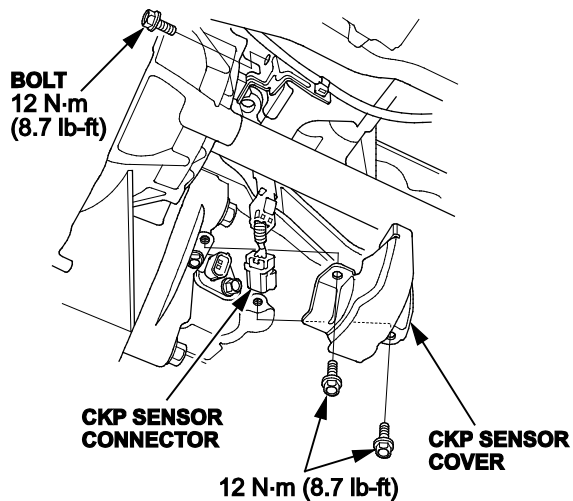
43. Remove the CKP sensor cover and bolts, then disconnect the CKP sensor connector.

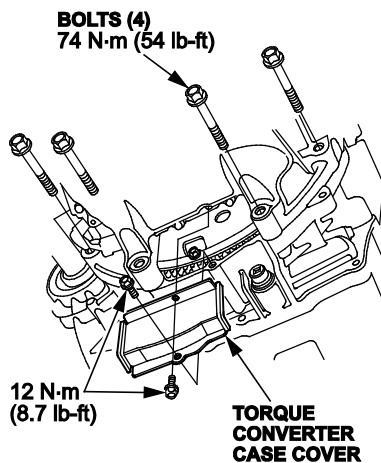
44. Remove the torque converter case cover and the four bolts securing the oil pan to the transmission.

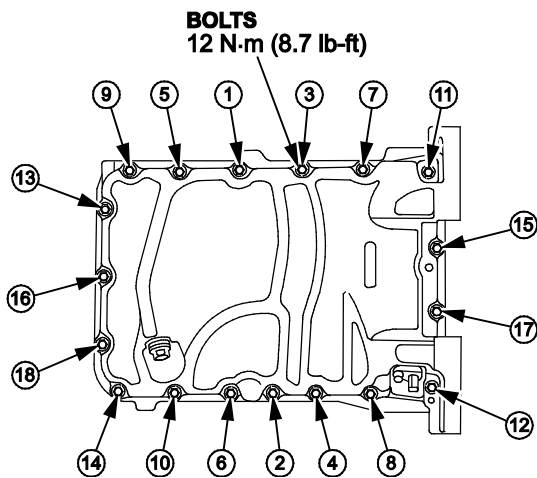
45. Remove all bolts securing the oil pan.

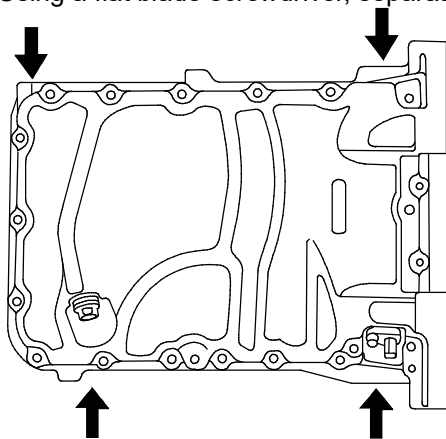
46. Using a flat blade screwdriver, separate the oil pan from the engine block in the areas shown.

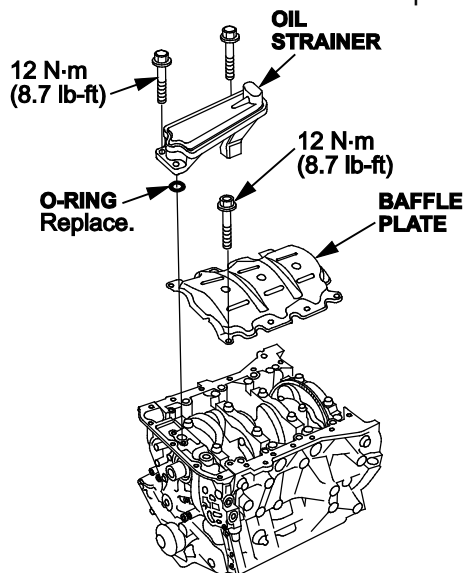
47. Remove the oil strainer and baffle plate.

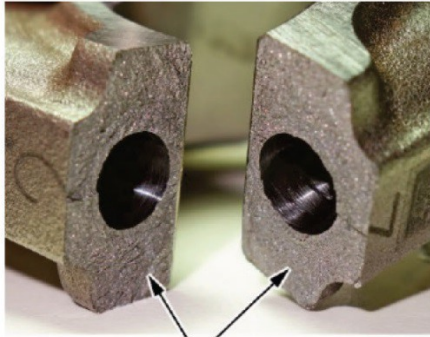
49. Remove the appropriate piston depending on diagnosis, then go to PISTON CLEANING PROCEDURE.

- Before removing the rod caps, use a grease pencil or suitable marking pen to mark each cap and its corresponding connecting rod with the cylinder number it came from.
- Do not confuse the existing marking on the side of the connecting rod and rod cap with a cylinder number. They are just manufacturing marks referring to the size of the big end of the rod.
- Installing a rod cap incorrectly will result in engine knock and/or engine failure. Remove and mark one rod assembly at a time to make sure it is assembled correctly.
- When torquing the rod cap bolts, refer to the service information for details.
- Click [HERE](#) to go to the *Tech2Tech*® video "Tips When Working with Fracture Rods".

The uneven mating surfaces are uniquely matched and not interchangeable.

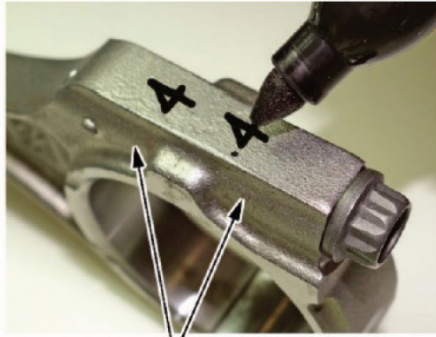
Mark the connecting rod and rod cap with the cylinder number.

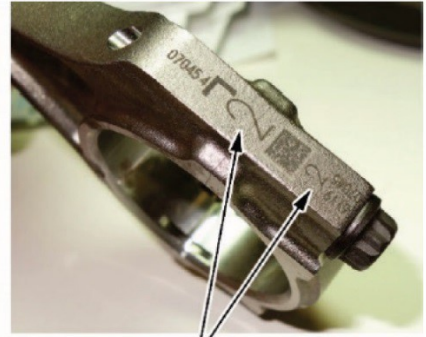
These are manufacturing marks, and do not indicate the cylinder number.

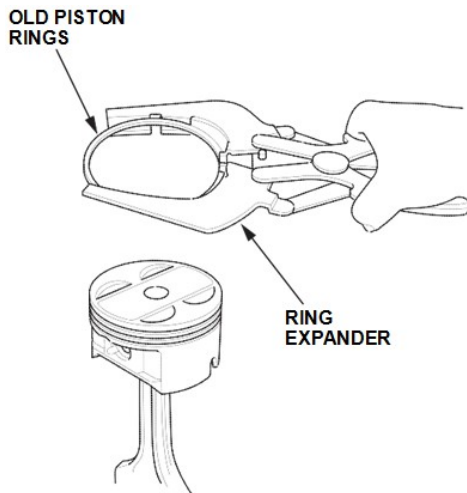
1. Remove the piston rings from the piston using a ring expander. Be careful not to damage the piston.

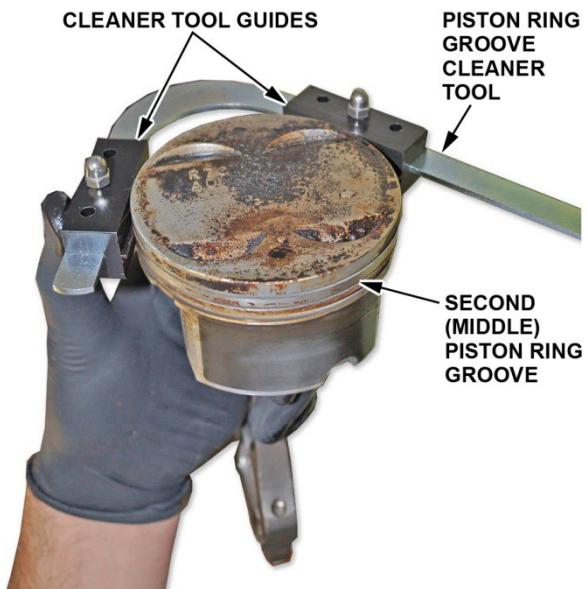
3. While holding the piston upright in your left hand, take the piston ring groove cleaner tool in your right hand and line up the cleaner tool guides with the second (middle) piston ring groove.

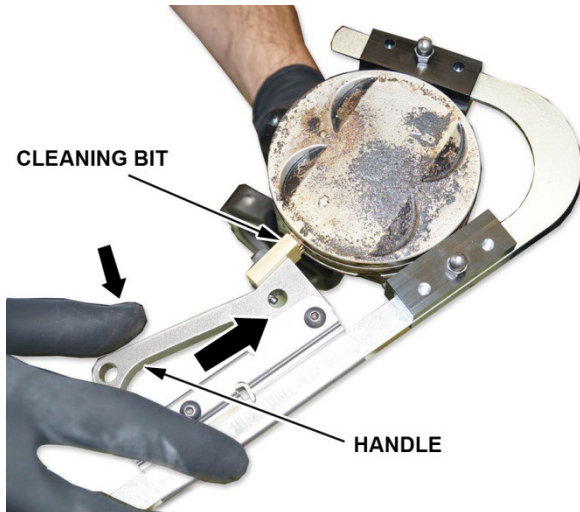
4. Press the handle on the piston ring groove cleaner tool and slide the cleaning bit onto the appropriate piston ring grooves.

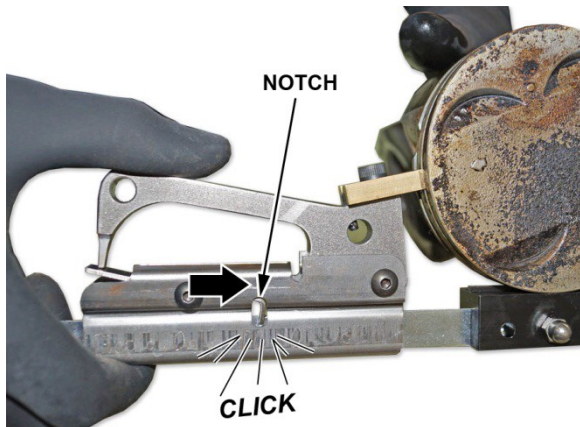
5. Once the cleaning bit is in the appropriate ring grooves of the piston, make sure the tool handle clicks in to place.
NOTE: There is only one notch on the tool for the handle to engage.

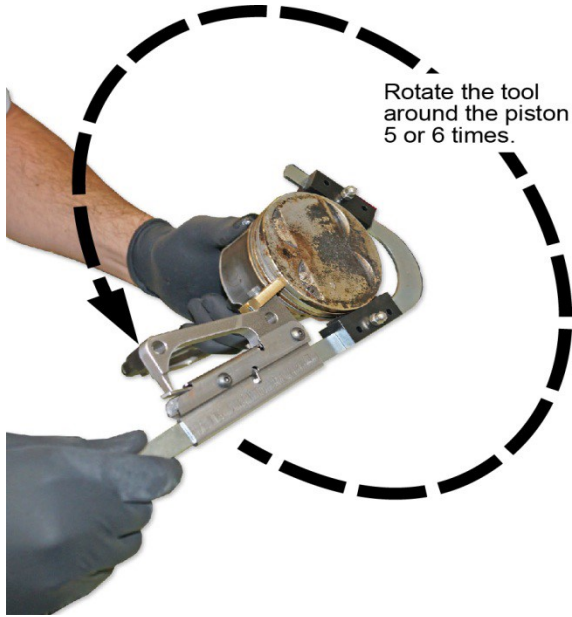
6. Hold the piston steady and rotate the tool counter-clockwise five to six times to remove any carbon deposits in the piston ring grooves. **Do not** rotate the tool clockwise.

NOTE: You can watch this procedure in the *Tech2Tech* segment "How to Clean Piston Ring Grooves".

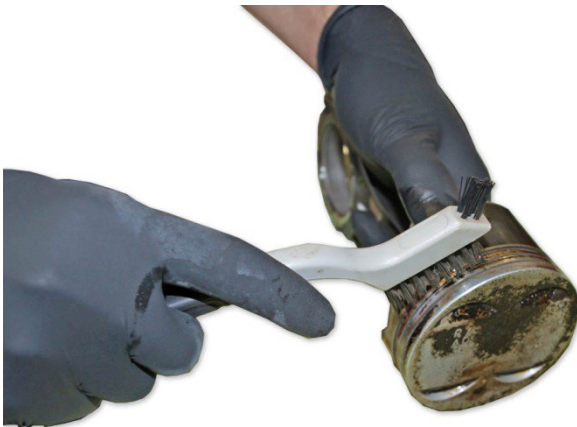
7. Remove the piston groove cleaning tool and clean off the carbon from the tool bit.
8. Finish cleaning the piston with throttle plate cleaner and the nylon brush. **Do not** use a steel wire brush.

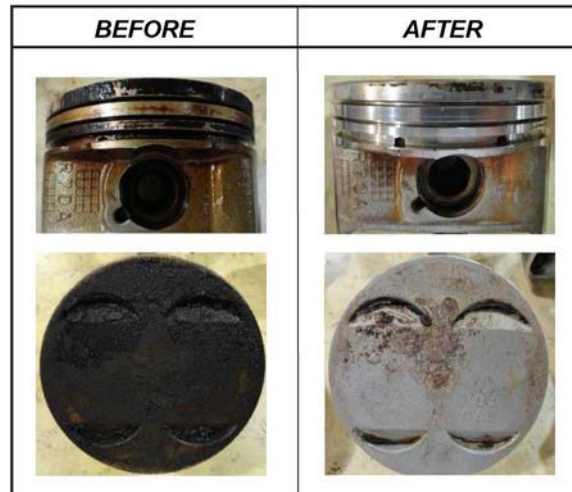
54K PISTON

NOTE: Below are some examples of before and after pictures. Depending on mileage and running conditions, the pistons will achieve different levels of cleanliness.

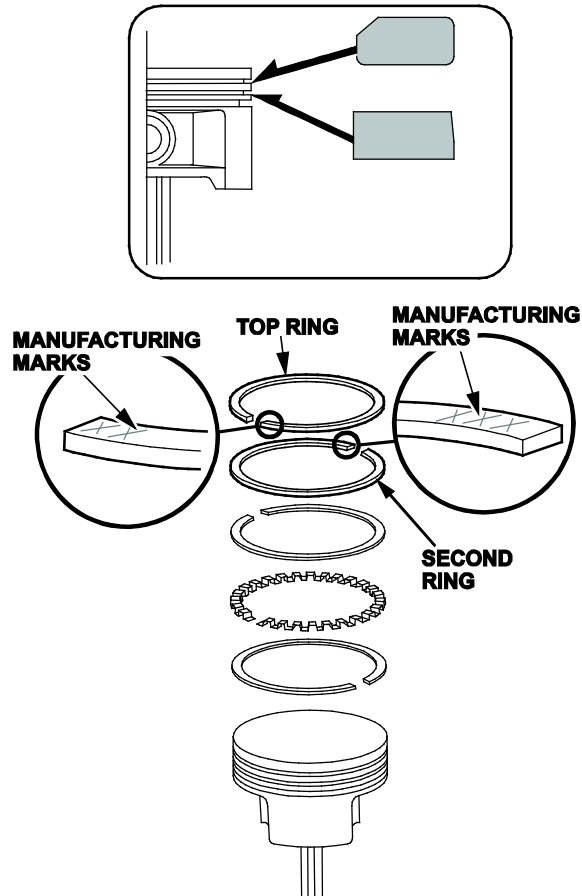
9. Install the piston rings as shown.

NOTE: The first (top) ring has a **1D** manufacturing mark and the second (middle) ring has an **SPR** manufacturing mark. The manufacturing marks must be facing upward.

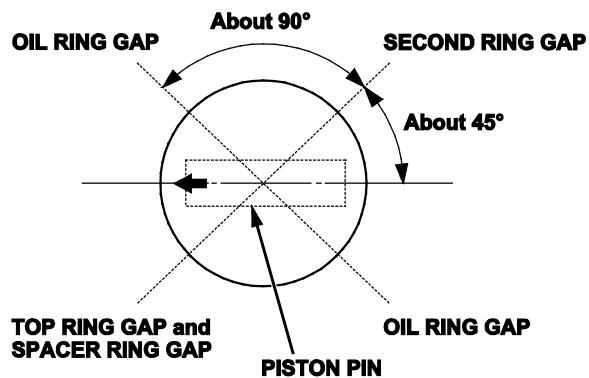
10. Position the ring end gaps as shown.

NOTE: If the ring gaps are not positioned correctly, excessive blowby may occur.

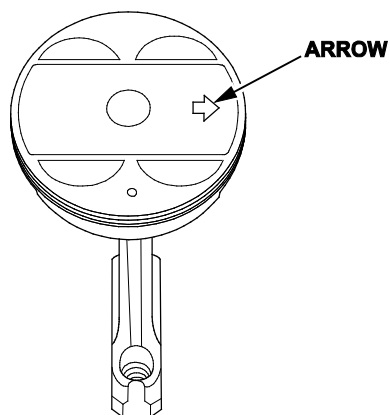
12. Install the piston/connecting rod assembly into the cylinder bore with the arrow on top of the piston facing the timing belt side of the engine.

NOTE: Be careful not to damage the cylinder wall when installing the piston.

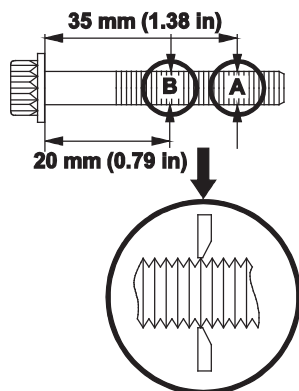
13. Measure the diameter of the connecting rod bolts to determine if they need replacement. Calculate the difference in diameter between point A and point B. It should not be more than **0–0.1 mm (0–0.004 in)**.

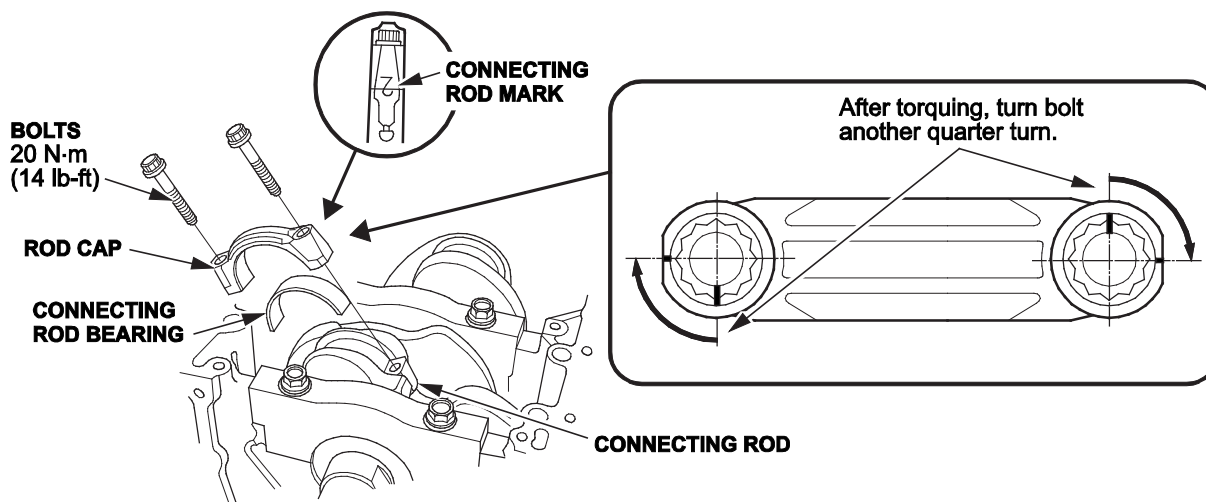
14. Apply new oil to the connecting rod bolt threads and flanges. Torque the bolts to **20 N•m (14 lb-ft)** then tighten the connecting rod bolts an additional **90 degrees**.
