< Shunt Sensing >

Title		<Title>	
Size	Document Number	Rev	
B	<Doc>	<RevCode>	
Date:	Thursday, August 27, 2015	Sheet	1 of 5

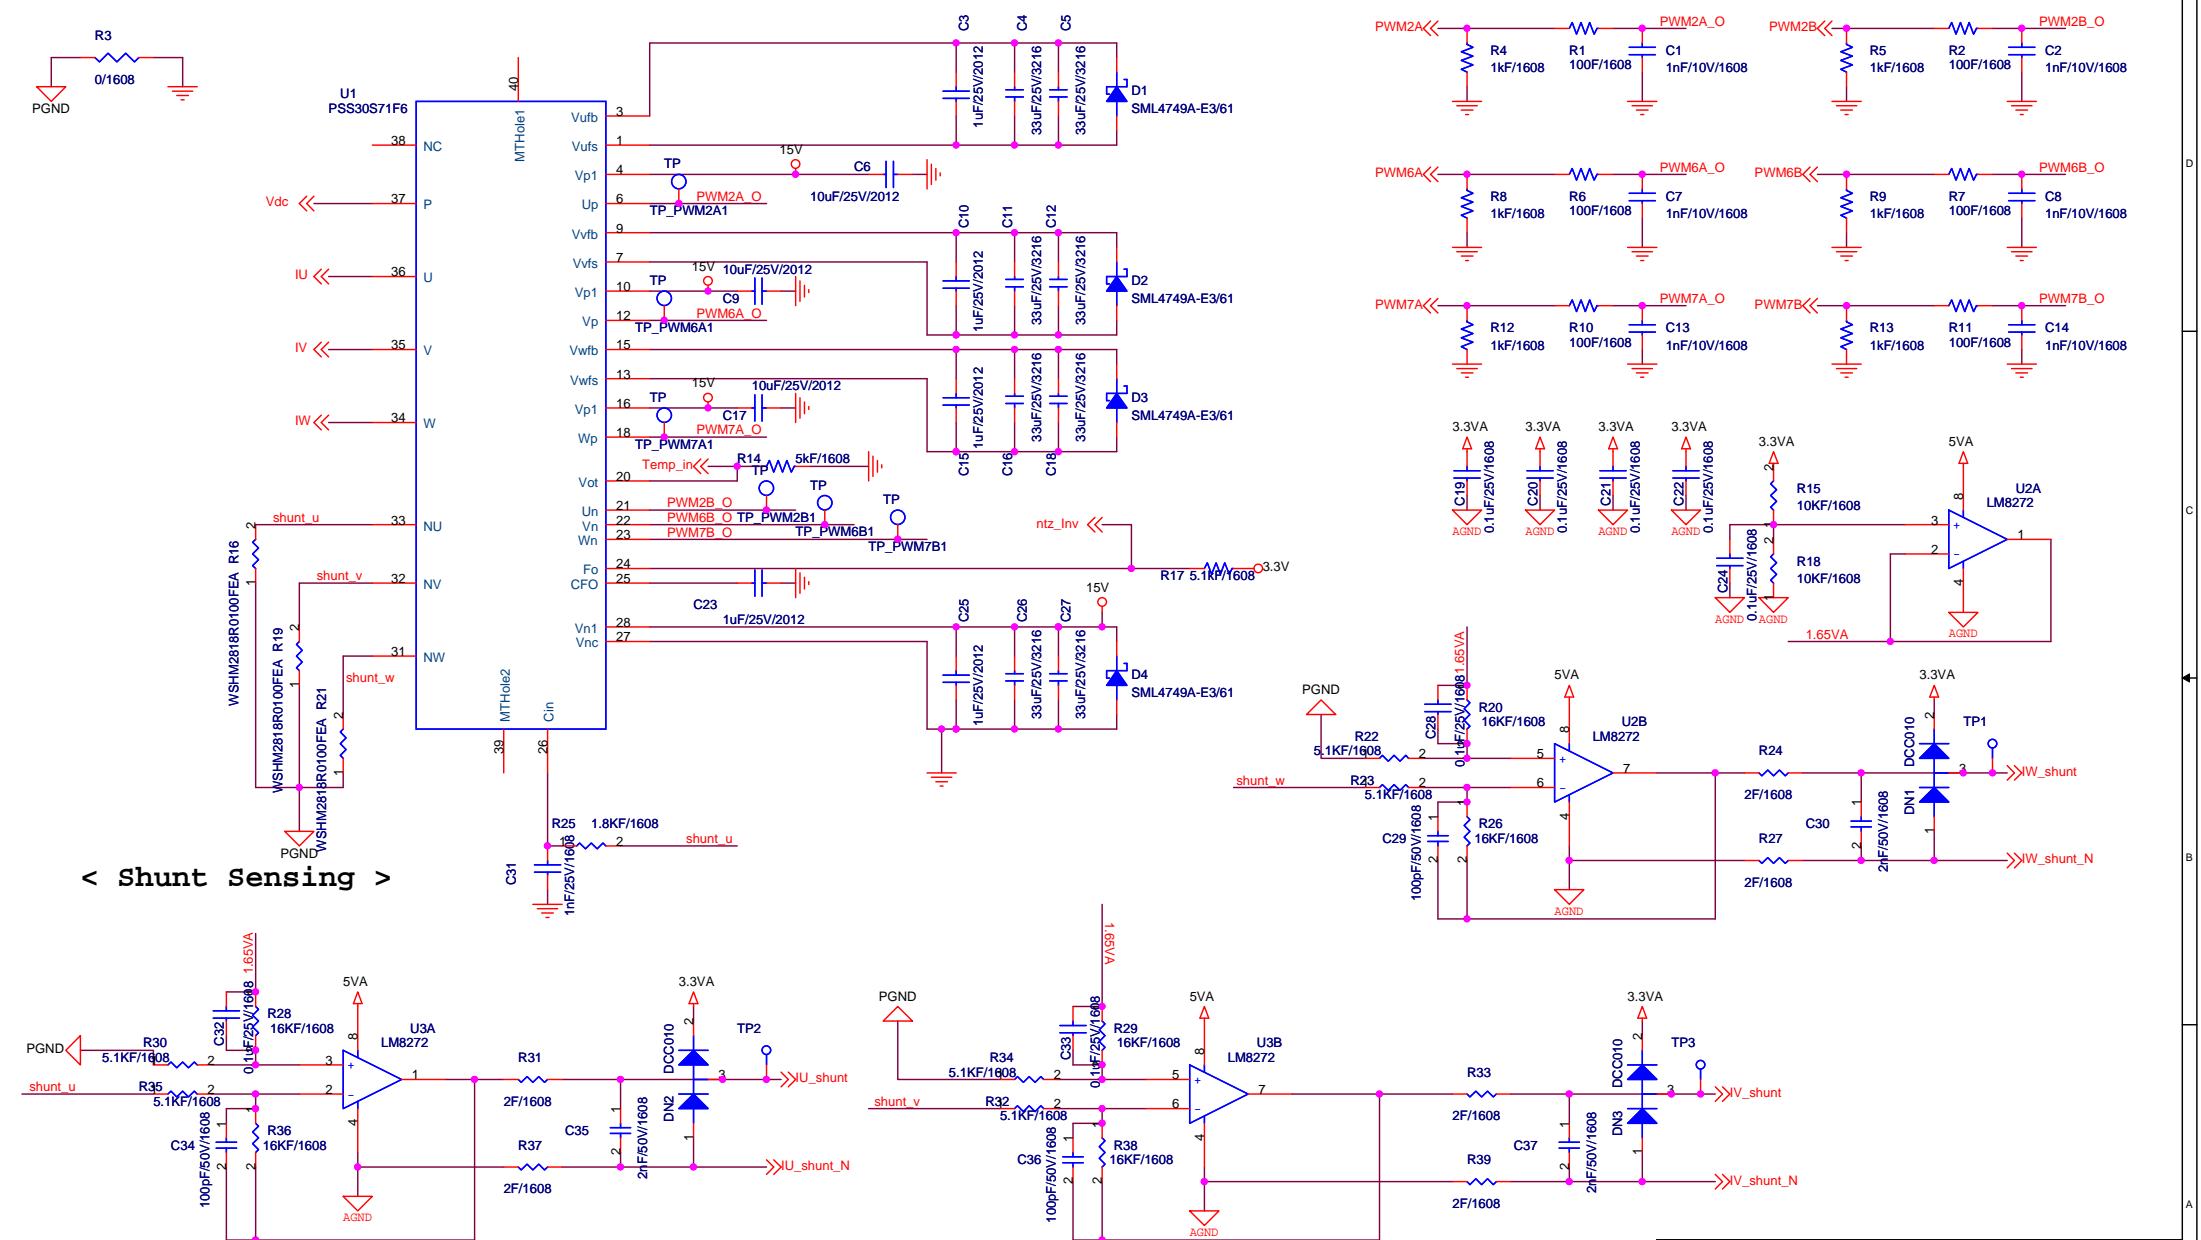
Decoupling Cap
각 pin 근처에 하나씩 배치

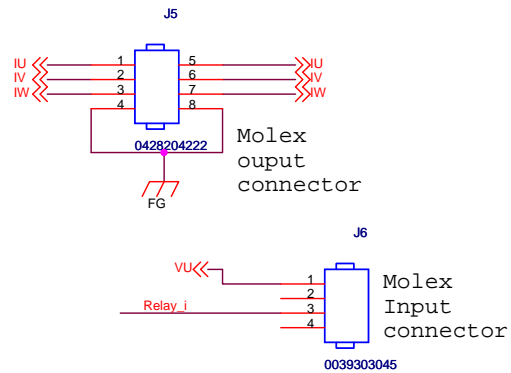
Relay 16A

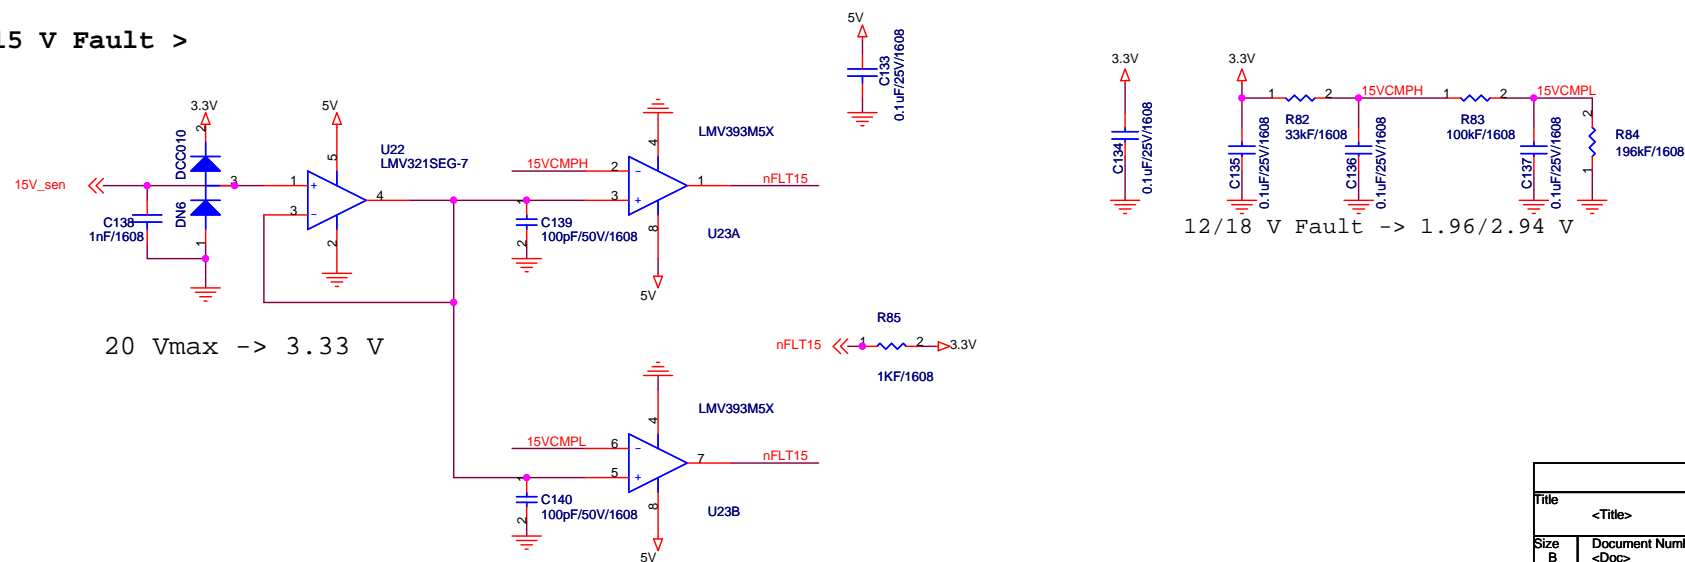
12/18 V Fault -> 1.96/2.94 V
