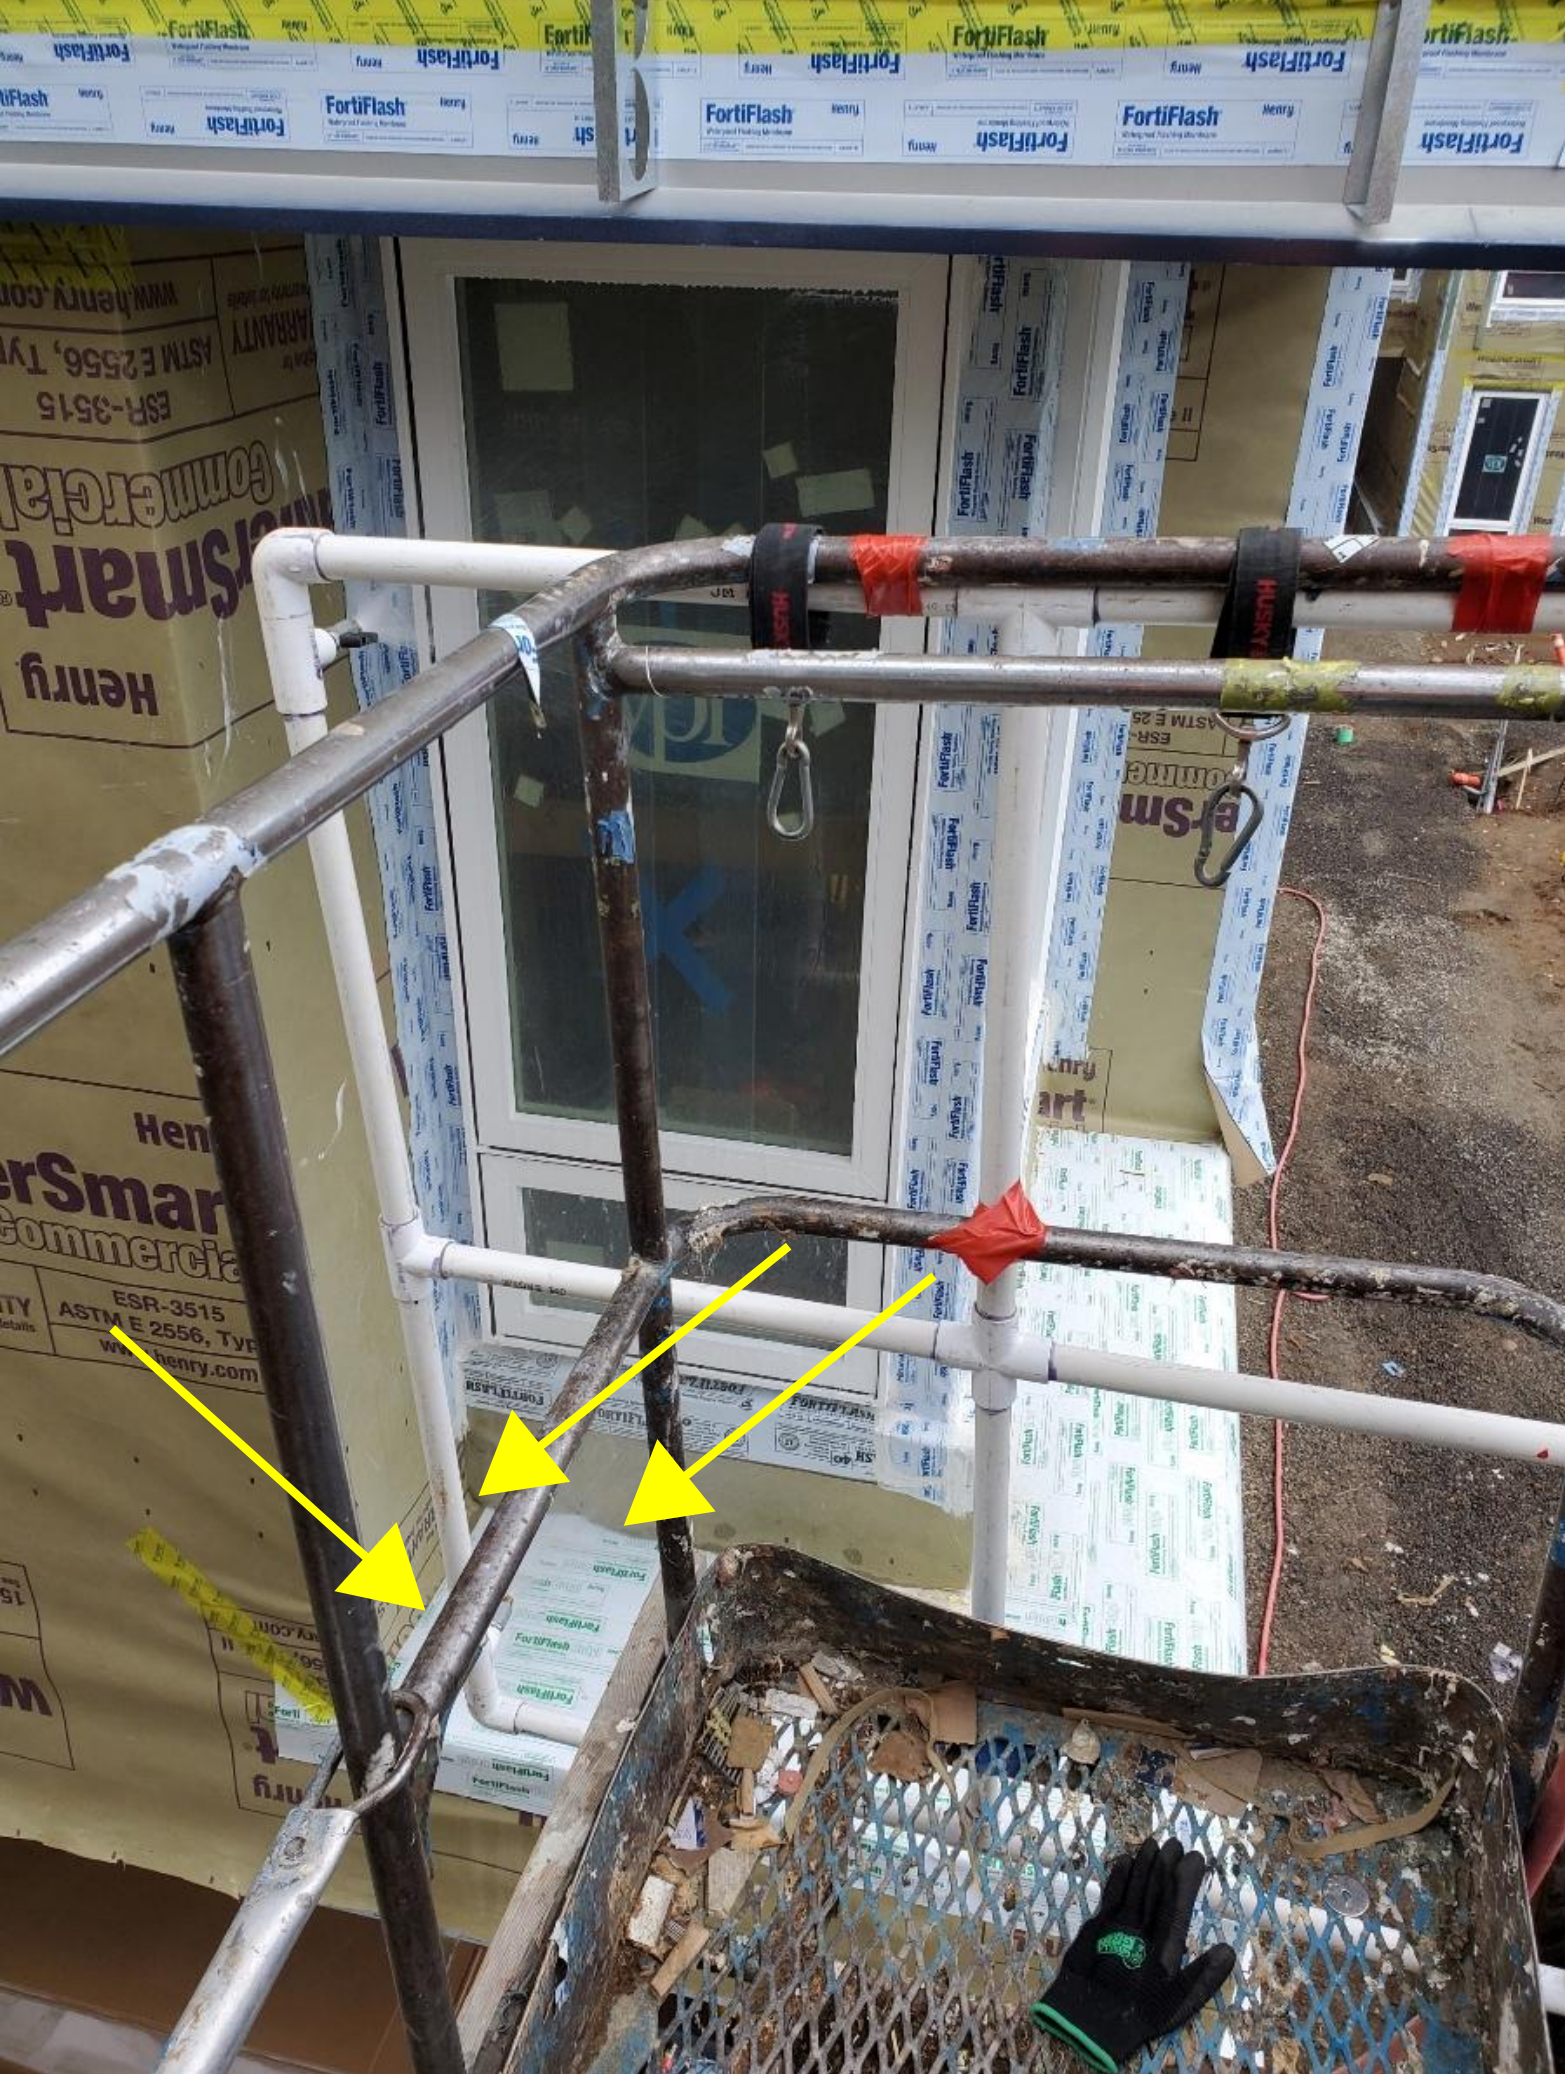
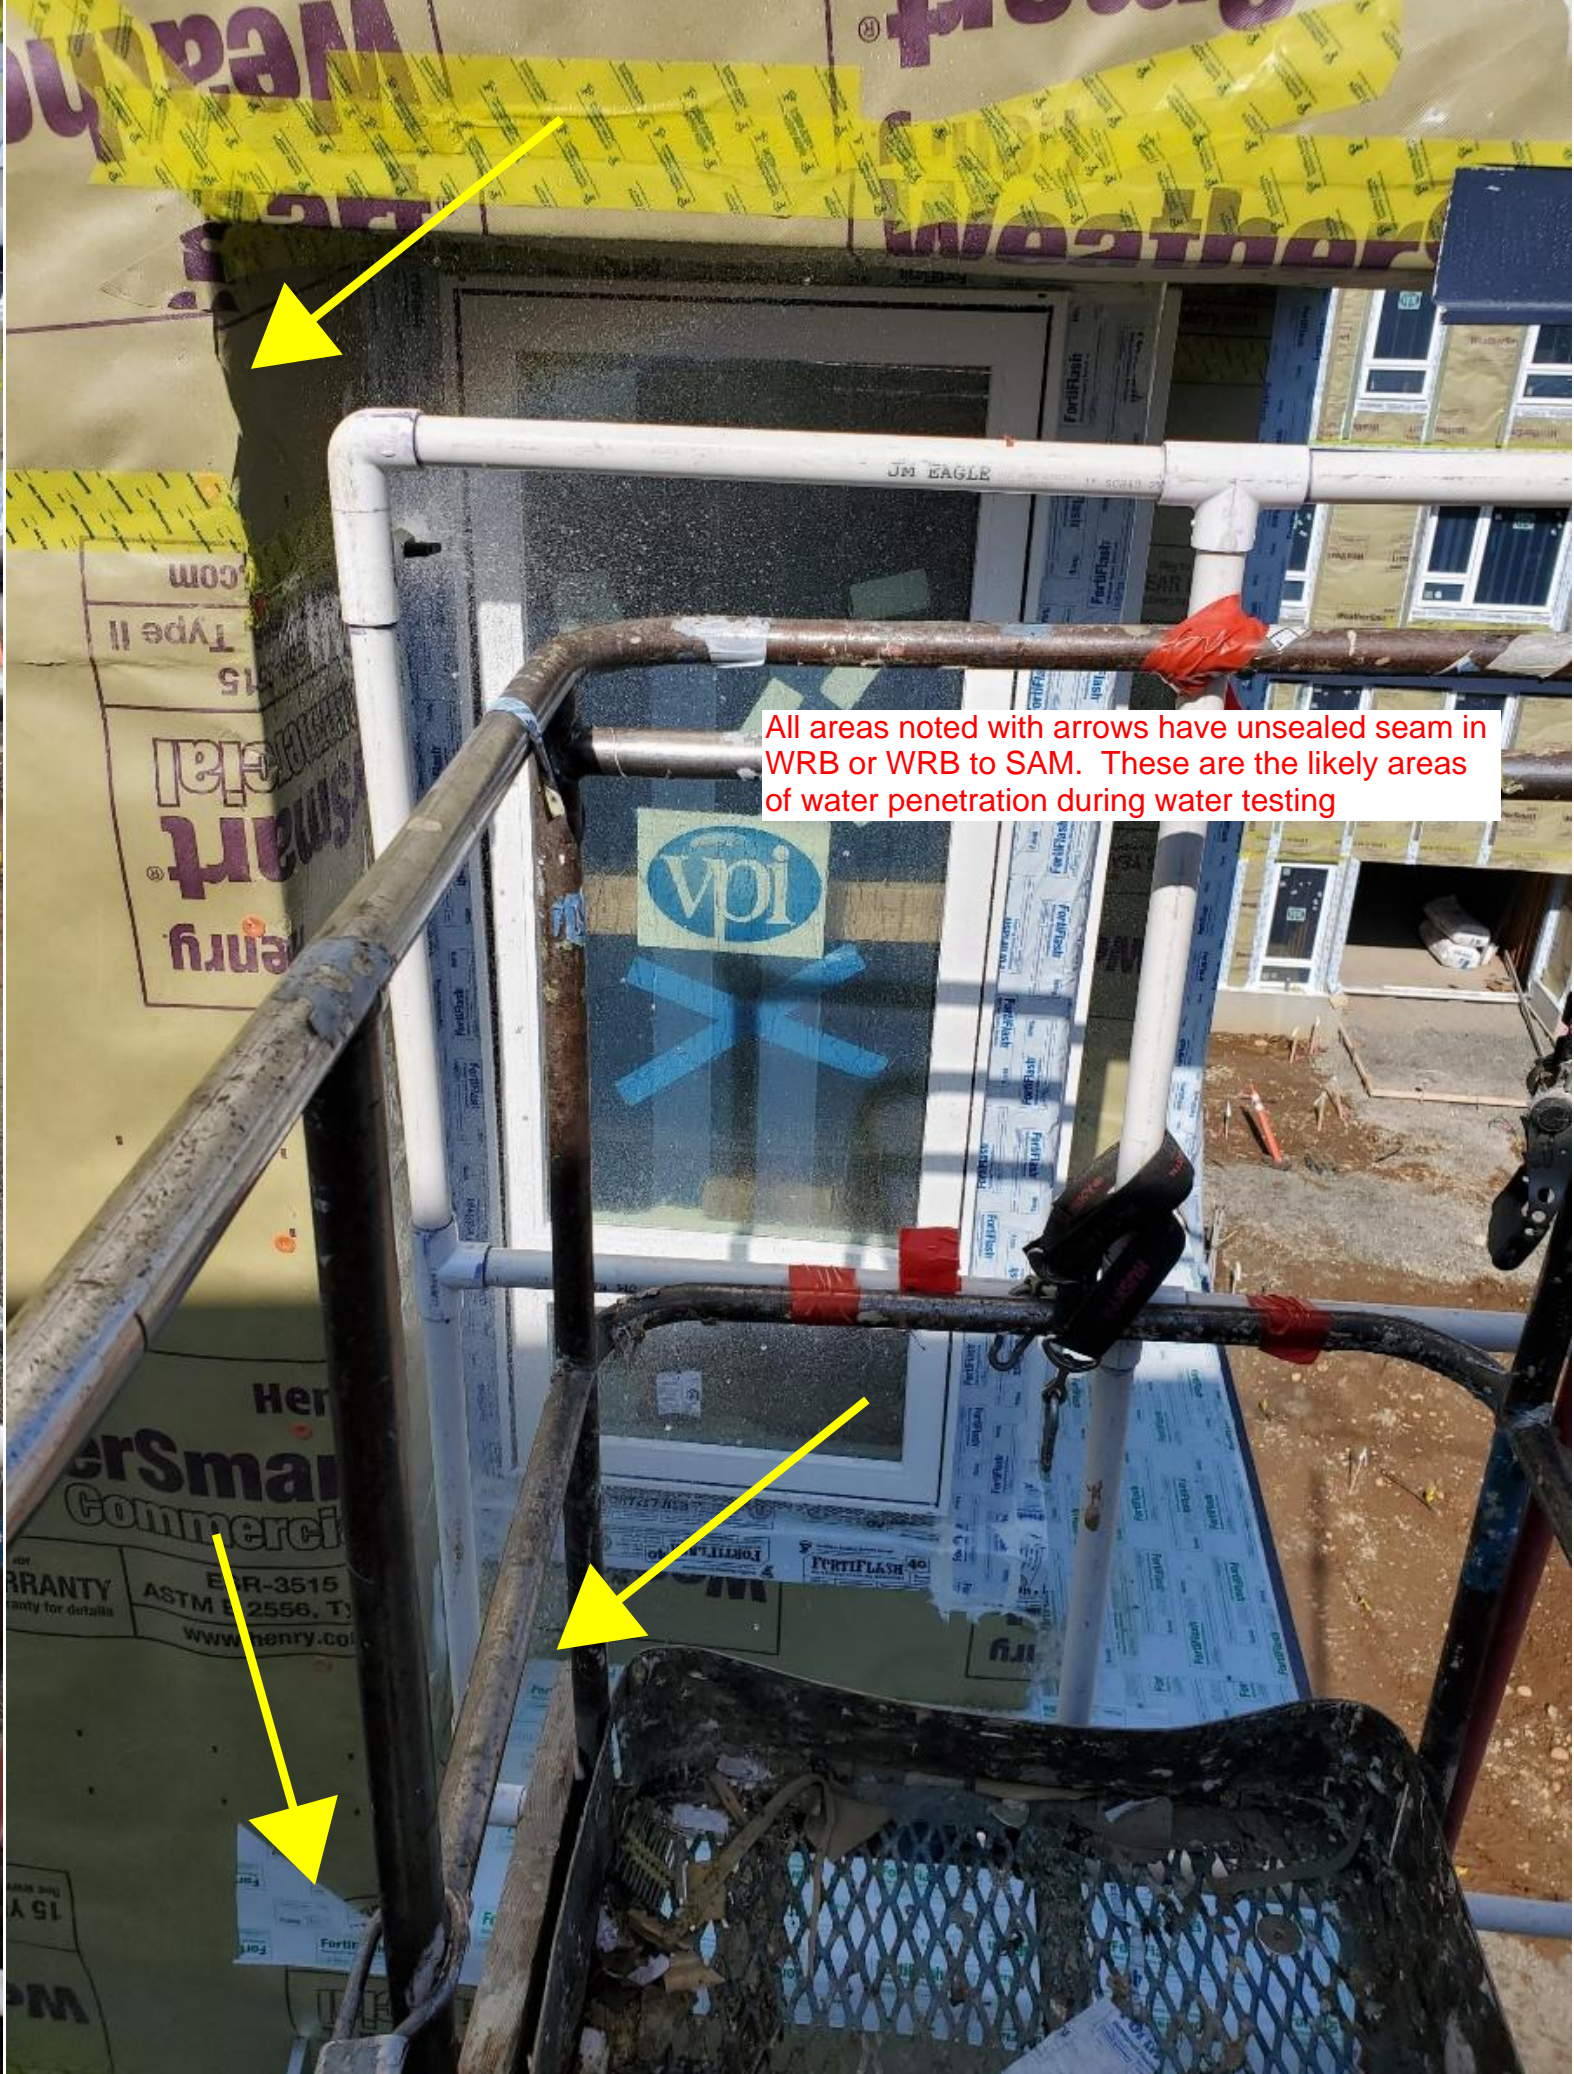
All areas noted with arrows have unsealed seam in WRB or WRB to SAM. These are the likely areas of water penetration during water testing
