NOAA-PMEL-FOCI
7600 Sandpoint Way NE
Seattle, Wa. 98115
(206) 526-6175

| MOORING: 23BS-5A | |
| LOCATION: BERING SEA, SITE 5 | |

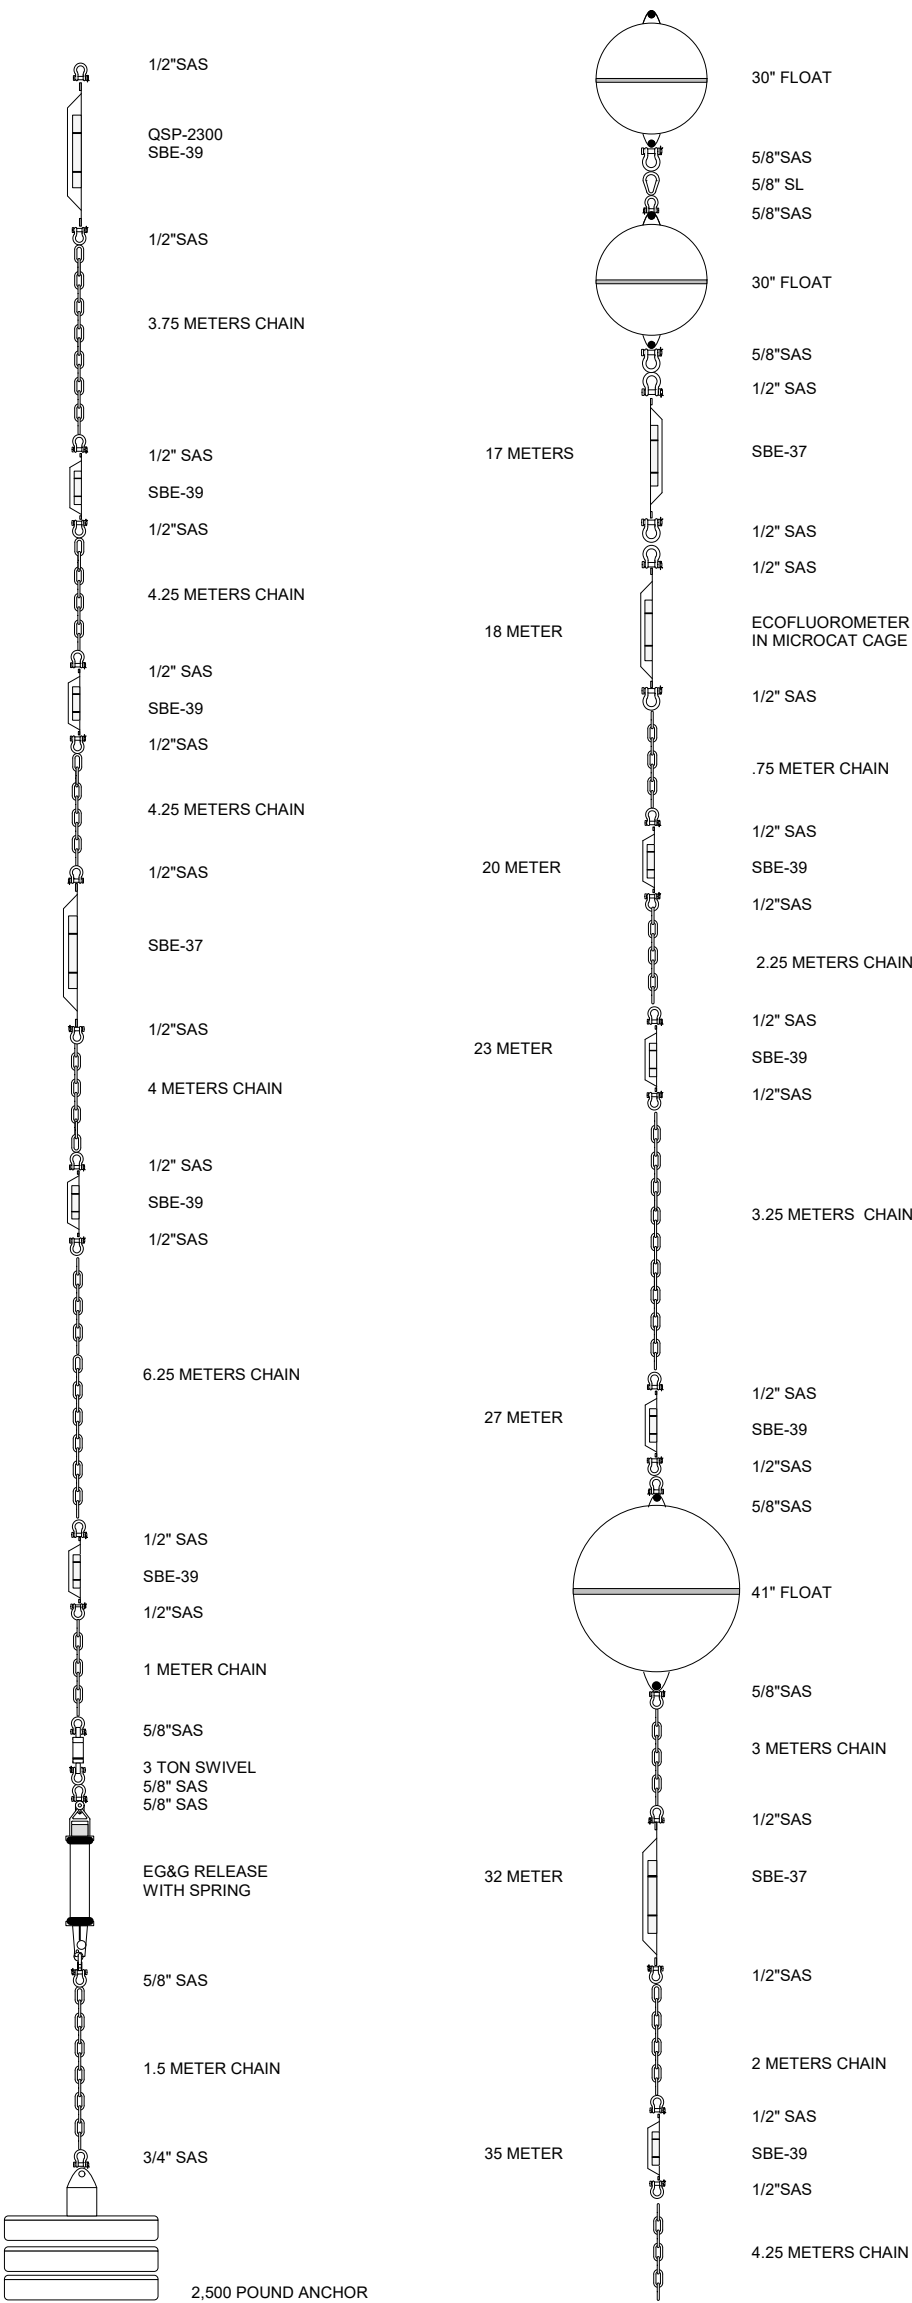
| SUBSURFACE INSTRUMENTS | | |
| DEPTH | INST. | SER # |
| 17 | SBE-37 | |
| 18 | ECOFLUOR | |
| 20 | SBE-39 | |
| 23 | SBE-39 | |
| 27 | SBE-39 | |
| 32 | SBE-37 | |
| 35 | SBE-39 | |
| 40 | SBE-39 | |
| 45 | SBE-39 | |
| 50 | SBE-39 | |
| 55 | SBE-37 | |
| 60 | SBE-39 | |
| 67 | SBE-39 | |
| 71 | BOTTOM | |
