GE Energy

Functional Testing Specification*Parts & Repair Services
Louisville, KY***LOU-ATE1-DS200TCQC****Test procedure for a card tested on the ATE1 System****DOCUMENT REVISION STATUS:** Determined by the last entry in the "REV" and "DATE" column

Functional test procedure for an ATE tested item.

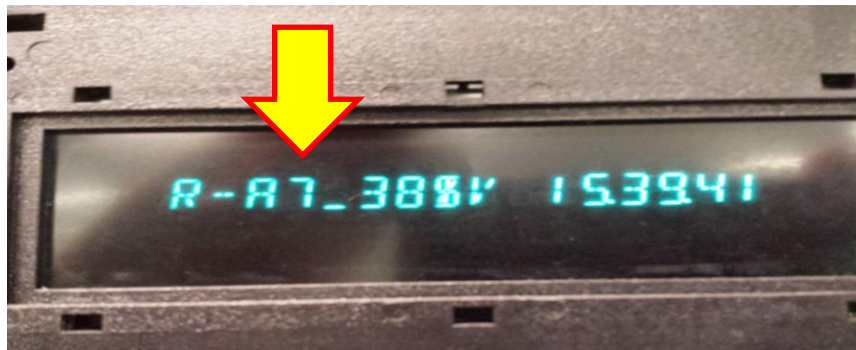
6.3.1 Verify that the core boots and condition is A7 via the SLCC display
