GE Energy

Functional Testing Specification*Parts & Repair Services
Louisville, KY***LOU-GED-IS210AEPS**
Alternate Energy Power Supply

Test Procedure for a IS200AEPS Power Supply Board

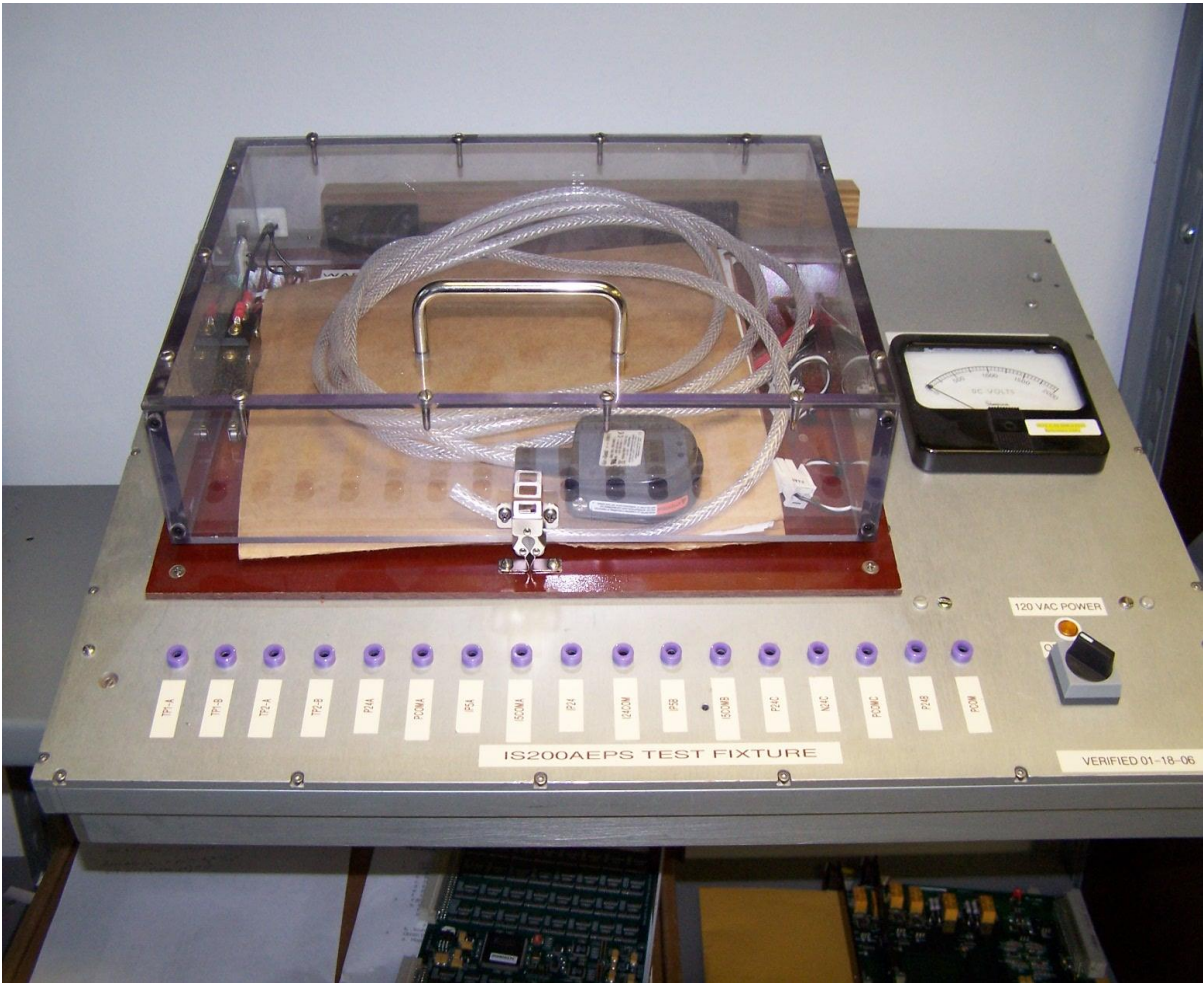
8.2 Picture of AEPS Test Fixture.

6.1 Safety Warning to Operator: Be aware that the fixture to power the board under test uses a Link Voltage of approximately 1000vdc. This voltage could be DEADLY. The large analog voltmeter on the top of the fixture is used to indicate when Link Voltage is present. When you open the Lexan cover, the safety switch on the left side of the cover will turn off and discharge the Link Voltage within 1 second. If this does not happen immediately turn off the fixture and unplug it. Notify test development that the fixture needs repair.

- 6.2.1** Make sure the power switch is OFF and the Link Voltage Meter reads 0vdc.
- 6.2.2** Mount the board under test on the test fixture using the 4 threaded stand-offs to hold the board down in the corners.
- 6.2.3** Connect all labeled cables from the test fixture to the board under test with pin 1 of a cable always being the white wire. Be very careful to ensure that the Red link voltage wire goes to the LINKP terminal and the Black link voltage wire goes to the LINKN terminal.
- 6.2.4** Close the Lexan cover.
