GAYTON CONSERVATION AREA APPRAISAL AND MANAGEMENT PLAN

PART 1 – CONSERVATION AREA APPRAISAL

Prepared for Wirral Council by Donald Insall Associates Ltd 2007 – Wirral Council 2009

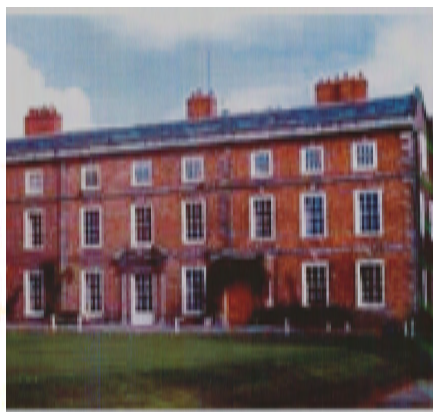
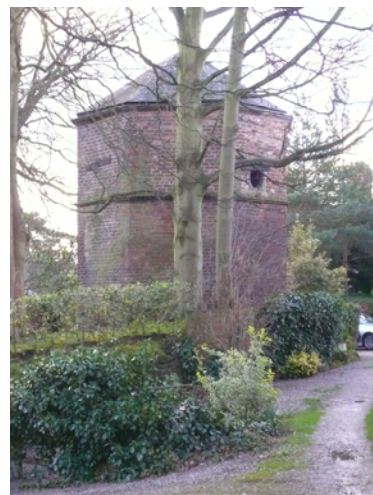
Gayton Hall was refaced in the mid 18th century around 17th century core

The dovecote is dated 1630 and bears the initials EG (Edward Glegg)

- 2.2.1 The Hall remained the home of the Glegg family throughout the 16th and 17th centuries. Surviving structures from this period include the dovecote (1630) and much of the Hall was constructed in the late 17th century.
- 2.2.2 During this period nearby Parkgate was an important port for ships crossing to Ireland. In 1689 William III stayed at Gayton Hall on his way to Ireland. William Glegg was given a knighthood as a result of his hospitality. Two evergreen oaks in the garden are reputed to have been planted in honour of the royal visit and are named William and Mary.

- 2.3.1 The Hall was updated with an elegant façade around 1750, giving it the appearance of a Georgian house.

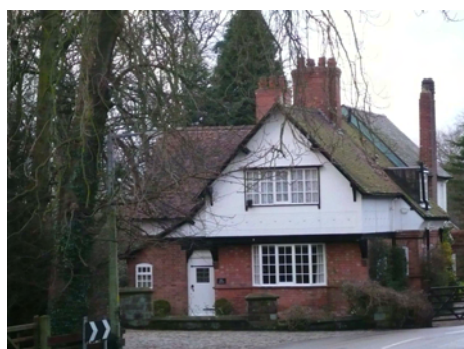
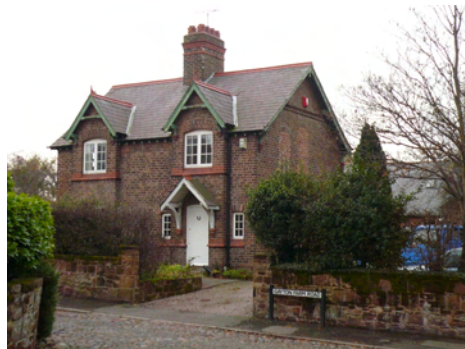
The Lodge on Gayton Lane and a former pair of cottages, now one house, known as Lister Lodge on Gayton Farm Road, both date from the late 19th century.

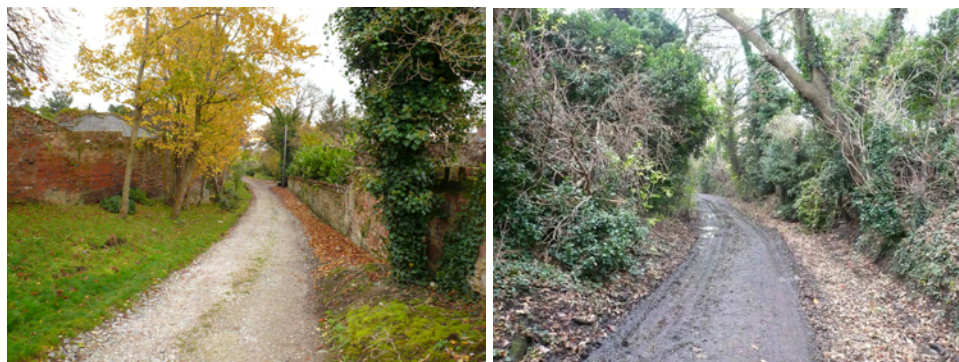
Gayton Farm Road, looking south away from The Old Farm and further south as it leaves the village. The unmade surface of the lane is fundamental to its character.

4.3.1 Gayton Farm Road is the most important route in the village. From Well Lane to the Hall it is surfaced in traditional cobbles (round, water worn duck-stones, not setts) which have been smoothed with years of use. The cobbled surface runs the full width of the highway between property boundaries with no pavement at its southern end, and has a pavement only on the west side at its northern end. The forecourt to Gayton Farm Barns / Little Gayton Farm is also in cobbles, with an area of stone flags.

4.3.2 Past the Hall as the Lane turns south it becomes an unmade track with stones and gravel loose laid to improve the surface. Other visually significant tracks and drives in the village have the same gravel or unmade appearance. After

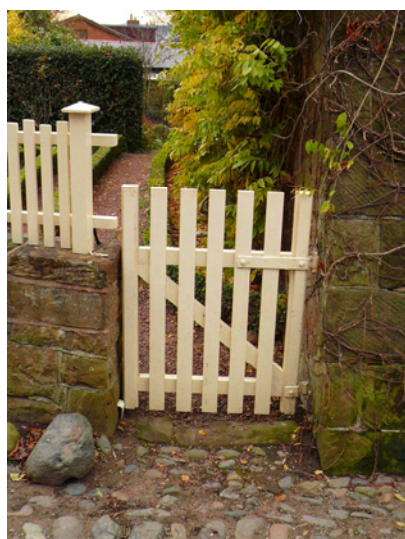
Roughly coursed sandstone walls, a simple picket fence and a gate inserted into a wall with no gate posts are all appropriate to the modest vernacular context. The wall on the right is in a poor state of repair and has been badly pointed.

- 4.3.3 Stone boundary walls within the conservation area are a key part of its visual character. Most walls are constructed of local red sandstone. Low walls are used around both agricultural and domestic properties. There are some variations in construction and design, but all are of roughly coursed stone, with some simple form of stone capping. High walls are also used, more often around the higher status historic houses and acting as retaining walls. The wall around the Hall is partially in brick and is buttressed along the lower part of Gayton Farm Road.

- 4.3.4 In many instances the boundary wall is backed by a hedge, such as clipped privet or hawthorn or a low picket fence. In some cases a high fence has been used to increase privacy, but a number of these fences are visually intrusive. Field boundaries and some property boundaries are hedging, mainly traditional varieties such as privet or mixed hedges with hawthorn predominating.

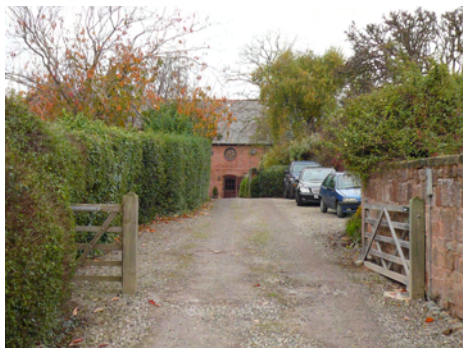
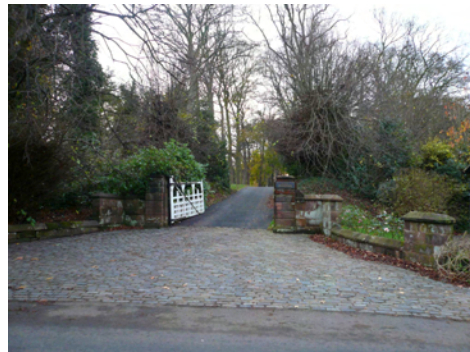
The vernacular character of the village is typified by unmade tracks, roughly coursed stone walls, five-bar gates and informal hedging. In contrast the grand entrance to Dormy House (formerly the drive to Gayton Hall) features dressed stone walls, an elaborate gate, regular stone setts and an avenue of trees.

- 4.3.5 A small number of stone gateposts are present, mainly associated with the entrances to higher status residential sites. The majority of gates are timber,

either five-bar, vertical boarded or, for smaller garden gates, vertical rails. The entrance gates adjacent to the Lodge on Gayton Lane are more elaborate in design, befitting the status of the entrance. Field gates are generally metal or timber five-bar gates.

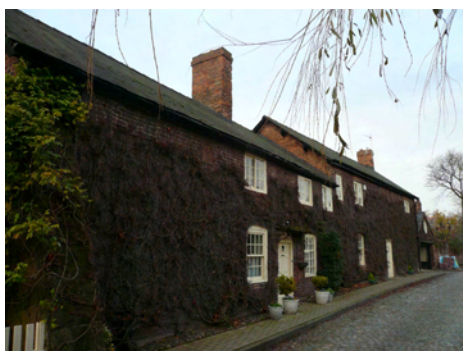
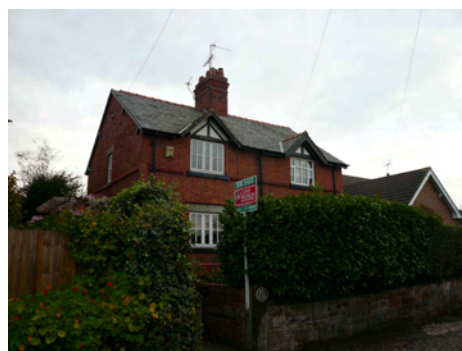
The Old Farm embodies many of the characteristics of a typical historic building in Gayton village. The late 19th century cottages are more symmetrical and have modest decoration yet represent the continuation of many vernacular characteristics.

5.1.2 Former agricultural buildings and historic houses are constructed from locally sourced materials. Forms are simple and rectilinear and the buildings have moderate pitched or low pitched roofs with a central ridge line. Window openings are typically small and the buildings generally have a 'robust' character.

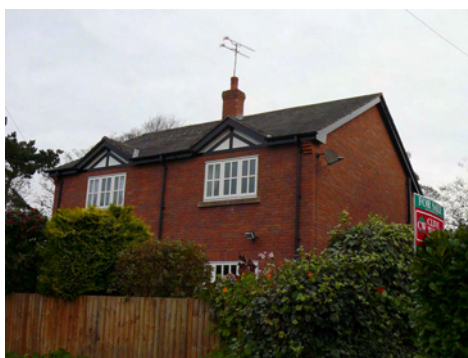
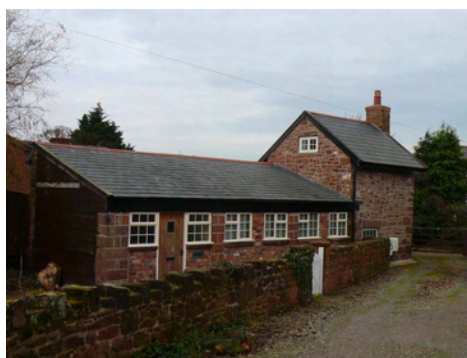
The Laurels, 79 Well Lane reflects the materials and details of the adjacent historic cottages. The Willows has been extended in local sandstone and Welsh slate.

- 5.1.6 Two late 20th century house have been constructed in red brick, one in imitation of the late 19th century cottages on Gayton Farm Road. Local red sandstone has been used for some small extensions as well as for rebuilding on the sites of former ancillary estate buildings.

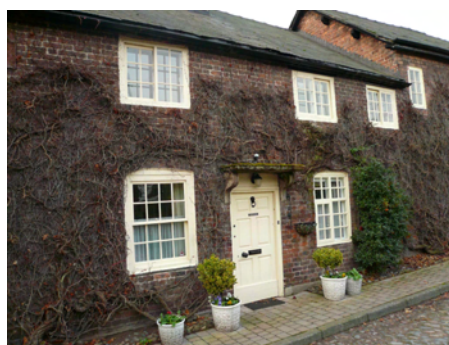
Vertical and horizontal sliding sash windows and casements can all be seen on one building here at The Old Farm. The window openings are unadorned.

- 5.4.1 **Windows** within the Gayton village conservation area that enhance its character are principally traditional timber windows. These are of three main types: small paned side hung casements; small paned vertical sliding sashes with exposed sash boxes; and small paned horizontal sliding sashes (or Yorkshire lights). Traditionally these timber windows are painted and are most usually found in domestic buildings. Some historic agricultural buildings may have had casements, but shutters were more likely to have been used.

- 5.4.2 Window openings to the lower status historic houses and former agricultural buildings are typically small, squarish in proportion and have little or no decoration to their surrounds. Some original large openings, such as cart doors, in former agricultural buildings have had large windows and door screens inserted. Gauged brick arches are most often used to form window heads although some openings are supported on the timber window frame. Most window openings have no projecting cill.

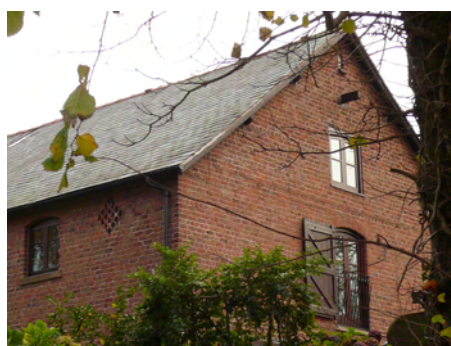
The simple roof form and verge detail of Little Gayton Farm / Gayton Barns is typical of the conservation area.

5.4.4 **Roof details** to almost buildings within the conservation area are very simple. The roof pitches are low to medium and clad in Welsh slate. Clay ridge tiles of angular form are used, in both red and grey. Ridges mainly run parallel to the front of the building and end gables are simply treated. On the majority of the historic buildings the purlins project beyond the gable wall to allow the roof verge to overhang. Some of these gables are finished with a narrow barge board, others have exposed rafters. Eaves typically have a minimal overhang.

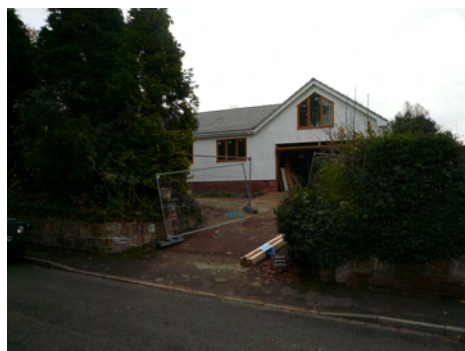
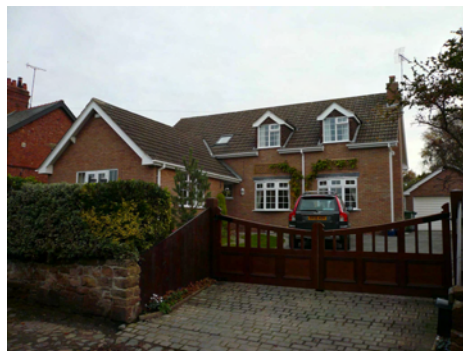
Two developments which are not in keeping with the character of the conservation area, one at the edge and one in the heart of the village. Importantly however the sandstone boundary walls and planting are very much characteristic of the area.

6.2.3 The majority of the development has not been sensitive to the historic character of the village. However, most of these newer buildings are around the edges of the historic settlement. They form part of the contemporary setting of the village but generally do not intrude into views within the conservation area.

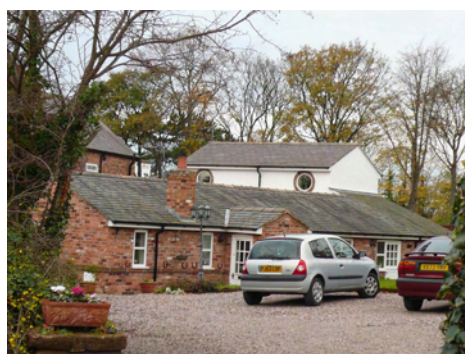
The Old Bakehouse is a new development that has attempted to reflect the characteristics of former farm buildings with mixed success.

6.2.4 The most recent developments within the heart of the conservation area have been modest in scale. They have generally attempted to reflect the forms and materials of the historic estate buildings but sometimes display a limited understanding of traditional construction techniques and details.

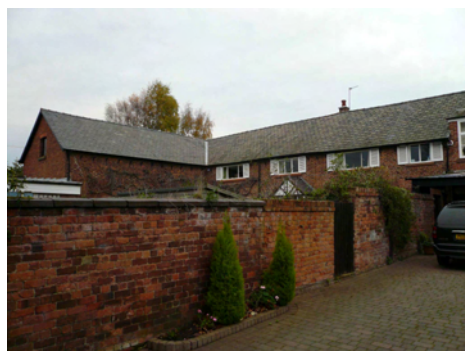
The conversion of the Coach House and the adjoining property introduced an excessively domestic porch and intrusive window details to this former farm building. The strong form of the original building survives and any future alterations can be carried out to better reflect the original character of the building.

6.3.2 Barns and many other former agricultural buildings by their nature have few window openings and their conversion to residential use can compromise their appearance. Too many new window openings and openings of large size can result in a loss of character. Where new windows have been created in former agricultural buildings it is small openings that have least impact on the building's original character. Sometimes single paned windows are more successful than multi-paned windows, being simpler and less "domestic" in appearance.

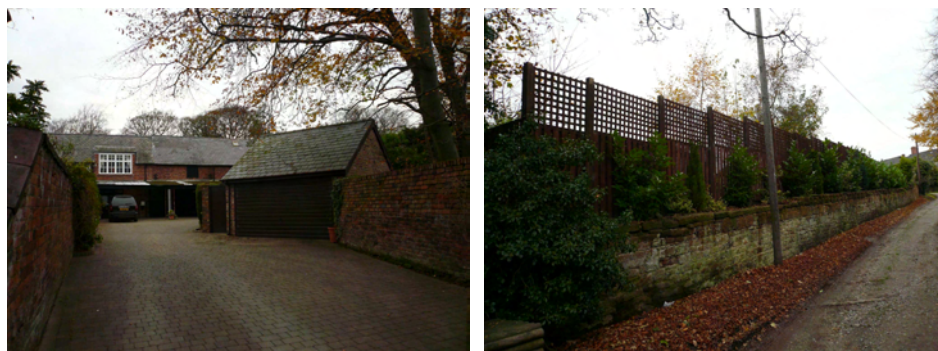
Man made setts are too uniform in colour and texture for use in large areas. This low stone wall to Gayton Farm Road is topped by a very high timber fence and a mixture of unsuitable shrub species. In both cases the effect is too harsh.

courtyard atmosphere. However some modern paving materials have been employed which are harsh and alien in appearance.

- 6.3.6 The desire for privacy also brings potential conflict. Hedges grow more slowly than a fence can be erected and a number of properties have high boarded fences on boundaries facing the public realm. These introduce a modern element, lacking in the texture and subtle colours of traditional boundary treatments. Such fences also obstruct longer views and reduce the visual permeability of the area. Fast growing hedge materials such as conifers and large leafed laurel also introduce colours and textures out of context with the vernacular landscape.
