## OXTON CONSERVATION AREA APPRAISAL

Prepared for Wirral Council and The Oxtan Society  
by Donald Insall Associates Ltd

January 2010

## **VOLUME 1 – CONSERVATION AREA APPRAISAL**

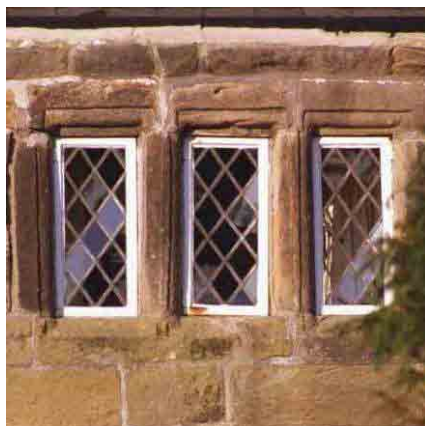
*C17th sandstone 3-light ovolo moulded mullioned window, fitted with metal frames and leaded lights*

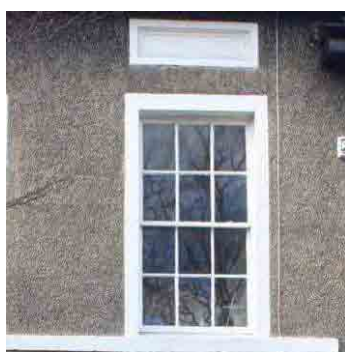
*Conventional 12-pane double-hung sliding sash window with fine glazing bars in rectangular opening, given additional character by recessed panel above and projecting cill band below*

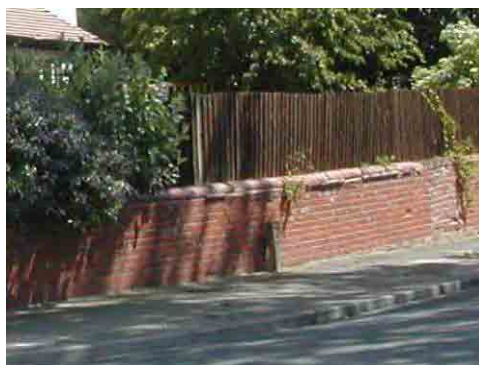
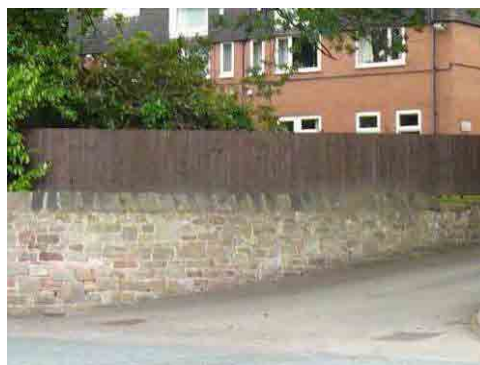
*Inappropriate panel fencing atop a brick wall and sandstone wall*

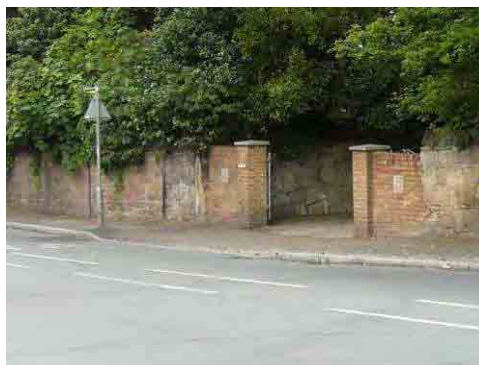
*Inappropriate brick infilling and 'crazy paving' retaining wall behind*

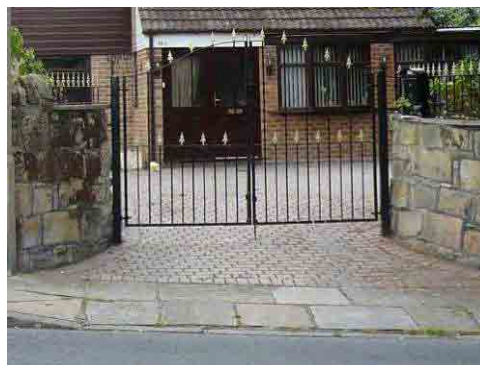
*A well-intentioned attempt at introducing iron railings and gates, sadly out of character with both the character of the conservation area and the style of the house.*

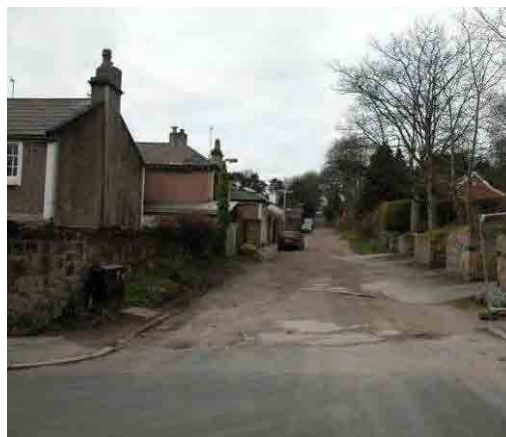
*Arno Road West of Fairview Road is unmade, but heavy use has led to the creation of potholes and some uncoordinated patch repairs*

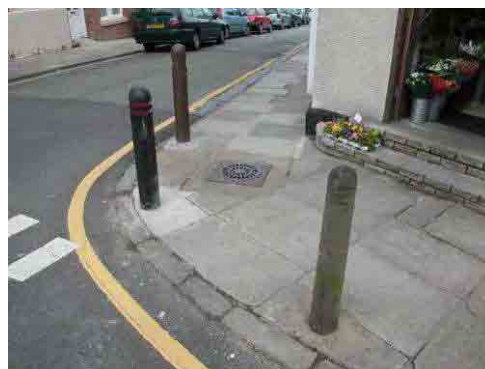
*The requirements of road users and the need for frequent repairs impact on the visual quality of the roads and pavements*

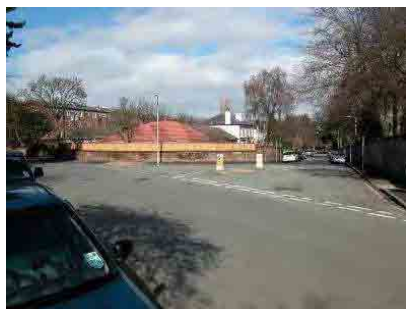
*At the junction of Village Road and Alton Road all that can be seen of this bungalow is its bright red roof. It fails to add positively to the townscape of this important junction and detracts from the prevalent characteristics of the area.*

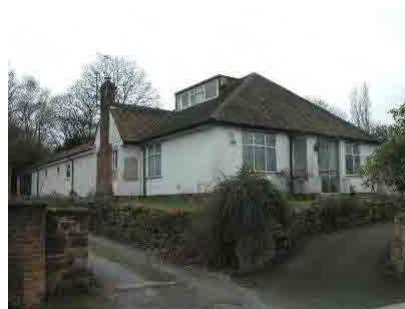
*This bungalow on the site of a former villa on Victoria Mount is highly visible due to its elevated position and weak boundary treatment to the adjacent track.*

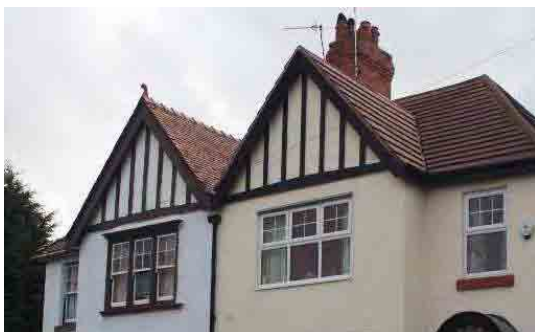
*This pair of houses on Glenmore Road illustrate the impact of replacement windows and roof covering (right) as compared with the originals (left). Concrete tiles have a harsh stepped appearance. The decorative finial and subtle pattern of lapped ridge tiles have been lost. The replacement uPVC windows are flat and lacking in the attractive modelling of sashes with horns, cill and cornice detail and vertical rhythm of sash boxes.*

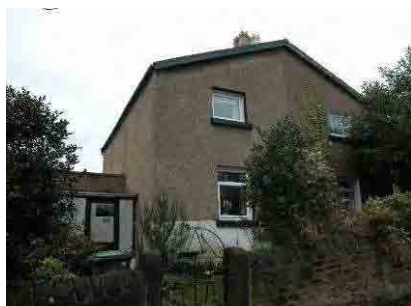
*Sandstone house on Parr's Road with rendered façade and modern replacement windows*

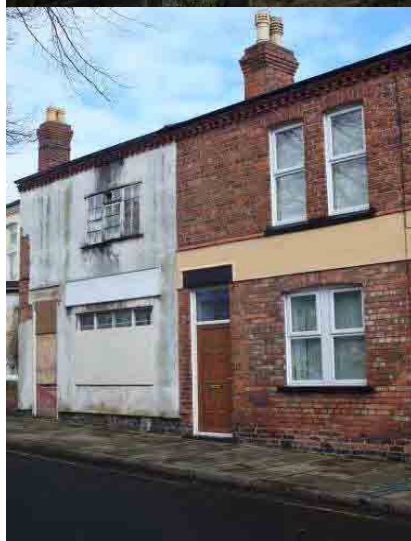
*(left) Brick terrace on Claughton Firs where the application of painted render and insertion of horizontally proportioned small paned windows, along with vacancy and neglect has had a disastrous effect on the building.*

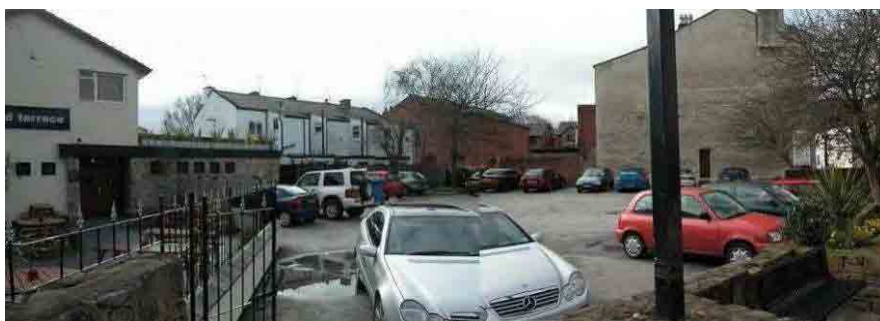
*Loss of enclosure around car park at village centre*

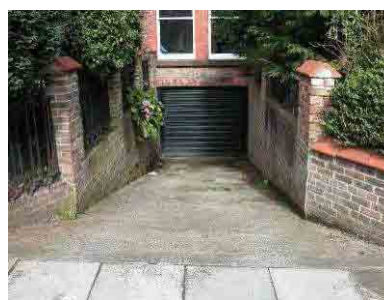
*Basement converted to garage on Village Road*
