FINAL ASSEMBLY INSTRUCTION	PT5664
	POWER SUPPLY 4008 109 71110 MB	Digital & Analog Composite WMF
Prepared by : BKB/Gbg

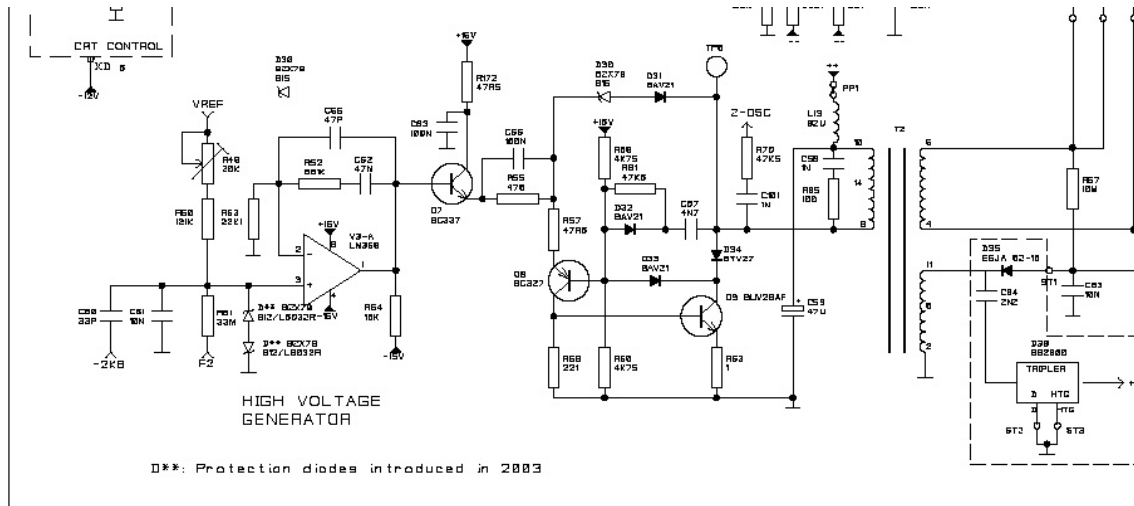
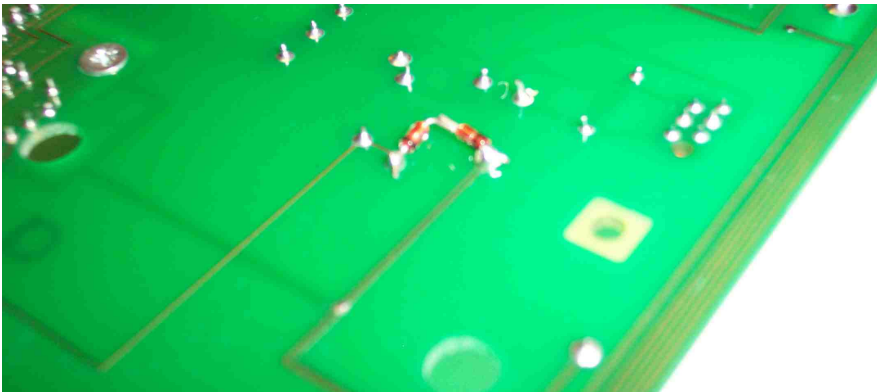
A pair of Zenerdiodes BZX79-12V is mounted on the solder side of the PCB in an antiparallel mode.

Please refer to diagram and picture below:
