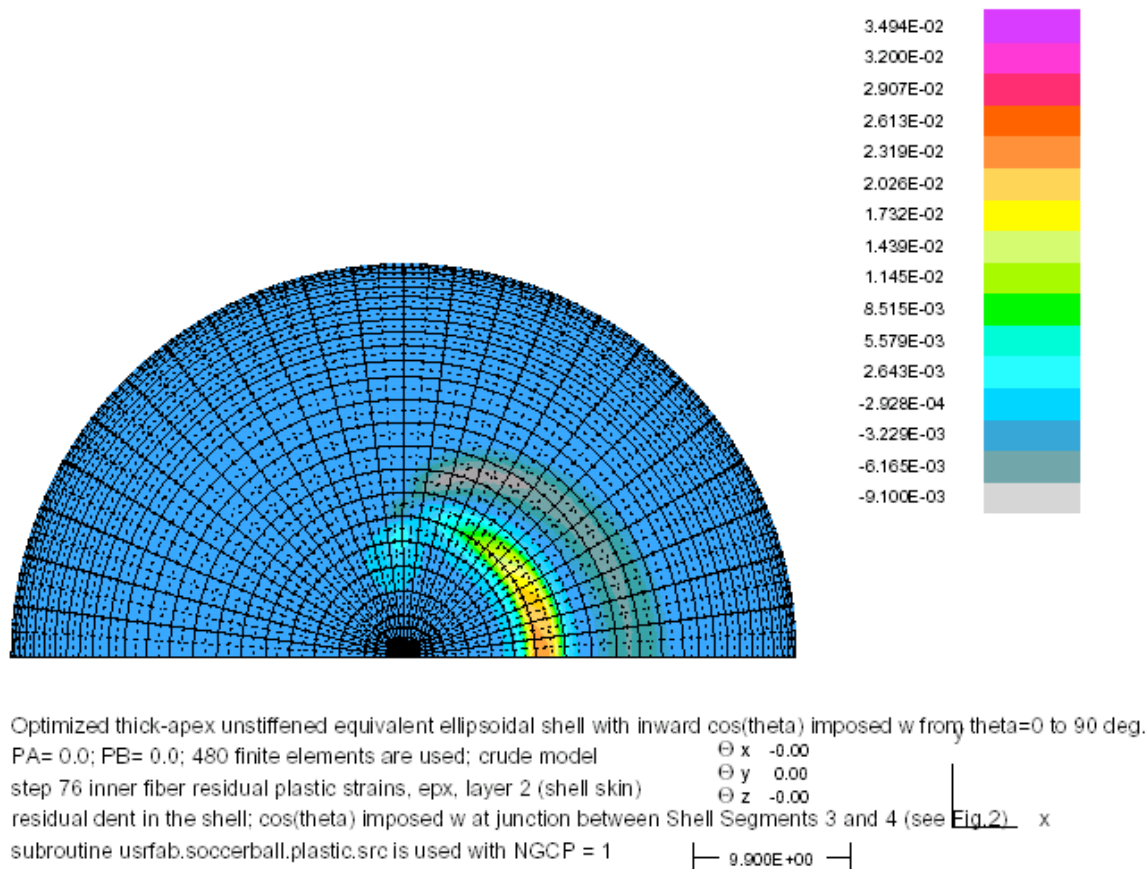
Fig. 198 Elastic-plastic analysis of the **optimized unstiffened equivalent ellipsoidal shell with the thick apex with  $t(\text{apex}) = 0.4$  inch;  $W_{\text{imp}}=0.2$  inch; the optimum design is listed in Table 78.** State of the shell at load set B (PB) step no. 76 at the end of Run 6. (See Fig. 193). This is the **inner fiber** meridional plastic strain, epx, associated with the residual dent shown in the previous figure. Load set B consists of a number of concentrated normal inward-directed imposed **displacements** applied along the junction of Shell segments 3 and 4 (Figs. 2, 169, 181, 190, 191) distributed as  $\cos(\theta)$  from  $\theta = 0$  to  $90$  degrees in the circumferential coordinate along Row no. 5 in Shell Units 11 and 12. (See Table a40). This imposed normal displacement distribution is used because it generates a dent that **locally** resembles the deformation in Figs. 190 and 191, that is, the linear buckling modal imperfection with  $n = 1$  circumferential wave.
