## Front Wiper Position Circuit

### CIRCUIT DESCRIPTION

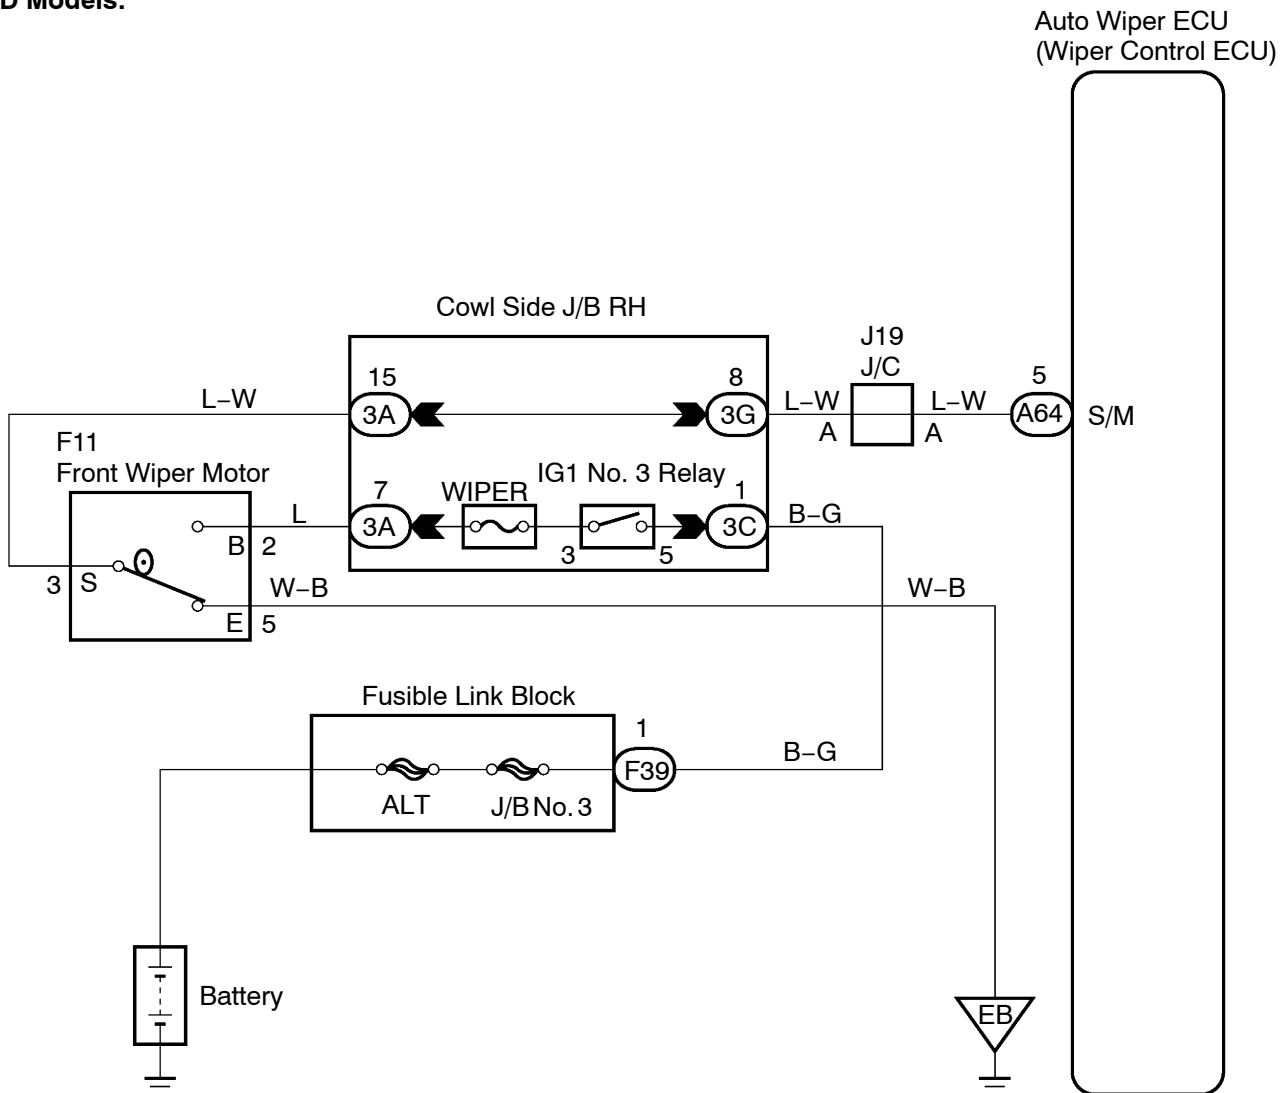
I26023

This signal is taken into Body ECU. If this signal cannot be received, Body ECU does not perform reverse linked function control.

LHD Models:

| 1 | Check wire harness between wiper control ECU and front wiper motor ( <a href="#">See page IN-38</a> ). |

| 2 | Check wire harness between wiper control ECU and body ECU ( <a href="#">See page IN-38</a> ). |

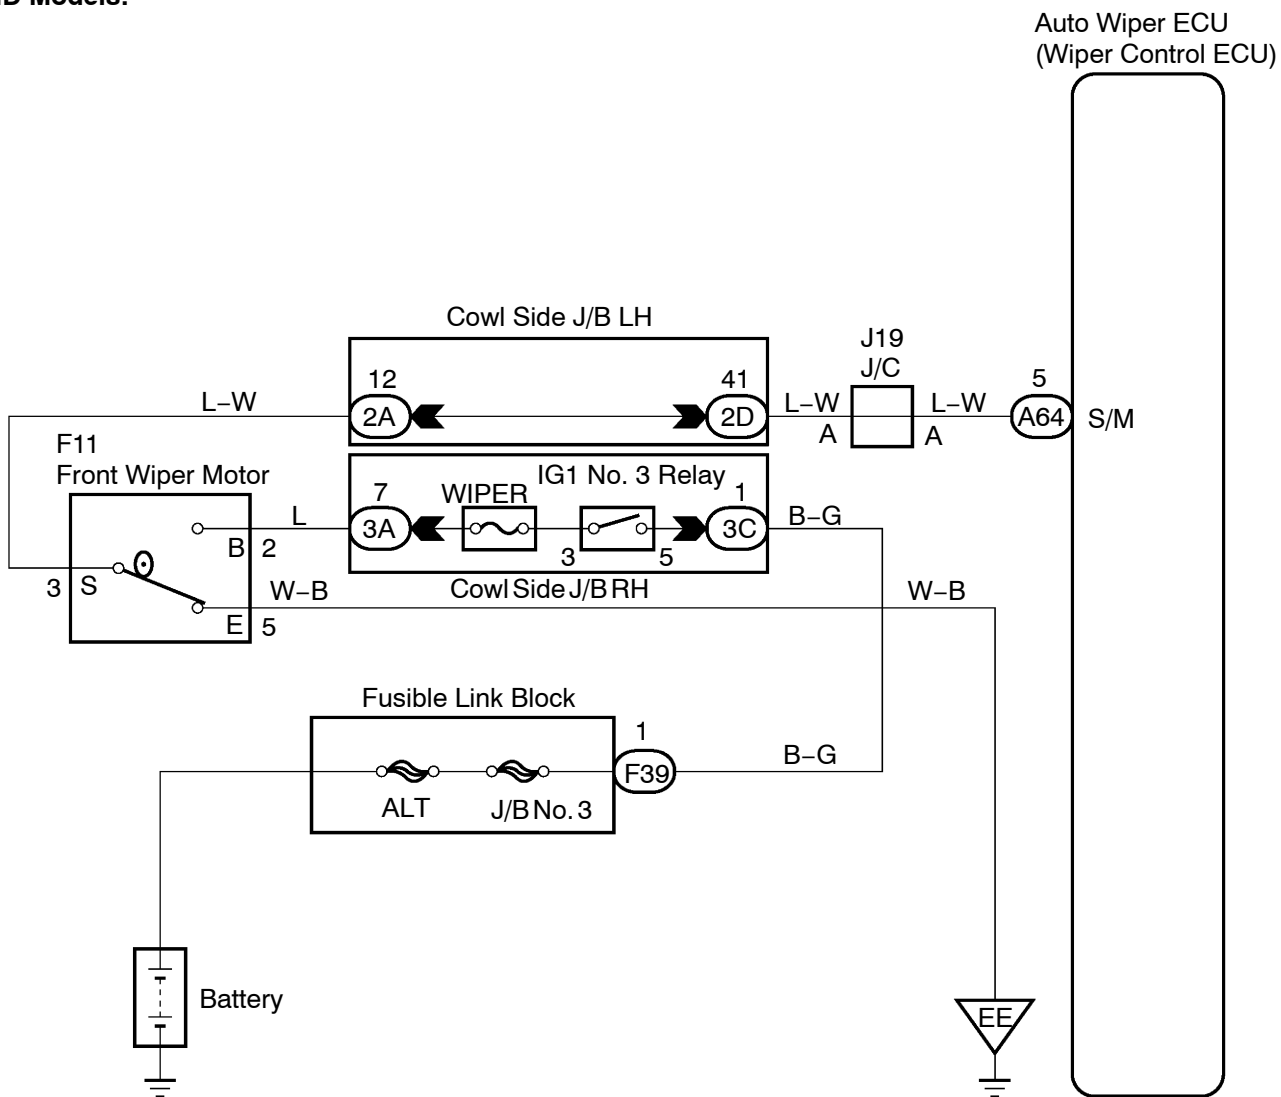
I26049

## RHD Models:
