<b>DTC</b>	<b>B1215 / 15</b>	<b>Door system communication bus malfunction (GND short)</b>
------------	-------------------	--

### CIRCUIT DESCRIPTION

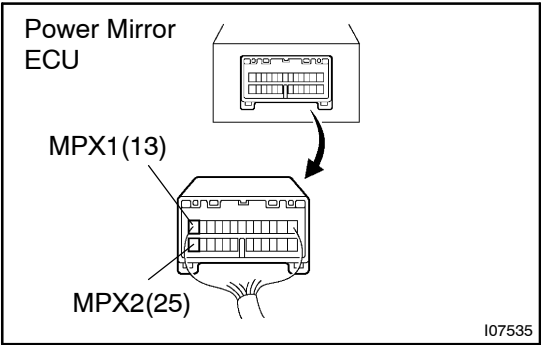
<b>1</b>	<b>Check the communication circuit inside power mirror ECU.</b>
----------	---

Disconnect the connector power mirror ECU.

Check the DTC.

Code B1215/15 is not output

<b>OK</b>	<b>Replace the power mirror ECU.</b>
-----------	--------------------------------------

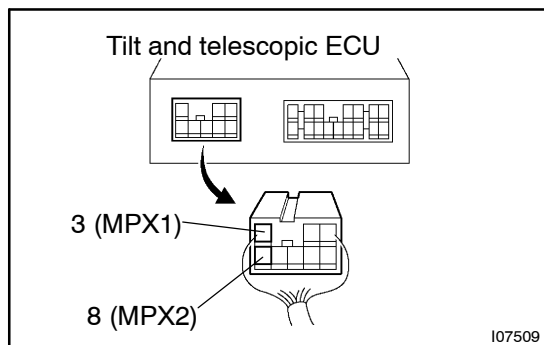
**2 Check the communication circuit inside tilt and telescopic ECU.**

- (a) Connect the connector power mirror ECU.
- (b) Disconnect the connector tilt and telescopic ECU.

Check the DTC.

Code B1215/15 is not output

**OK****Replace the tilt and telescopic ECU.****NG****3 Check the communication circuit inside power seat ECU.**

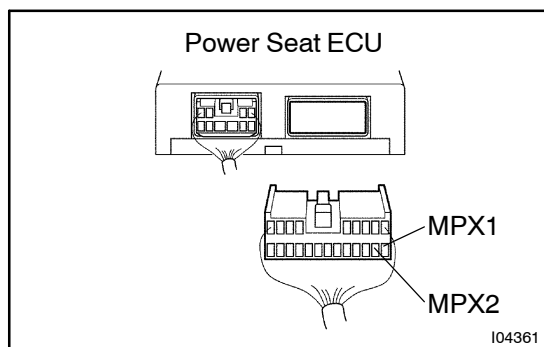
- (a) Connect the connector tilt and telescopic ECU.
- (b) Disconnect the connector power seat ECU.

Check the DTC.

Code B1215/15 is not output

**OK****Replace the power seat ECU.****NG**

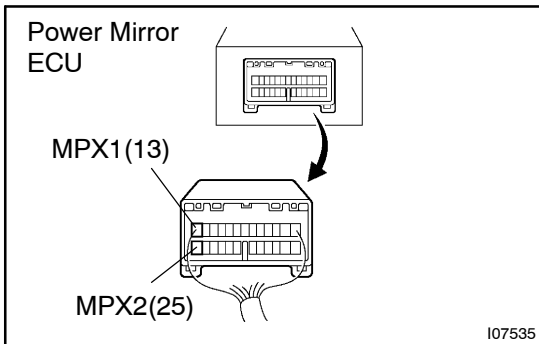
#### 4 Check for short circuit between body ECU and power mirror ECU.

Disconnect the connector power mirror ECU.

Check the DTC.

Code B1215/15 is not output

Repair or replace the wire harness between and body ECU and power mirror ECU.

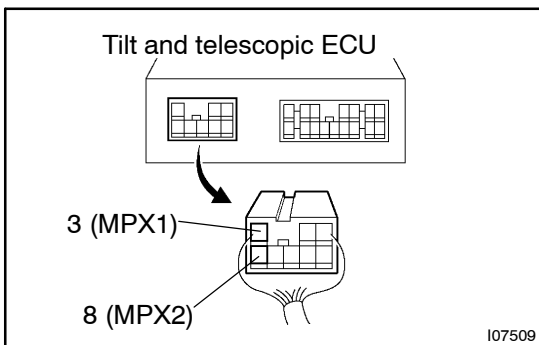
#### 5 Check for short circuit between power mirror ECU and tilt & telescopic ECU.

Disconnect the connector tilt & telescopic ECU.

Check the DTC.

Code B1215/15 is not output

Repair or replace the wire harness between power mirror ECU and tilt & telescopic ECU.

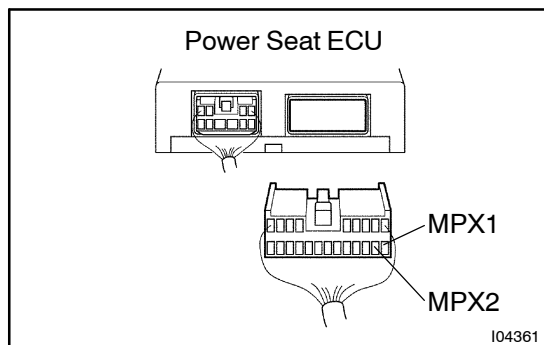
**6 Check for short circuit between tilt & telescopic ECU and power seat ECU.**

Disconnect the connector power seat ECU.

Check the DTC.

Code B1215/15 is not output

**Repair or replace the wire harness between and tilt & telescopic ECU and power seat ECU**

**Replace the body ECU.**
