DTC	C 1521 / 21	VGRS Actuator Malfunction
-----	-------------	---------------------------

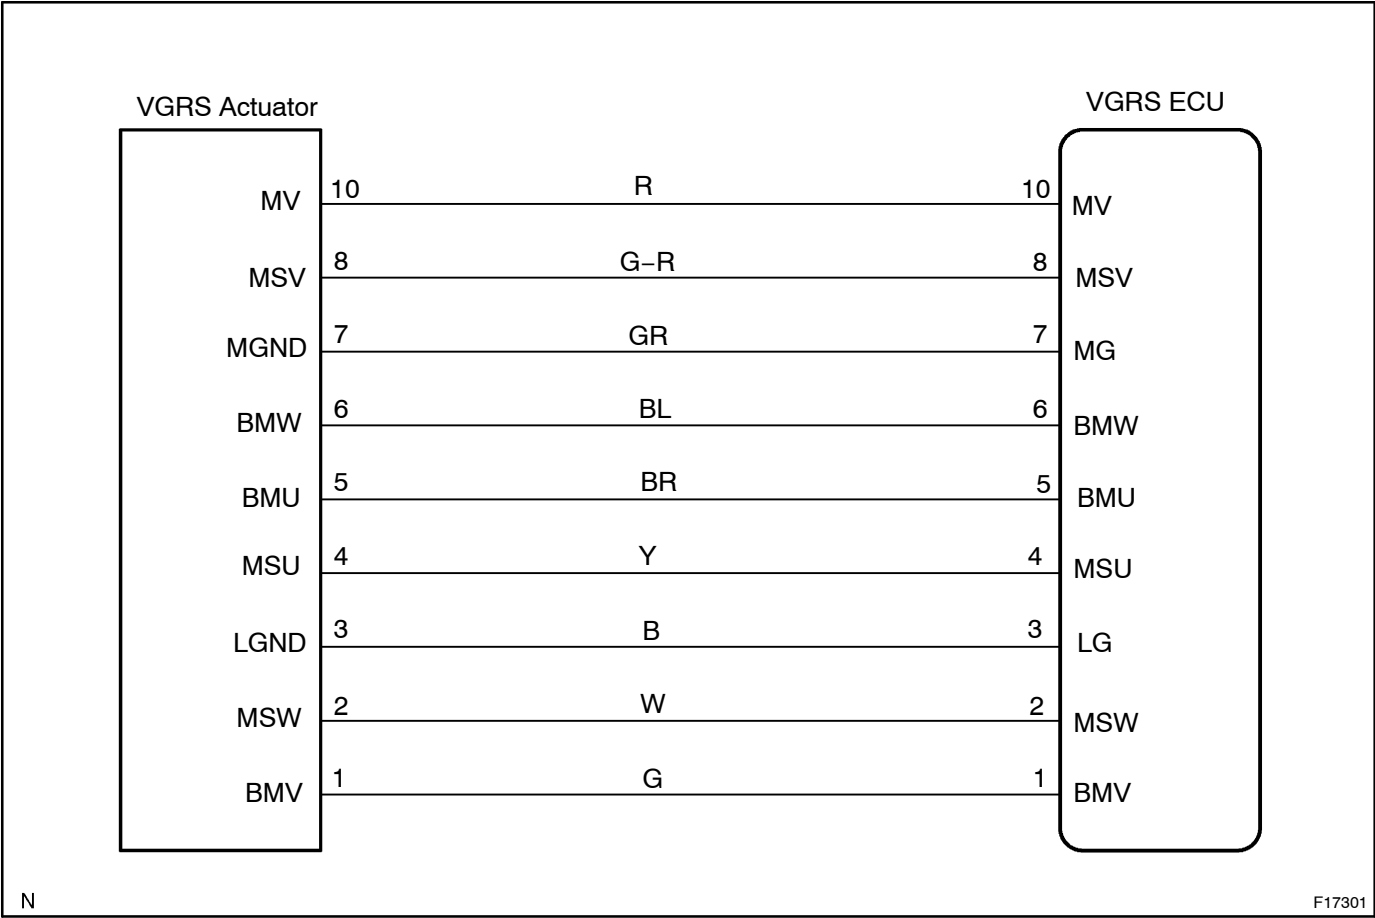
WIRING DIAGRAM

The VGRS ECU drives the actuator while turning the steering wheel to set the gear ratio. It detects the current flowing into the actuator motor driving circuit. When the VGRS ECU detects excessive current, it records the DTC, turns on the VGRS warning light, and stops VGRS operation.

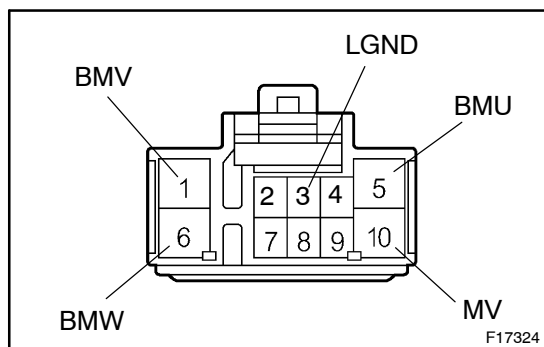
1 Inspect the VGRS actuator.

- Turn the ignition switch OFF.
- Disconnect the actuator connector from the VGRS ECU.

- Measure resistance between terminals.

Symbols (Terminals)	Resistance
BMV (1) - BMU (5)	0.1 Ω to 1. Ω
BMV (1) - BMW (6)	
BMU (5) - BMW (6)	
MV (10) - LGND (3)	1 Ω to 100 Ω

Replace VGRS actuator.

Replace VGRS ECU.

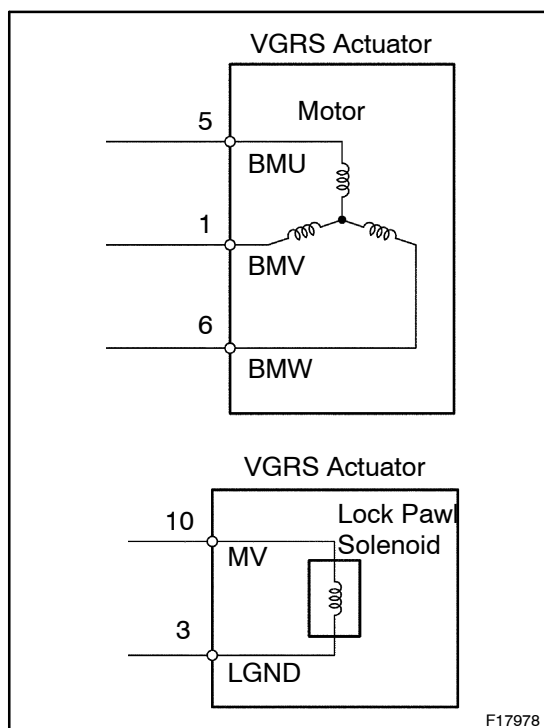
- Check continuity between terminals of actuator connector and body ground.

Symbols (Terminals)	Specified condition
BMV (1) - Body ground	No Continuity,
BMU (5) - Body ground	
BMW (6) - Body ground	
MV (10) - Body ground	
LGND (3) - Body ground
