Tecnomatix Plant Simulation 16 Statistics

Created on	martes, 17 de agosto de 2021 3:40 a. m.
Model name	C:\Users\leo7s\Documents\Universidad\01 APM\02 Proyecto Final\Proyecto_APM\SimulacionProceso\Simulación Playera completa sin automatizar.spp
Simulation time	8:00:00.0000

Resource Statistics - Resource Statistics

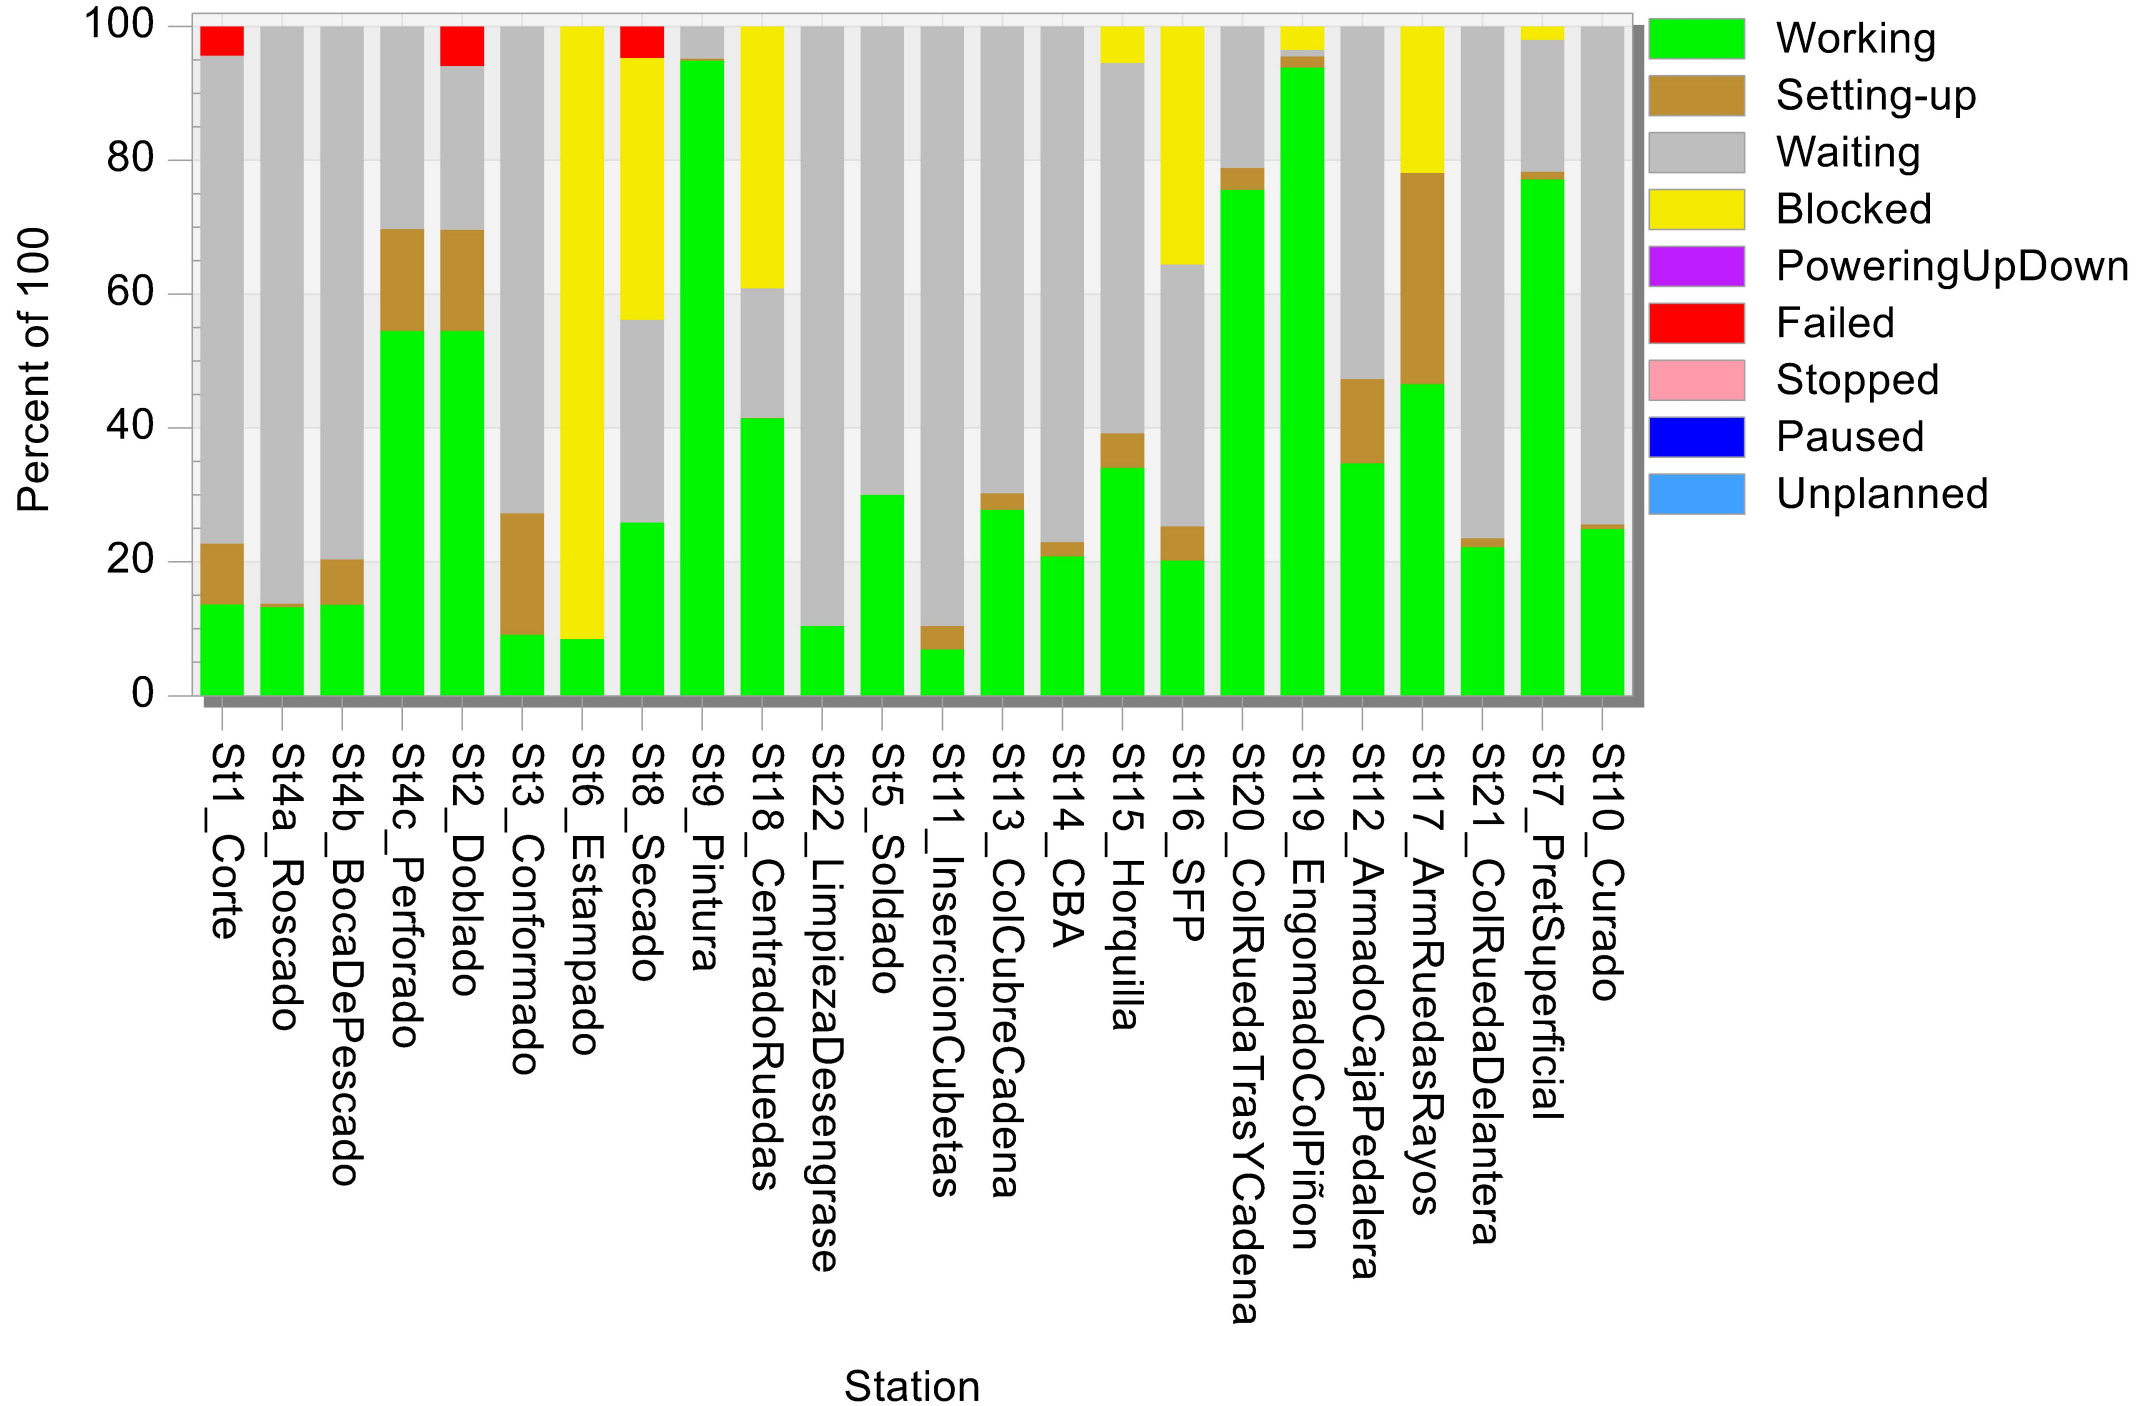
Portions of the States

Object	Working	Set-up	Waiting	Blocked	Powering up/down	Failed	Stopped	Paused	Unplanned	Portion
St1_Corte	13.64%	9.10%	72.90%	0.00%	0.00%	4.37%	0.00%	0.00%	0.00%	
St4a_Roscado	13.25%	0.52%	86.24%	0.00%	0.00%	0.00%	0.00%	0.00%	0.00%	
St4b_BocaDePescado	13.61%	6.78%	79.61%	0.00%	0.00%	0.00%	0.00%	0.00%	0.00%	
St4c_Perforado	54.53%	15.17%	30.30%	0.00%	0.00%	0.00%	0.00%	0.00%	0.00%	
St2_Doblado	54.50%	15.14%	24.48%	0.00%	0.00%	5.88%	0.00%	0.00%	0.00%	
St3_Conformado	9.08%	18.17%	72.75%	0.00%	0.00%	0.00%	0.00%	0.00%	0.00%	
St6_Estampado	8.46%	0.05%	0.00%	91.50%	0.00%	0.00%	0.00%	0.00%	0.00%	
St8_Secado	25.88%	0.01%	30.26%	39.16%	0.00%	4.69%	0.00%	0.00%	0.00%	
St9_Pintura	94.93%	0.25%	4.82%	0.00%	0.00%	0.00%	0.00%	0.00%	0.00%	
St18_CentradoRuedas	41.45%	0.04%	19.39%	39.12%	0.00%	0.00%	0.00%	0.00%	0.00%	
St22_LimpiezaDesengrase	10.44%	0.01%	89.55%	0.00%	0.00%	0.00%	0.00%	0.00%	0.00%	
Producto_terminado	0.00%	0.00%	100.00%	0.00%	0.00%	0.00%	0.00%	0.00%	0.00%

St5_Soldado	30.00%	0.00%	70.00%	0.00%	0.00%	0.00%	0.00%	0.00%	0.00%	
St11_InsercionCubetas	6.94%	3.51%	89.55%	0.00%	0.00%	0.00%	0.00%	0.00%	0.00%	
St13_ColCubreCadena	27.78%	2.45%	69.77%	0.00%	0.00%	0.00%	0.00%	0.00%	0.00%	
St14_CBA	20.83%	2.10%	77.06%	0.00%	0.00%	0.00%	0.00%	0.00%	0.00%	
St15_Horquilla	34.03%	5.21%	55.32%	5.44%	0.00%	0.00%	0.00%	0.00%	0.00%	
St16_SFP	20.21%	5.10%	39.15%	35.54%	0.00%	0.00%	0.00%	0.00%	0.00%	
St20_ColRuedaTrasY Cadena	75.59%	3.30%	21.11%	0.00%	0.00%	0.00%	0.00%	0.00%	0.00%	
St19_EngomadoColPiñon	93.86%	1.67%	0.97%	3.50%	0.00%	0.00%	0.00%	0.00%	0.00%	
St12_ArmadoCajaPedalera	34.72%	12.62%	52.65%	0.00%	0.00%	0.00%	0.00%	0.00%	0.00%	
St17_ArmRuedasRayos	46.58%	31.52%	0.00%	21.90%	0.00%	0.00%	0.00%	0.00%	0.00%	
St21_ColRuedaDelantera	22.19%	1.32%	76.49%	0.00%	0.00%	0.00%	0.00%	0.00%	0.00%	
St7_PretSuperficial	77.15%	1.12%	19.72%	2.01%	0.00%	0.00%	0.00%	0.00%	0.00%	
St10_Curado	24.89%	0.70%	74.41%	0.00%	0.00%	0.00%	0.00%	0.00%	0.00%
