MICHELIN
Digital Inspection

Fleet Inspection Analysis

for Opicorp,
Opicorp

01/02/2026 - 13/02/2026

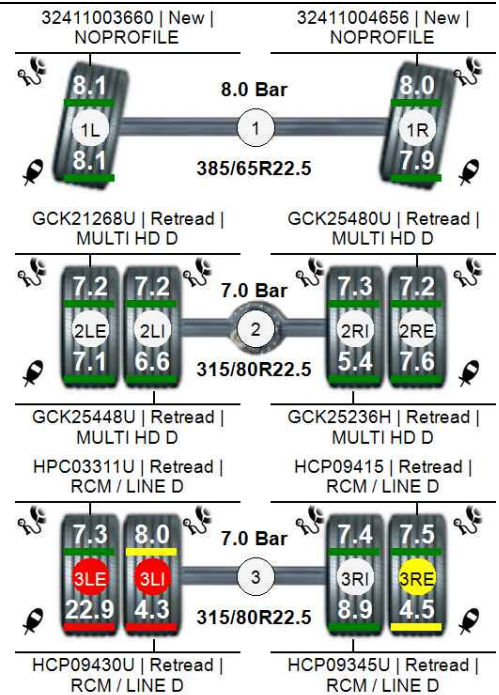
AC315

Pos.	Issue	Action
3LE	Twin Mismatch (RTD)	URGENT Correct Mismatch
3LI	Twin Mismatch (RTD)	URGENT Correct Mismatch
3LI	Low Tread Depth - Retread	Plan Regrooving
3LI	Over-Inflation	Adjust Pressure
3RE	Low Tread Depth - Retread	Plan Regrooving

Reg. Number	Pos.	Tyre Make	Tyre Size	Tyre Pattern	Tread Depth	Tyre Life	Defects
CF222938	3LI	Recamic	315/80R22.5	LINE D	4.3	Retread	Low Tread Depth - Retread, Twin Mismatch (RTD), Over-Inflation
CF222938	3RE	Recamic	315/80R22.5	LINE D	4.5	Retread	Low Tread Depth - Retread
CF224953	3R	Continental	285/70R19.5	RZ	4.6	New	Low Tread Depth - New
T408	1L	BLACKLION	285/70R19.5	BT165	5.0	New	Low Tread Depth - New
T408	1R	BLACKLION	285/70R19.5	BT165	4.7	New	Low Tread Depth - New
T408	3R	BLACKLION	285/70R19.5	BT165	4.2	New	Low Tread Depth - New

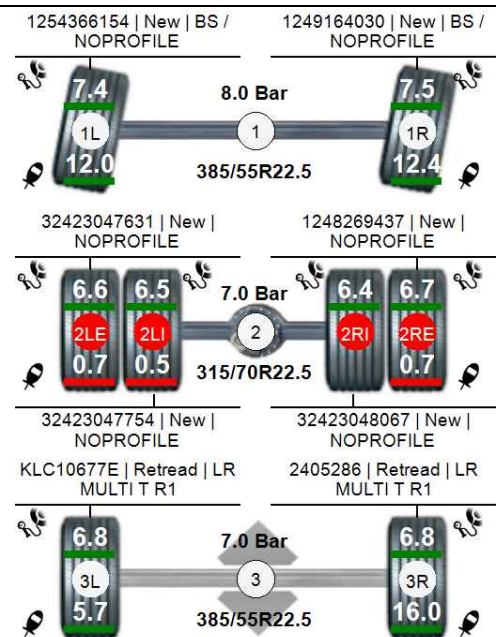
AC318

Pos.	Issue	Action
2LE	Urgent Excessive Wear	URGENT Replace
2LI	Urgent Excessive Wear	URGENT Replace
2RI	Urgent Excessive Wear	URGENT Replace
2RE	Urgent Excessive Wear	URGENT Replace

Reg. Number	Pos.	Tyre Make	Tyre Size	Tyre Pattern	Tread Depth	Tyre Life	Defects
CF218808	2LE	BLACKLION	315/70R22.5	NOPROFILE	0.7	New	Urgent Excessive Wear
CF218808	2LI	BLACKLION	315/70R22.5	NOPROFILE	0.5	New	Urgent Excessive Wear
CF218808	2RI	BLACKLION	315/70R22.5	NOPROFILE	0.0	New	Urgent Excessive Wear
CF218808	2RE	BLACKLION	315/70R22.5	NOPROFILE	0.7	New	Urgent Excessive Wear
CF239002	2LE	Michelin	315/70R22.5	X MULTI HD D	0.0	New	Urgent Excessive Wear, Over-Inflation
CF343124	2LI	BLACKLION	315/80R22.5	NOPROFILE	1.2	New	Urgent Excessive Wear, Low Pressure, Twin Mismatch (RTD)
CF343124	2RI	BLACKLION	315/80R22.5	NOPROFILE	0.1	New	Low Pressure, Urgent Excessive Wear
CF343124	2RE	BLACKLION	315/80R22.5	NOPROFILE	0.7	New	Urgent Excessive Wear

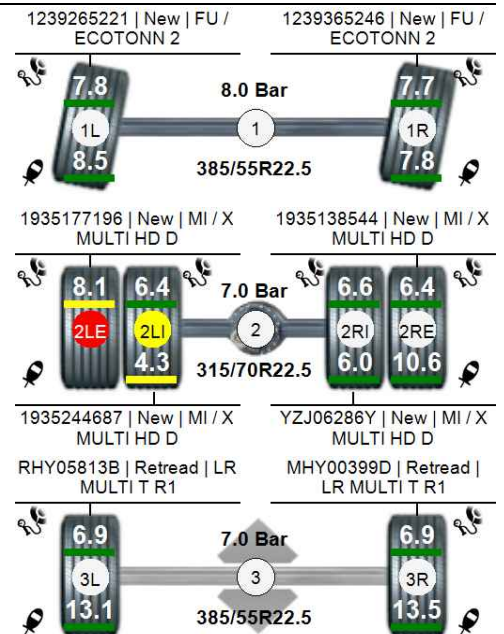
AC319

Pos.	Issue	Action
2LE	Urgent Excessive Wear	URGENT Replace
2LE	Over-Inflation	Adjust Pressure
2LI	Low Tread Depth - New	Plan Regrooving

Reg. Number	Pos.	Tyre Make	Tyre Size	Tyre Pattern	Tread Depth	Tyre Life	Defects
CF239002	2LI	Michelin	315/70R22.5	X MULTI HD D	4.3	New	Low Tread Depth - New

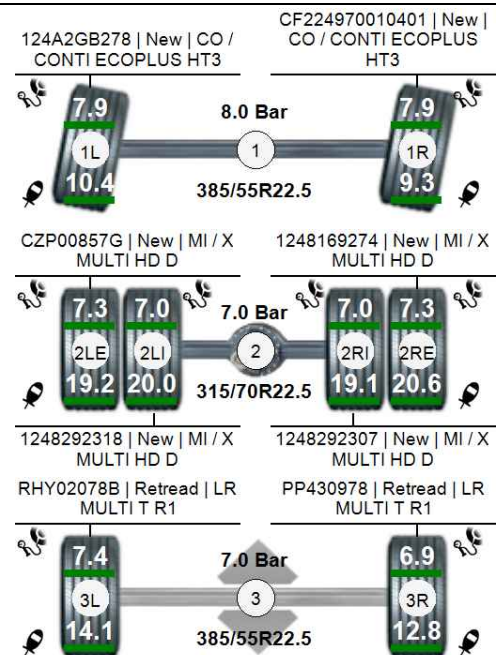
AC321

Registration No.	CF224970	Location	Durban
Make	VOLVO	Date/Time	03/02/2026
Model	FM 12-400	ODO	15718615
Vehicle Class	Tractor Unit	Hours	
		Inspector	Mohamed.sha27@outlook.com
		Inspection Type	Inspection

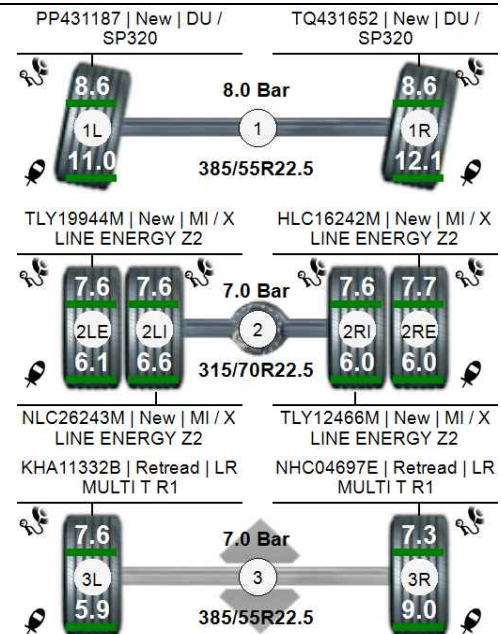
AC324

Registration No.	CF270298	Location	Durban
Make	VOLVO	Date/Time	05/02/2026
Model	FM 12-400	ODO	1135695
Vehicle Class	Tractor Unit	Hours	
		Inspector	Mohamed.sha27@outlook.com
		Inspection Type	Inspection

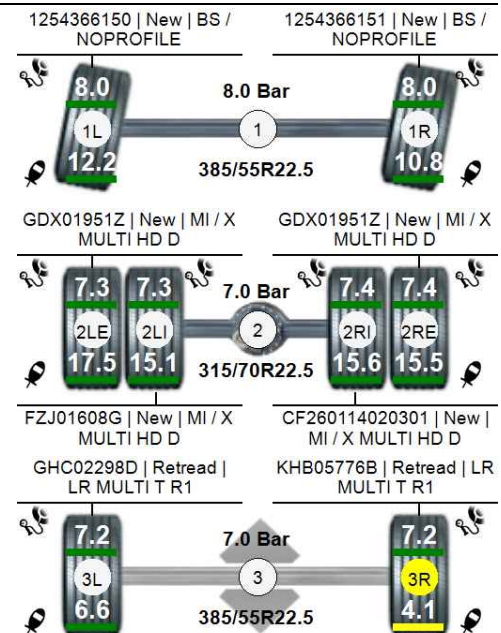
AC328

Pos.	Issue	Action
3R	Low Tread Depth - Retread	Plan Regrooving

Reg. Number	Pos.	Tyre Make	Tyre Size	Tyre Pattern	Tread Depth	Tyre Life	Defects
CF260114	3R	Laurent Retread	385/55R22.5	LR MULTI T R1	4.1	Retread	Low Tread Depth - Retread

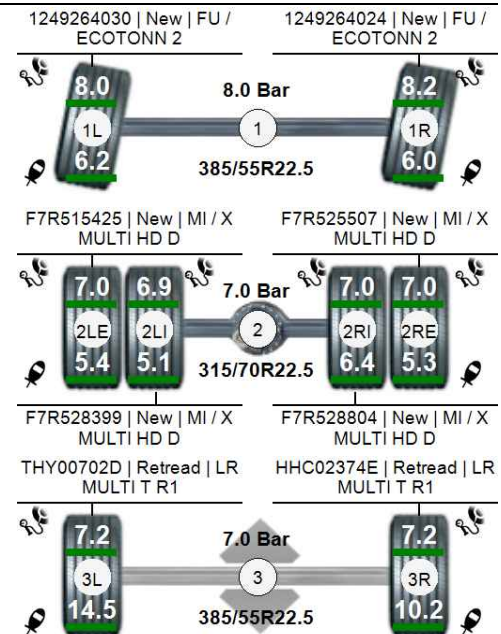
AC342

Registration No.	CF274381	Location	Durban
Make	VOLVO	Date/Time	02/02/2026
Model	FM 12-400	ODO	781331
Vehicle Class	Tractor Unit	Hours	
		Inspector	Mohamed.sha27@outlook.com
		Inspection Type	Inspection

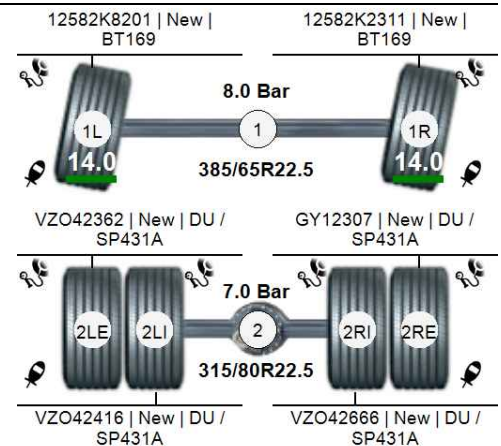
AC367

Registration No.	CF256166	Location	Durban
Make	VOLVO	Date/Time	02/02/2026
Model	FM330	ODO	
Vehicle Class	Tractor Unit	Inspector	Mohamed.sha27@outlook.com
		Inspection Type	VisualInspection

Pos.	Issue	Action
1L	Urgent Low Pressure	URGENT Check/Repair/Replace
1L	Urgent Excessive Wear	URGENT Replace
1L	Pronounced irregular wear	Turn on Rim or Replace
2LE	Twin Mismatch (RTD)	URGENT Correct Mismatch
2LE	Low Pressure	Check/Repair/Replace/Adjust
2LI	Urgent Excessive Wear	URGENT Replace
2LI	Twin Mismatch (RTD)	URGENT Correct Mismatch
2LI	Low Pressure	Check/Repair/Replace/Adjust
2RI	Urgent Excessive Wear	URGENT Replace
2RI	Low Pressure	Check/Repair/Replace/Adjust
2RE	Urgent Excessive Wear	URGENT Replace

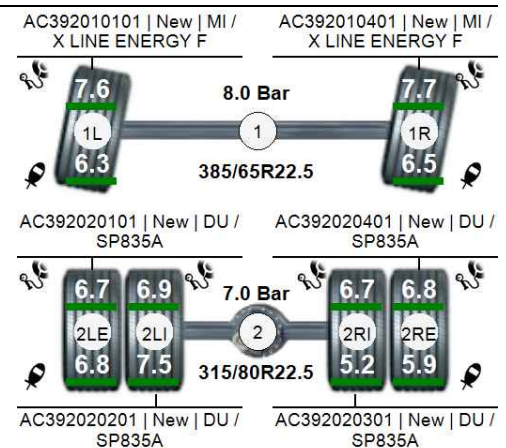
Registration No.	AC392	Location	Durban
Make	VOLVO	Date/Time	10/02/2026
Model	FM 330	ODO	1167436
Vehicle Class	Tractor Unit	Hours	
		Inspector	Mohamed.sha27@outlook.com
		Inspection Type	Inspection

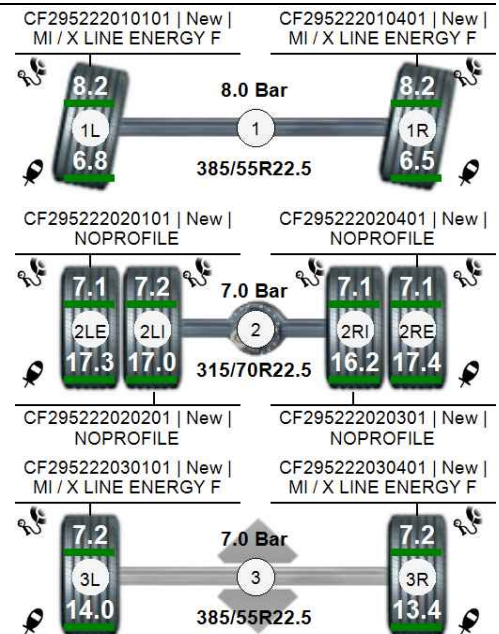
AC408

Registration No.	CF295222	Location	Durban
Make	VOLVO	Date/Time	10/02/2026
Model	400	ODO	172396
Vehicle Class	Tractor Unit	Hours	
		Inspector	Mohamed.sha27@outlook.com
		Inspection Type	Inspection

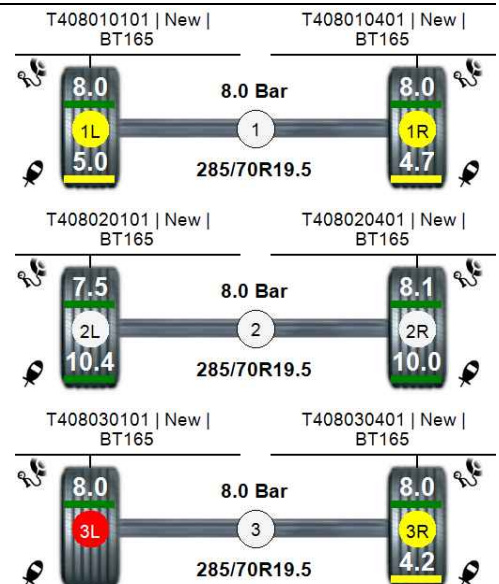
CF246681

Pos.	Issue	Action
1L	Low Tread Depth - New	Plan Regrooving
1R	Low Tread Depth - New	Plan Regrooving
3L	Urgent Excessive Wear	URGENT Replace
3R	Low Tread Depth - New	Plan Regrooving

Reg. Number	Pos.	Tyre Make	Tyre Size	Tyre Pattern	Tread Depth	Tyre Life	Defects
CF242456	1R	BLACKLION	285/70R19.5	BT165	0.0	New	Urgent Excessive Wear
CF242456	3L	BLACKLION	285/70R19.5	BT165	1.0	New	Urgent Excessive Wear
CF270300	3L	Continental	285/70R19.5	RZ	1.1	New	Urgent Excessive Wear
T408	3L	BLACKLION	285/70R19.5	BT165	0.0	New	Urgent Excessive Wear

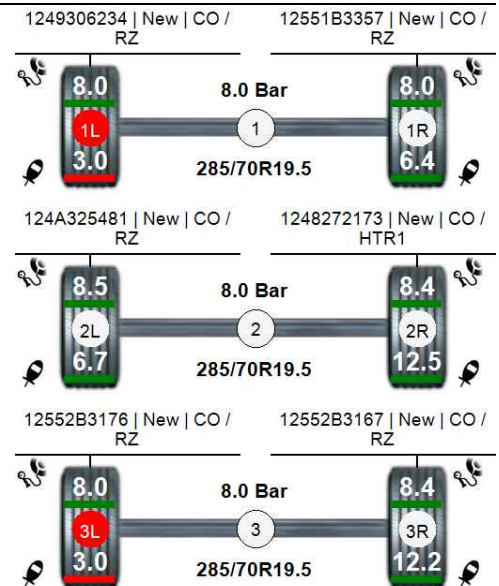
T315

Pos.	Issue	Action
1L	Urgent Excessive Wear - New	URGENT Dismount for Regrooving
1L	Tyre at regrooving level	Remove Tyre for Regrooving
3L	Urgent Excessive Wear - New	URGENT Dismount for Regrooving
3L	Tyre at regrooving level	Remove Tyre for Regrooving

Reg. Number	Pos.	Tyre Make	Tyre Size	Tyre Pattern	Tread Depth	Tyre Life	Defects
CF225238	1L	Continental	285/70R19.5	RZ	3.0	New	Urgent Excessive Wear - New, Tyre at regrooving level
CF225238	3L	Continental	285/70R19.5	RZ	3.0	New	Tyre at regrooving level, Urgent Excessive Wear - New

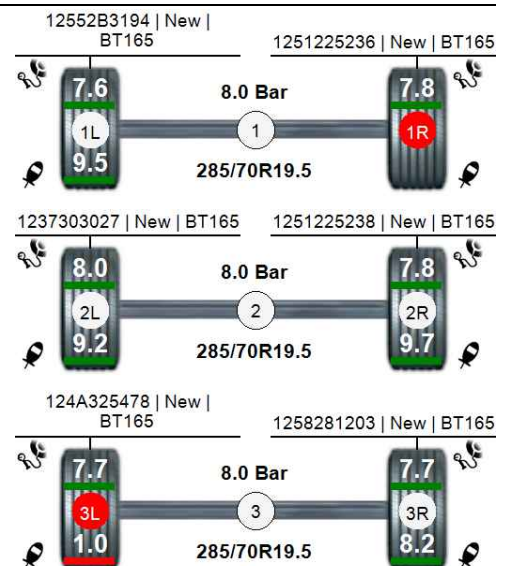
T318

Pos.	Issue	Action
1R	Urgent Excessive Wear	URGENT Replace
3L	Urgent Excessive Wear	URGENT Replace

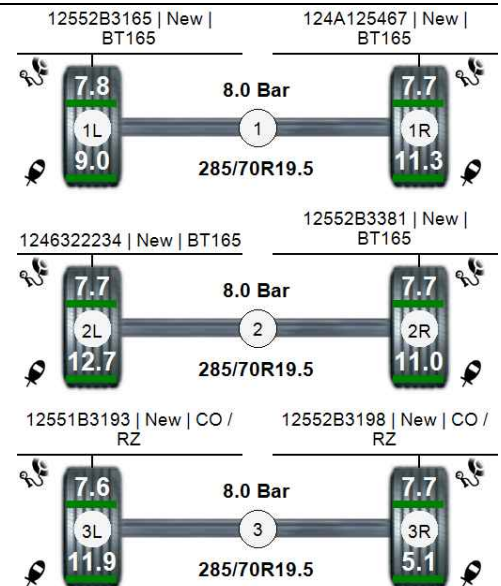
T319

Registration No.	CF242723	Location	Durban
Make	GENERAL TRAILERS	Date/Time	06/02/2026
Model	UNKNOWN	ODO	12146214
Vehicle Class	Semi-Trailer	Hours	
		Inspector	Mohamed.sha27@outlook.com
		Inspection Type	Inspection

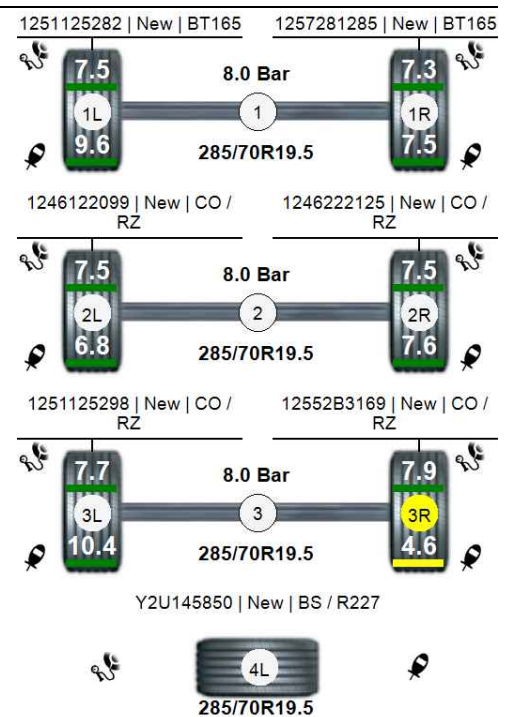
T321

Pos.	Issue	Action
3R	Low Tread Depth - New	Plan Regrooving

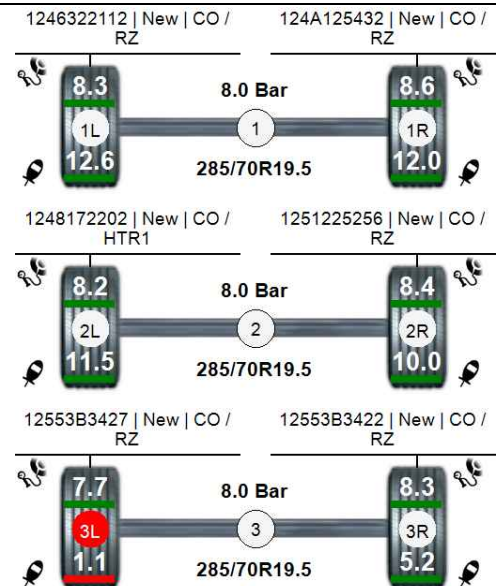
T324

Pos.	Issue	Action
3L	Urgent Excessive Wear	URGENT Replace

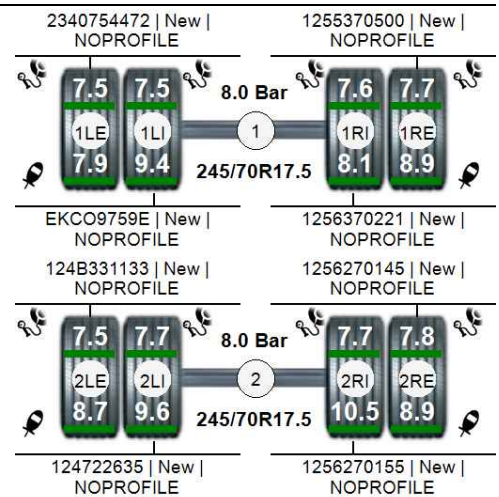
T342

Registration No.	CF274384	Location	Durban
Make	GENERAL TRAILERS	Date/Time	02/02/2026
Model	UNKNOWN	ODO	1600974
Vehicle Class	Semi-Trailer	Hours	
		Inspector	Mohamed.sha27@outlook.com
		Inspection Type	Inspection

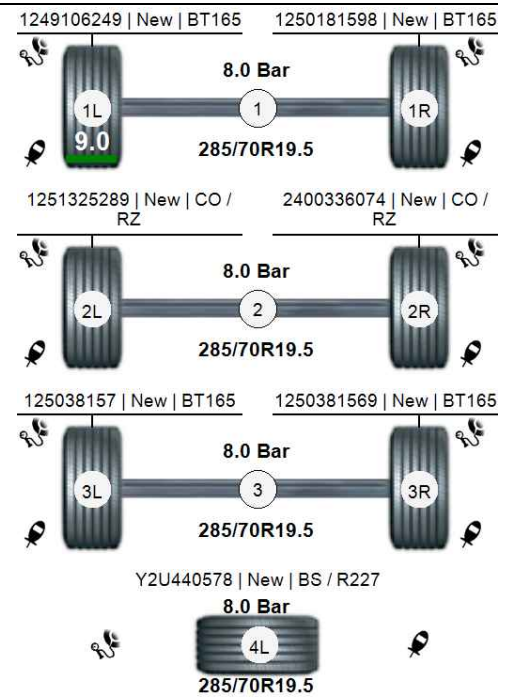
T374

Registration No.	KWS270MP	Location	Durban
Make	FRUEHAUF	Date/Time	03/02/2026
Model	FRUEHAUF 3	ODO	
Vehicle Class	Semi-Trailer	Inspector	Mohamed.sha27@outlook.com
		Inspection Type	Visual Inspection

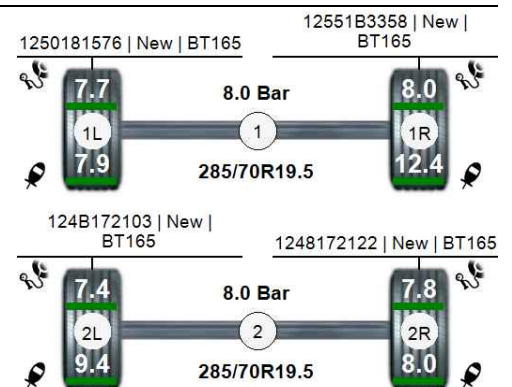
T391

Registration No.	CF343112	Location	Durban
Make	LOHR	Date/Time	04/02/2026
Model	LOHR 1	ODO	1220999
Vehicle Class	Semi-Trailer	Hours	
		Inspector	Mohamed.sha27@outlook.com
		Inspection Type	Inspection

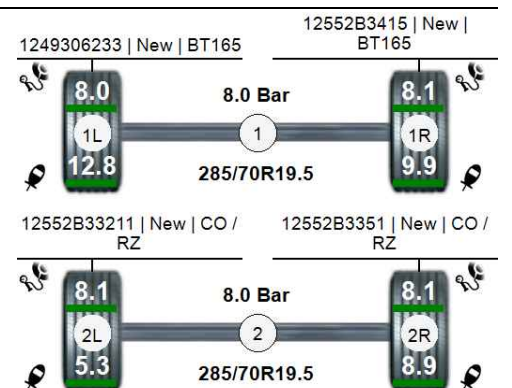
T392

Registration No.	CF343080	Location	Durban
Make	UNI-POWER	Date/Time	10/02/2026
Model	FLEXIPORTER	ODO	1167436
Vehicle Class	Semi-Trailer	Hours	
		Inspector	Mohamed.sha27@outlook.com
		Inspection Type	Inspection

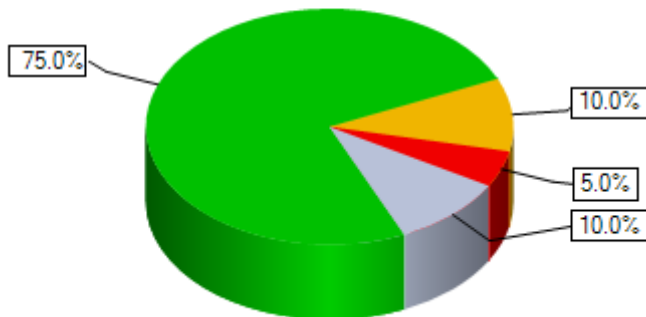
Steer Axle

- 2. Overinflated (> 5%) (2)
- 3. On Target (+/- 5%) (15)
- 4. Underinflated (> 5%) (2)
- 5. Underinflated (> 10%) (1)

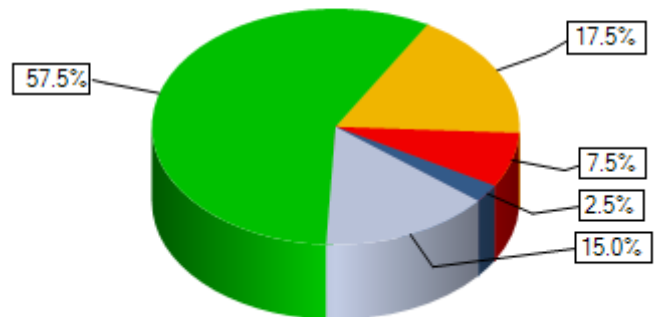
Drive Axle

- 1. Overinflated (> 10%) (1)
- 2. Overinflated (> 5%) (6)
- 3. On Target (+/- 5%) (23)
- 4. Underinflated (> 5%) (7)
- 5. Underinflated (> 10%) (3)

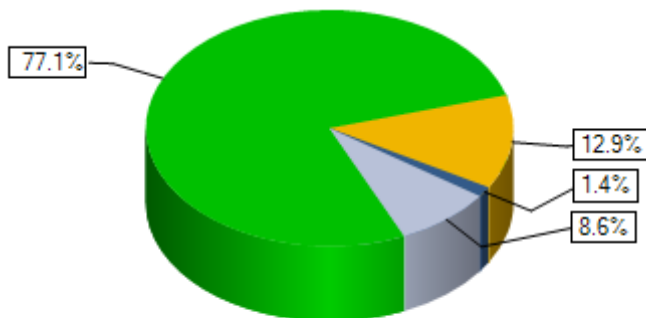
2nd Steer/Lift/Carry Axles

- 1. Overinflated (> 10%) (1)
- 2. Overinflated (> 5%) (6)
- 3. On Target (+/- 5%) (54)
- 4. Underinflated (> 5%) (9)
