Life-prolonging preventive maintenance techniques for porous asphalt

Peter The^{1, a}, Jan Voskuilen^{1, b}, Martin van de Ven^{2, c}

¹ Rijkswaterstaat, Ministry of Transport and the Environment, Utrecht, Netherlands

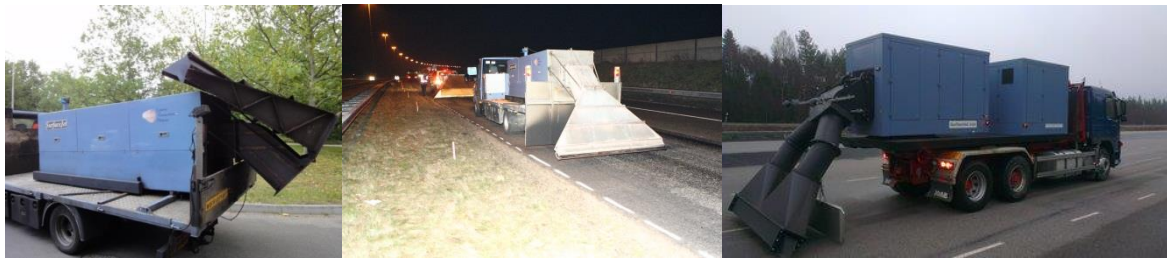
Figure 1: Special equipment used for Modimuls ZV : the air-jet turbine motor [2]

An airjet or surfacejet (<http://www.libertygasturbine.com/pagina.34.name.surfacejet-liberty.htm>) is a truck with an airplane turbine motor able to blow very hot air (up to 550°C) in the PA. The purpose of the Airjet seal method is to increase the service life of PA by blowing sprayed bitumen emulsion deeper in the PA layer. With this technique the bitumen emulsion is brought to the bridges connecting stones over the whole height of the PA. For this reason the bitumen emulsion is blown with an Airjet in the structure, after it is sprayed on the surface with a spray-truck. The bitumen emulsion will in this case also reach specifically the underside of the stones at the surface. The effect of the bitumen emulsion is twofold. First of all a rejuvenating component will revitalise the aged bitumen in the mortar bonding bridges and makes it flexible again. Secondly, a special component is added to repair and strengthen the weakened mortar (by erosion).

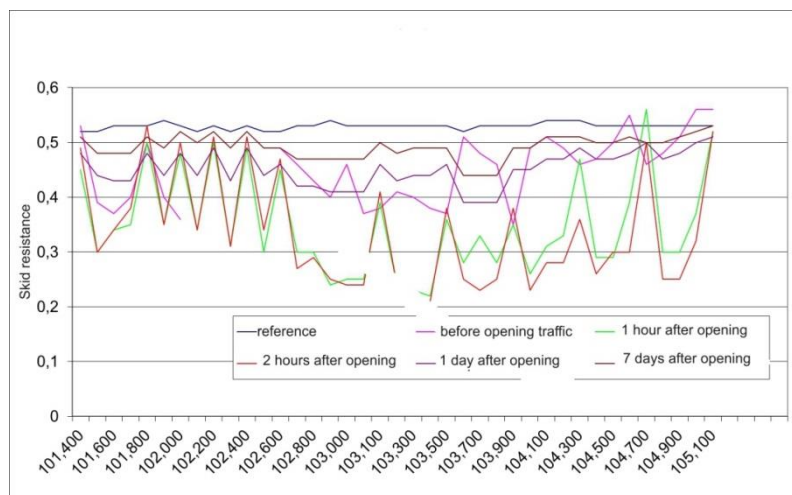
From figure 4 it becomes clear that the skid resistance on the treated sections is temporary decreasing, but that within a period of one week the skid resistance increases to the level before treatment. In principle this tendency was found for all other sections.

Figure 4: Results of skid resistance measurements during 7 days after the treatment for A15 [3]

Noise, skid resistance and brake deceleration measurements were carried out on all the test sections and pilots [3]. Especially the skid resistance tests were important and the results had to satisfy the requirements of the Code of Practice. An example of the typical development of the skid resistance is given in figure as taken from the pilot A15 [3].

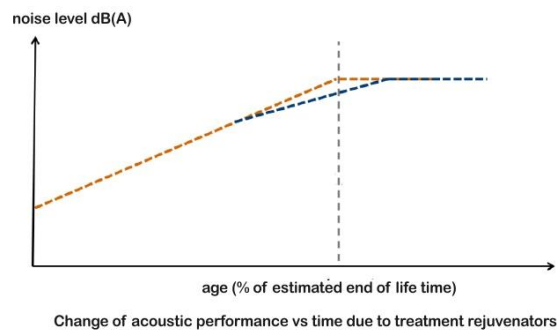
Figure 5: Model developed for the change in acoustic properties in time after application of the products (the blue line) [11]

Based on the measured noise levels directly after application and in time so far, it is expected that because of the reduction in raveling after the treatment compared to the reference sections, during a number of years after application the noise levels of the treated sections will increase considerably slower than the noise levels from the reference sections. [3,11].
