Background & Summary

The Zyla sCMOS camera platform, like the majority of commercial sCMOS cameras on the market, uses a backfilled chamber design to protect the sensor. To understand more about chamber technologies please refer to the article [“What are camera sensor enclosures and why to they matter?”](#)

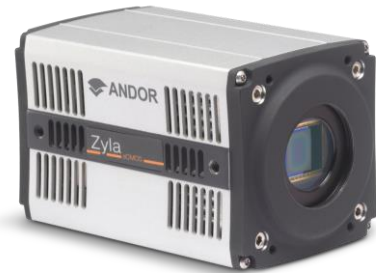
For ALL back-filled sensor enclosures, one expects a low-level moisture ingress past the O-ring seals and into the sensor chamber over time. All such cameras utilise a form of desiccant to control the ingress of moisture that does occur. Eventually, the desiccant will become saturated, and condensation may form on the camera window or sensor, indicating the need for the camera's sensor chamber to be serviced.
