## **Spindle extention:**

Without an extension, chips will fall in the gearbox damaging the gears. To solve this problem, I made an extension. The end of the spindle has just enough threads to Mount an extension. The thread type is M27 x 1.5

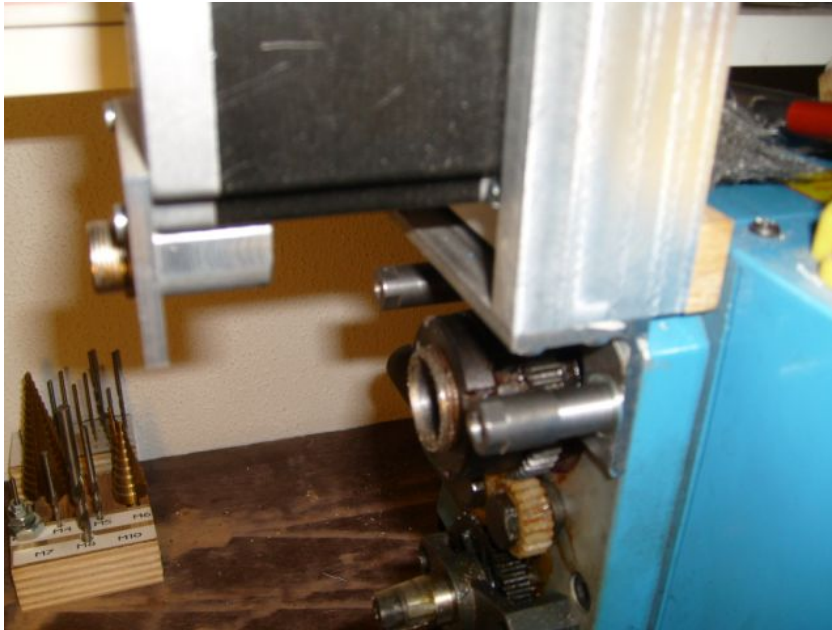
### ***Spindle showing just enough threads to mount the extension:***

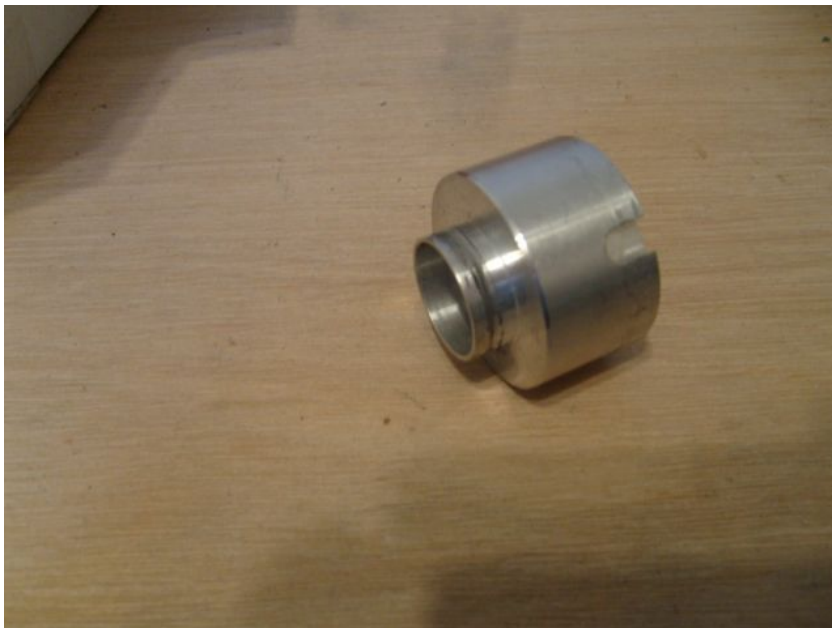
### ***The extension:***

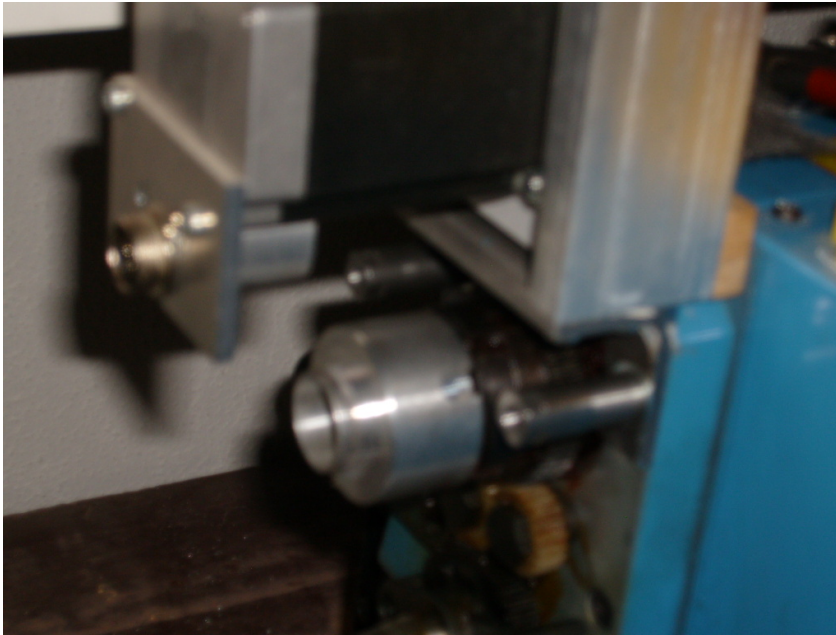
***The extension mounted:***

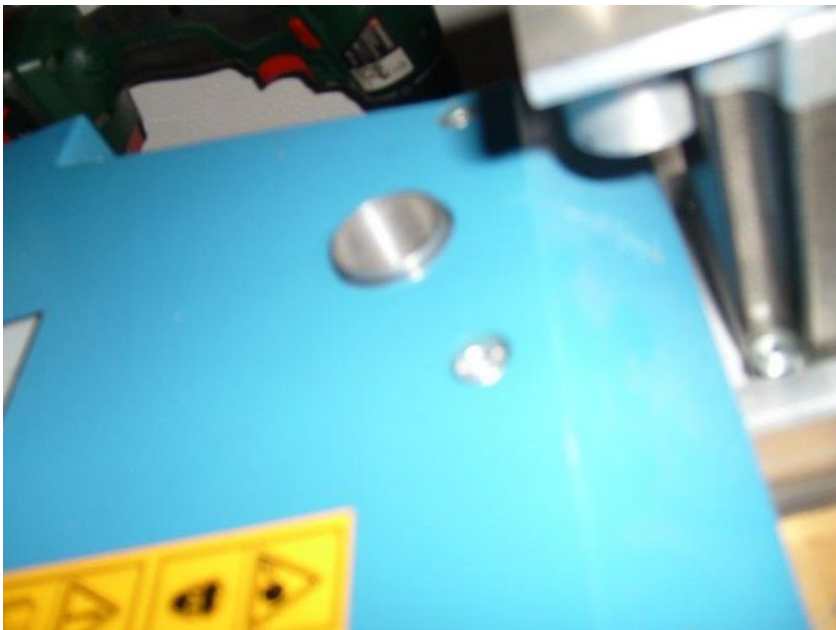
***The cover mounted:***
