MSc AI

Assignment on Multimodal Machine Learning

Defect identification on metallic surfaces with machine learning
techniques

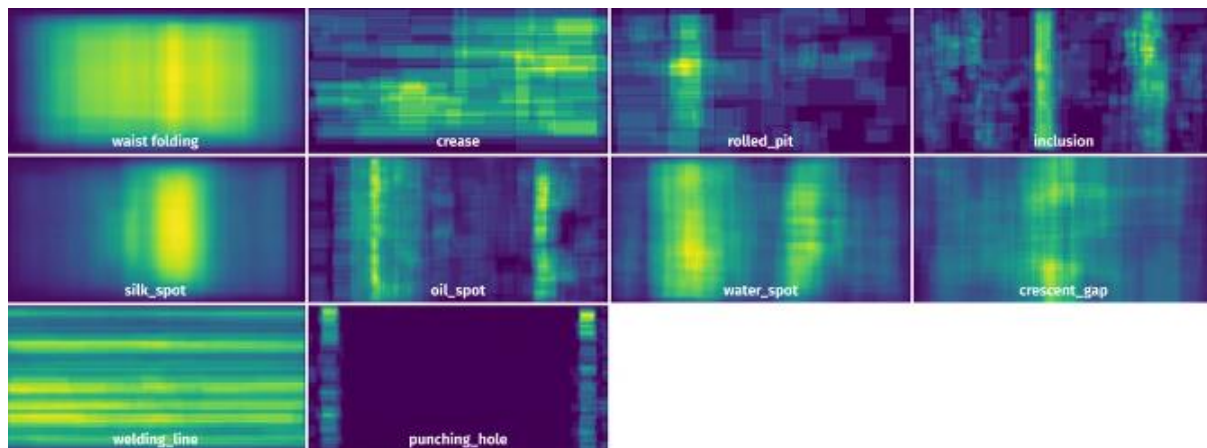
The dataset consists of 2300 images with 3563 labeled objects, each object is a defect that belongs to one of the ten different defect classes. The dataset is heavily imbalanced, and some images contain more than one defect. Also, each defect has a different shape and size and might occur in different locations of the surface. The image below is a heatmap of the spatial distribution of each defect. It visualizes the probability of each defect's location and also gives an insight into their shape and size.[1]

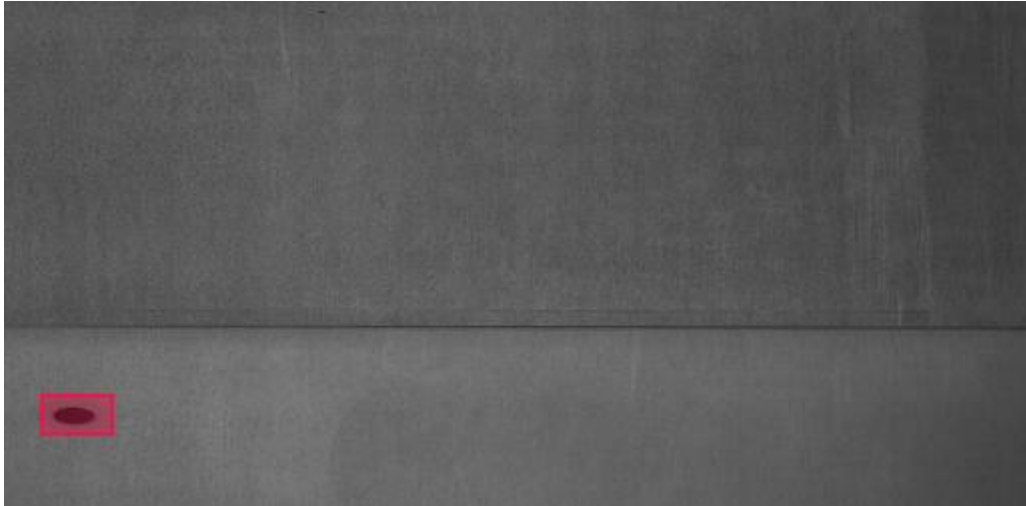
Punching, which occurs because the metallic surfaces are punched according to the product specifications and in some cases unwanted punches can cause punching defects.[1]

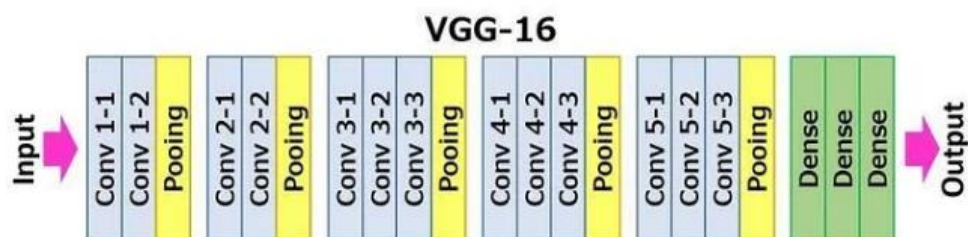
16 layers, 13 convolutional layers and 3 fully connected layers and its popularity derives from its simplicity and effectiveness. The convolutional layers use the ReLU activation function, and they are followed by max-pooling layers with progressively increasing depth, thus enabling the model to learn complex visual features. The fully connected layers use the ReLU activation function, and the last layer uses the softmax activation function because the model is implemented for classification. For the needs of this study, we froze the dense layers and divided the output into two. The regression output predicts the coordinates of the bounding boxes, and the classification output predicts the class of each object. Even though its architecture is rather simple, it is a robust and versatile technique that produces accurate results. [5]

VGG16 architecture [6]
