# One Exploit to Rule them All?

## On the Security of Drop-in Replacement and Counterfeit Microcontrollers

### Abstract

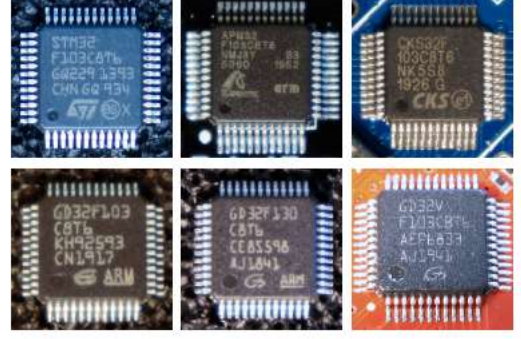
Figure 1: The Devices under Test, listed in Table 1.

For our analysis, we chose five replacements and an original device of the very popular STM32F103, a member of the STM32F1 family. They are shown in Figure 1 and listed in Table 1. In 2020, all these devices were available on the free market, sometimes advertised as STM32F103 drop-in replacements. The devices are based on an ARM Cortex-M3, except for the GD32VF103 that instead contains a RISC-V core. The GD32F130 is a special case as it does not have a direct STM32 counterpart; however, it appears to be a refined GD32F103 with additional capabilities, and most interestingly, extended security features. Thus, we analyze a broad range of devices from drop-in replacements to upgrades.

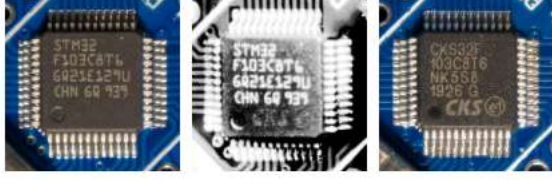
Figure 2: Under special illumination and image enhancements (center), the counterfeit STM32F103 (left) reveals the CKS marking of the actual chip (right).

While acquiring our devices under test (DuTs), we noticed that some vendors undercut the usual price of an STM32F103 by far; thus, we ordered a batch for analysis. Although components marked with STM32F103C8T6 were delivered, the debugger warned us that the `IDCODE 0x2BA01477` does not match the expected value of `0x1BA01477`. Under strong illumination and by tilting the device, a very faint *CKS* marking appears, as shown in Figure 2. This part of the marking exactly matches an actual CKS32F103 device, hence, counterfeit STM32F103 with a manipulated marking were delivered. Thus, users have a risk of unintentionally employing counterfeit devices in their systems – including their vulnerabilities that we describe in the paper.

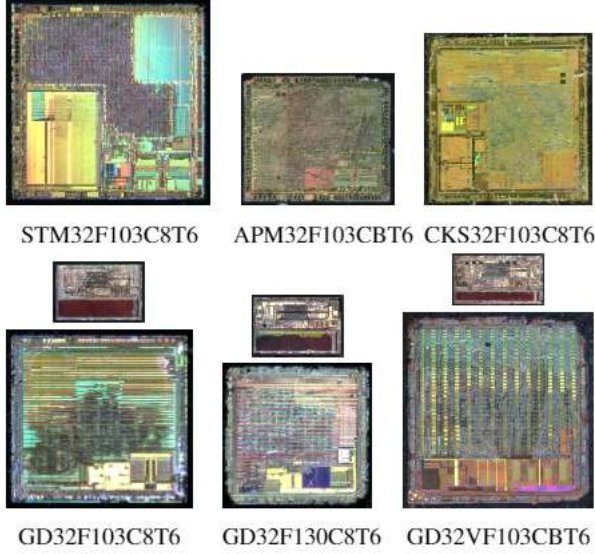
Figure 3: The silicon dies after decapping, true to scale; the exact dimensions are listed in Table 3 in Appendix A.

The chips, shown in Figure 3, are very different from each other, thus, all of them are individual developments. The sizes of the dies vary widely, as listed in Table 3 in Appendix A, even hinting at different manufacturing technologies. The GD32 devices contain two dies in their package which was seldom observed in microcontrollers. Further analysis showed, in accordance with other analyses [12, 21], that the smaller chip contains the flash memory and the larger one incorporates the remaining logic such as the CPU, SRAM, and peripherals.

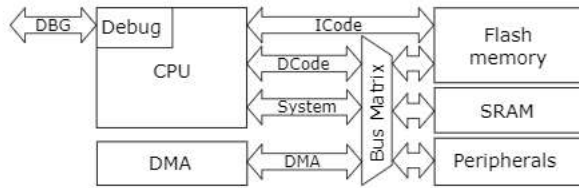
Figure 4: Simplified block diagram of the internal buses of a typical microcontroller.

system, a multitude of components is connected to the internal buses, as shown in Figure 4. The debug module, the CPU, and the Direct Memory Access (DMA) module are masters on the buses, thus, they can perform read-transactions from flash memory. For that, we test whether in RDP level 1,

As illustrated in Figure 4, the flash memory on an ARM Cortex-M based device is accessed via the data bus and instruction bus. The data bus serves data and debug accesses; the instruction bus is intended for instruction and interrupt vector fetches from flash memory [2].

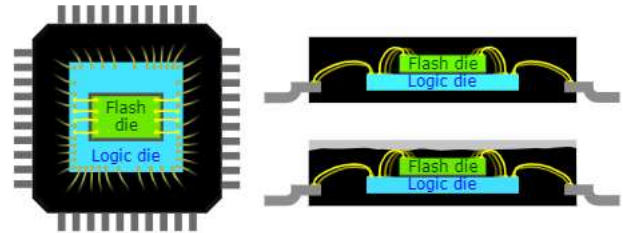
Figure 6: Top and side view of a dual-die device. The bonding wires between both dies become accessible by partially removing the casing (right, bottom).

All tested GD32 devices have a separate logic and flash memory die, as shown in Section 4.3. Both chips are stacked atop of each other and connected via bonding wires, illustrated in Figure 6. This sparked the question, whether such a design is sufficiently secure against invasive physical attacks – especially in the case of the GD32F130 that did not exhibit any debug interface vulnerabilities so far.

In order to gain access to the bonding wires for eavesdropping, the top of the casing is carefully removed via sand paper of 120 and 600 grit size. A small portion of the bonding wires' top curvature becomes sufficiently accessible to contact it momentarily with a very thin wire. Without requiring a pre-amplifier, these signals are connected to a logic analyzer.

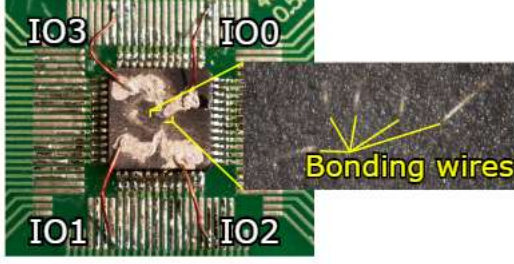
Figure 7: The prepared GD32F130 with access to all four QSPI data signals (IO0 to IO3).

To create a larger, electrically improved, and mechanically more stable contact area for further analysis, we applied conductive silver paint. A fine brush, manually made from a sin-

gle fiber of a bamboo stick, is helpful to apply the paint. Via additional thin wires, all four QSPI signals are permanently connected to the circuit board. The result of this rather tedious task is shown in Figure 7. Due to the regular communication pattern and availability of a datasheet of a functionally similar standalone QSPI flash device by GD [8], no additional signals need to be probed for reverse-engineering.

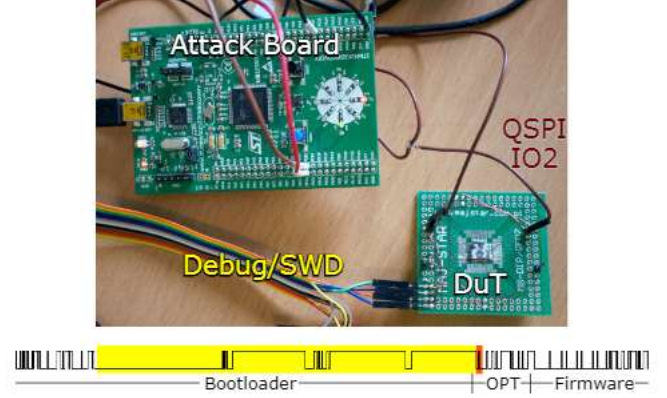
Figure 8: QSPI active manipulation setup with transaction excerpt. A fault (red) is injected into the IO2 signal to alter the option bytes, aligned to the distinct pattern (yellow) at the end of the bootloader.

showed that the RDP setting is loaded during startup and present on the bus in plain without obfuscation. The naive approach would be to interfere with the option byte loading by directly manipulating the option byte transmission. Downgrading from RDP level 2 to 1 to re-enable the debug interface is feasible by flipping any bit, however, this does not provide access to the firmware as no debug interface vulnerabilities are known for level 1. To downgrade from level 2 to 0, the option bytes would have to be altered from 0xCC33 to 0xA55A. While being at least theoretically possible, this would again require access to all four QSPI data signals at once.

The reason for this is unknown but it enables a new attack vector. Further analysis shows that the factory configuration is loaded from address 0x0400 and the option bytes are loaded from address 0x4000. Thus, by manipulating the *address* of the QSPI transaction loading the option bytes, they are forced to be loaded from the factory configuration region instead. This replaces the actual option bytes with the value 0xA55A and the device falls down to RDP level 0 – enabling full access to the entire user firmware via the debugger.

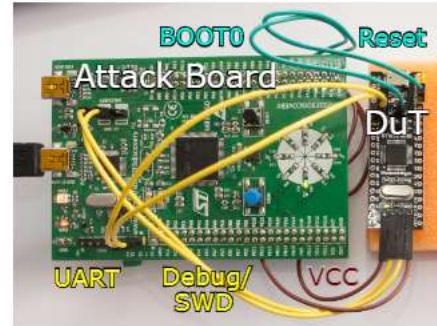
Figure 9: The setup for glitch generation, boot mode selection, and code extraction.

For the attack, we setup the DuT as shown in Figure 9. At first, we upload a two-stage exploit firmware to the SRAM with a debugger and shut down the debugger afterwards. Next, we configure SRAM-booting via the BOOT pins.

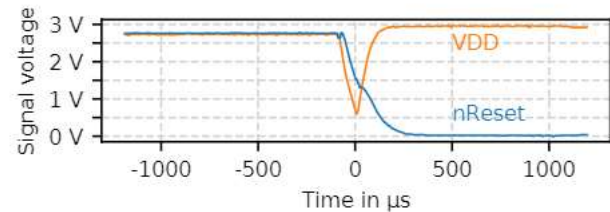
Figure 10: The VDD/supply glitch triggers a system reset.

However, the flash memory is still locked down since a debugger was connected. To release the lock down, we perform a very quick power cycle by cutting the power supply for a few hundreds of microseconds. During that glitch, we observe the microcontroller’s reset line to detect when the system goes into reset. At this moment, our setup automatically restores power, as shown in Figure 10. After this very short power-cycle, access to the flash memory is re-enabled. But due to SRAM data remanence [18], such a short interruption in the power supply leaves the data in SRAM intact.
