## Weekly Report

Topic: Robot Guided Surface Scanning with Ultrasound

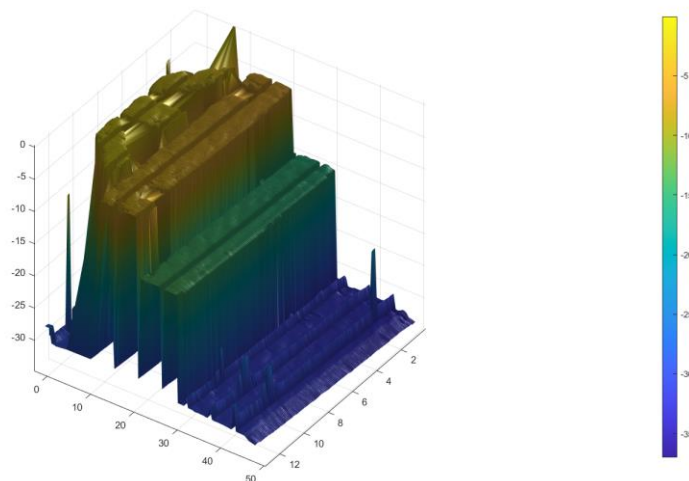
- I completed the calibration and the image reconstruction part
- For image reconstruction the images are segmented and then the pixels are treated as points to obtain a point cloud and I plot them as a surface. I have added a figure at the bottom for reference.

- The calibration results are really bad. I tried to sample the collected data but the results don't improve.
- I think I have made a mistake during data acquisition as I captured the images along the whole length of the phantom.
- Also, since I am generating a point cloud of the 3d part I have to scan it from multiple angles to cover all the faces.
