DOCKING PROGRESS REPORT – Day 7	
Ship Name	GAS NURI ARIZONA
Type of Docking	INTERMEDIATE SURVEY V
Location	Semarang
Main Contractor	PT . YWTS
Date	16 July 2018

**PHOTO REPORT**

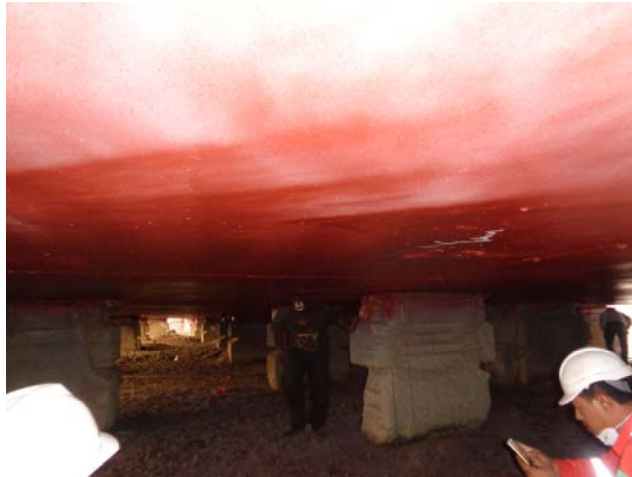
1<sup>st</sup>

AF Application on bottom area has been done

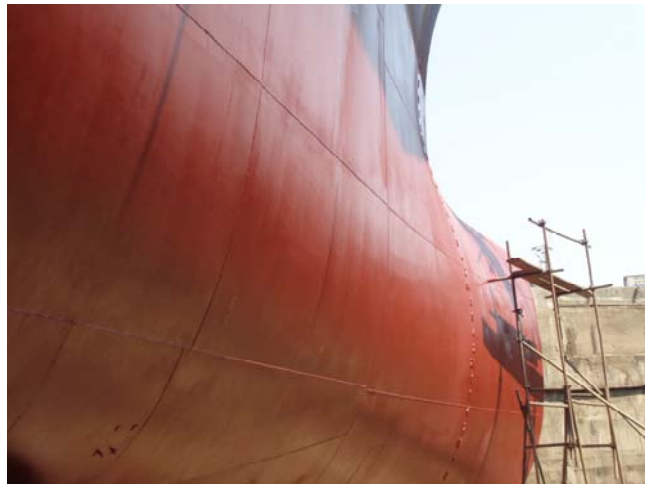
AF Application on bottom area

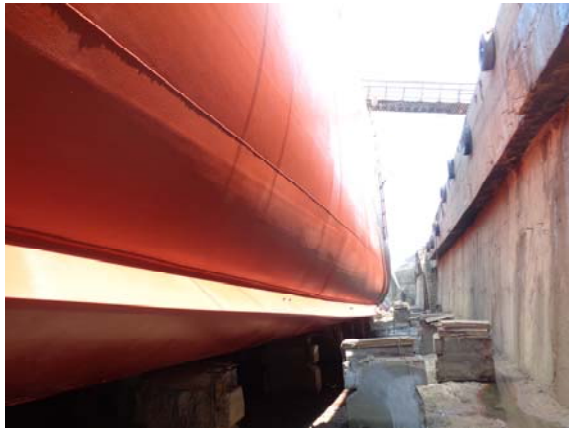
AF application on vertical side area

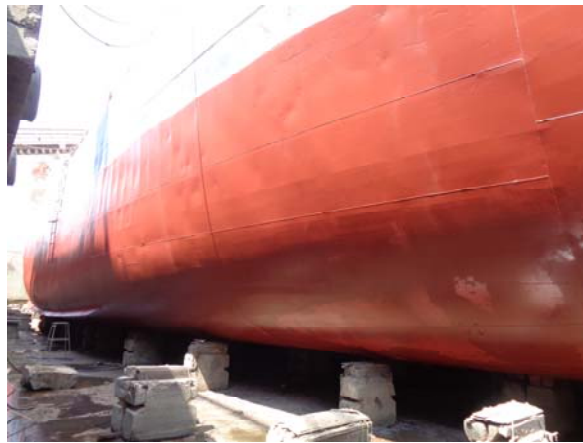
AF application on vertical side area

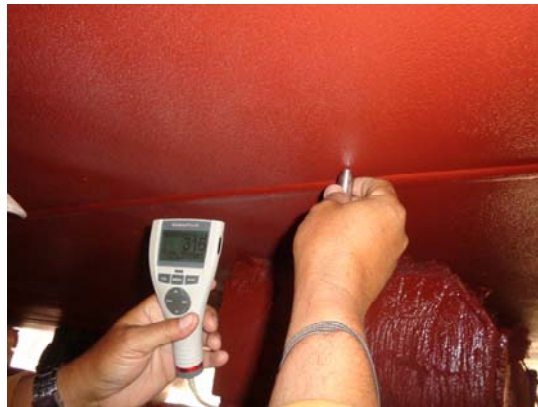
DFT measurement

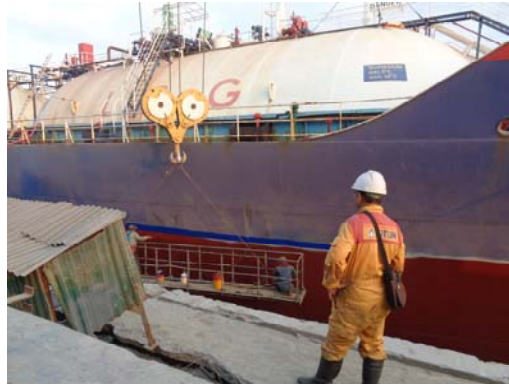
Listing vertical side

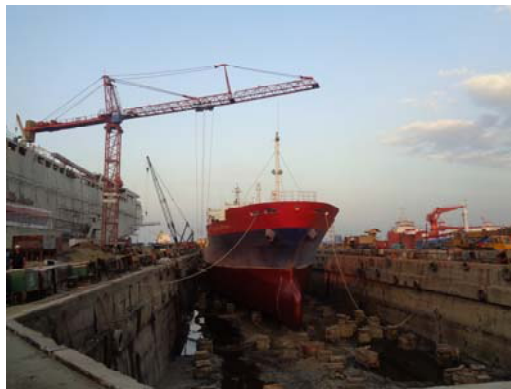
Ship Hull condition looking not good because only repainted bottom and vertical side area

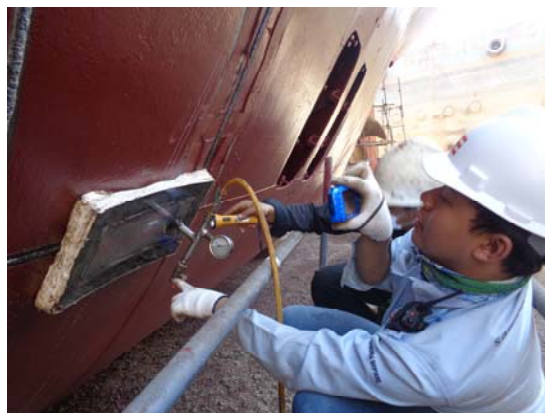
Vacuum test welding hull after replating found no leaked

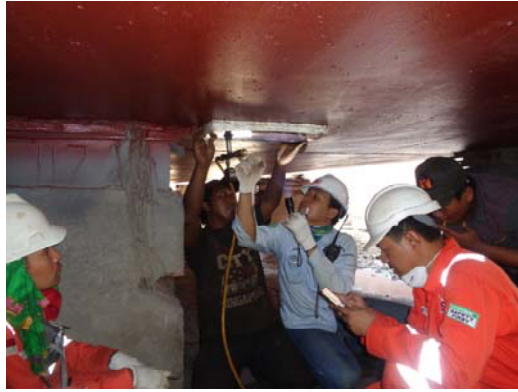
Vacuum test bottom plug

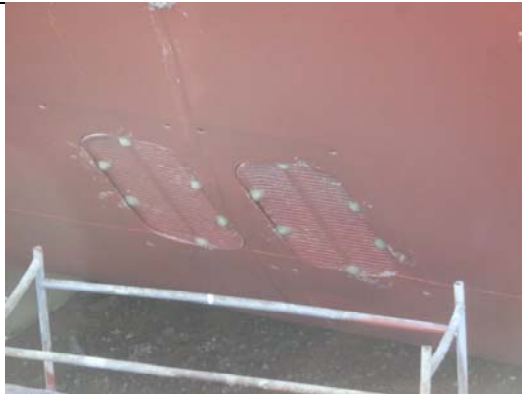
Sea Chest Has been closed
