FD 107

181022

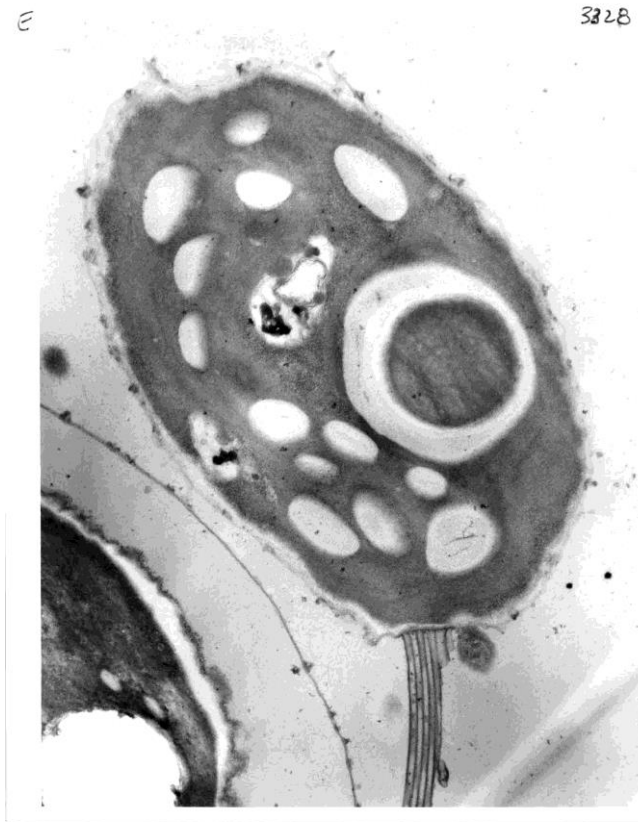
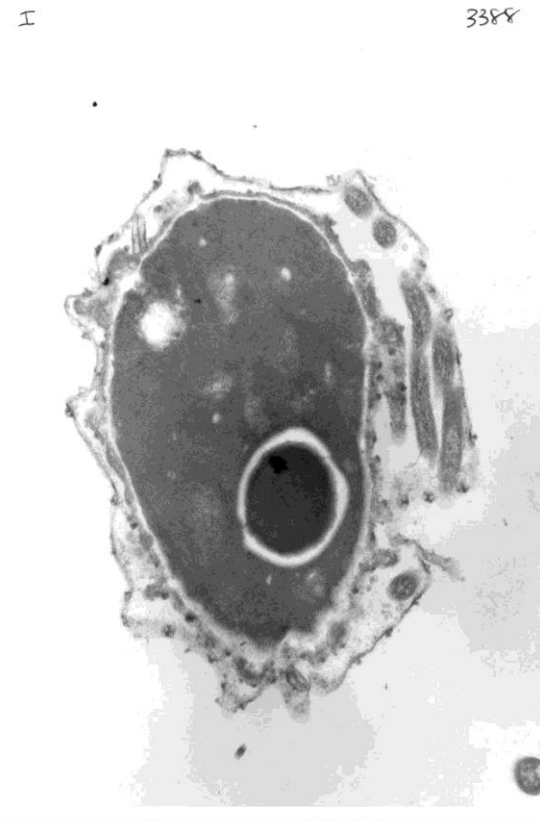
Host (L); host with early infection (R)

3388 pest:
Diam. = 0.2 micron;
L = 1.8-2.0 micron

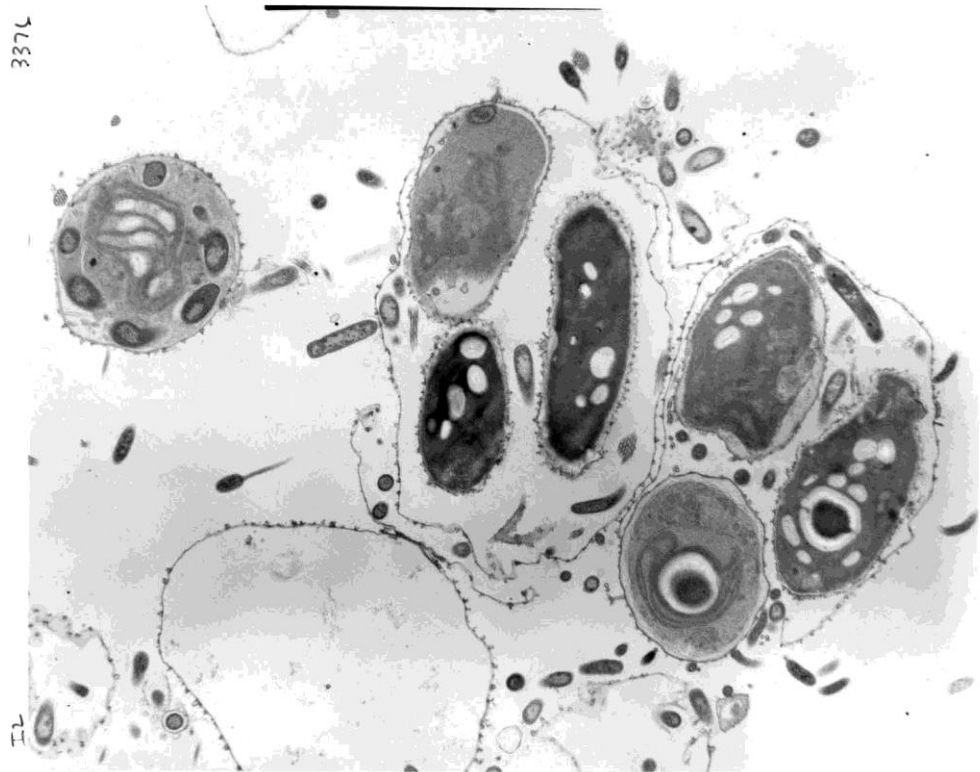
“Macro” of early infection

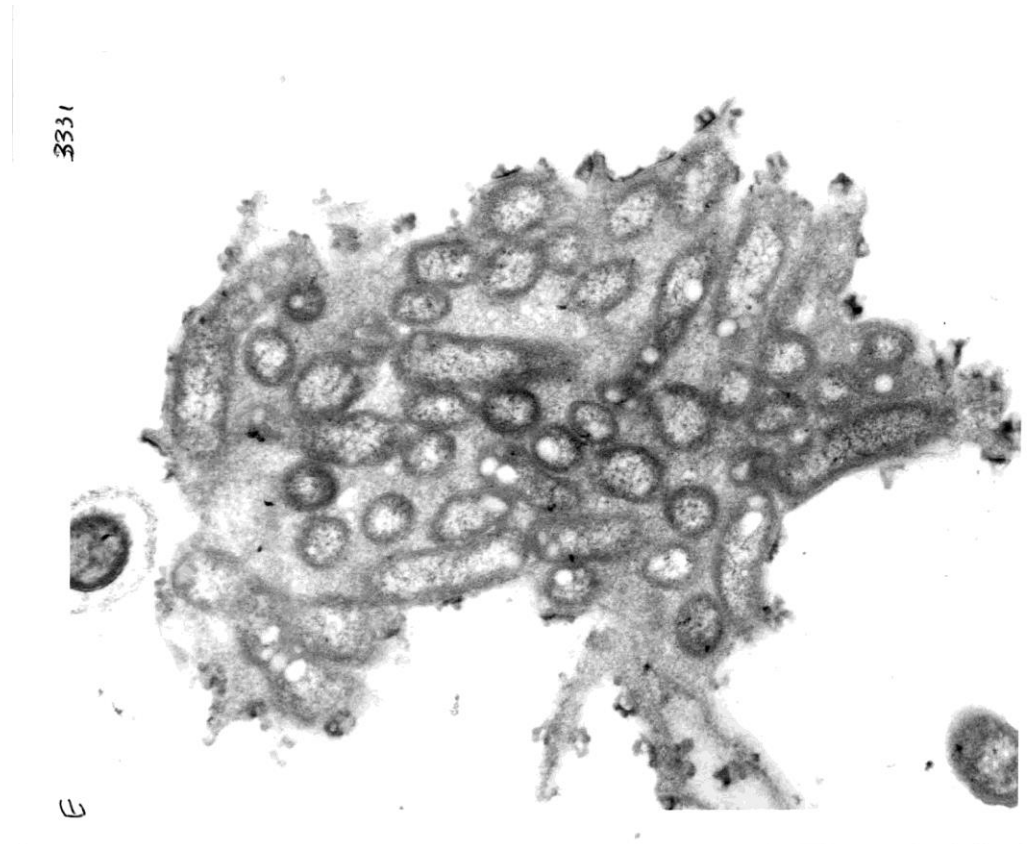
Heavy infection

3331 pest:
Diam. = 0.27 microns;
L = 0.8-0.93 microns

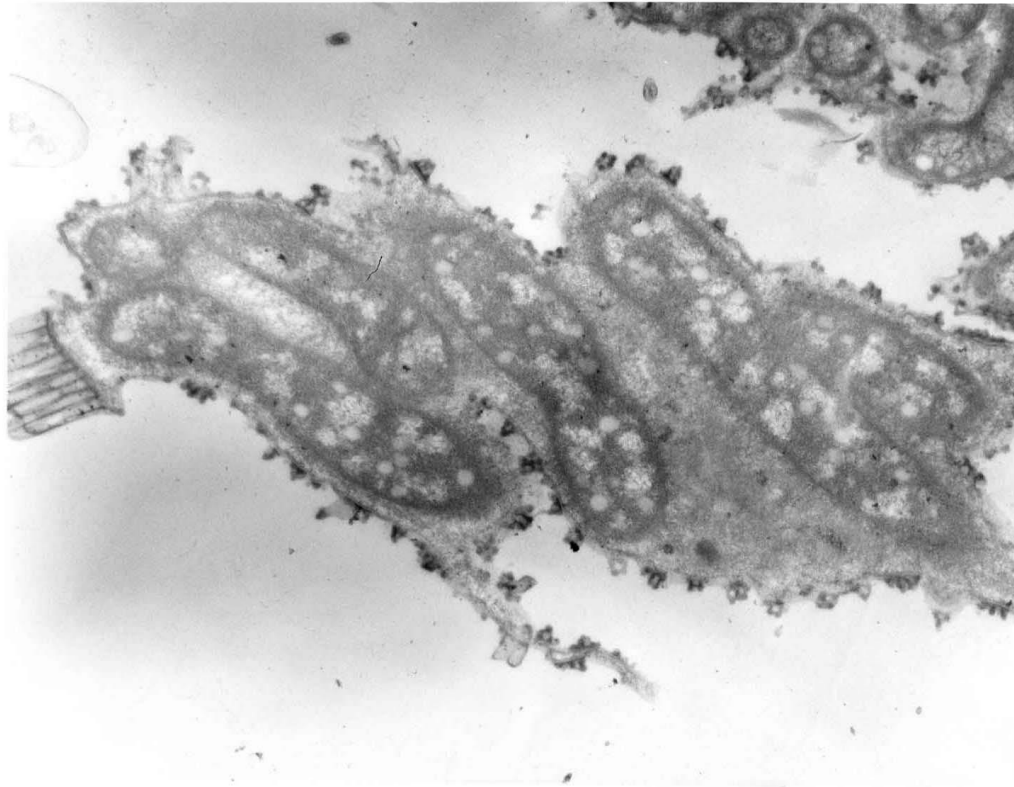
Heavy infection

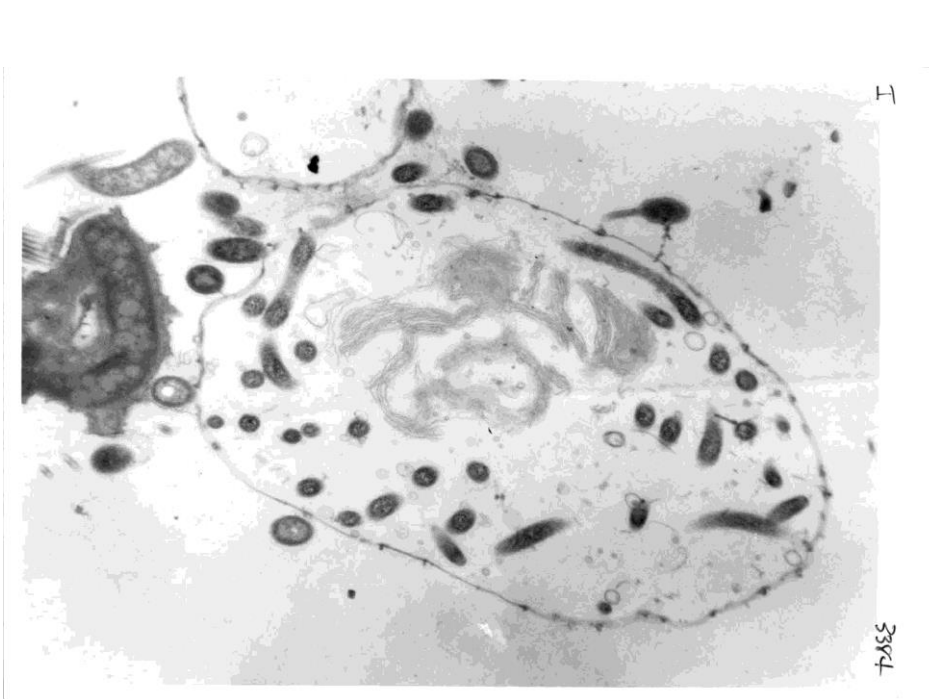
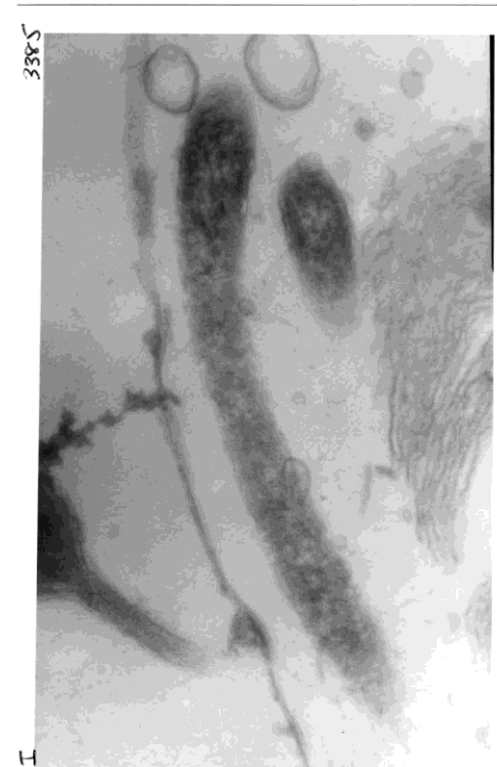
3324

Completely destroyed host (L); internal pest (R)

Diam. = 0.3 microns;
L = 1.86 microns

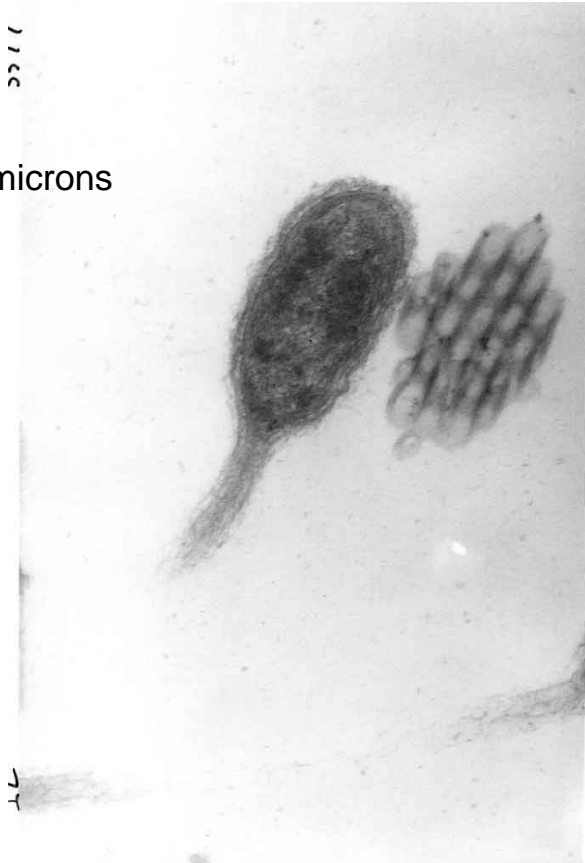
Pest

Head: 0.3 x 0.6 microns

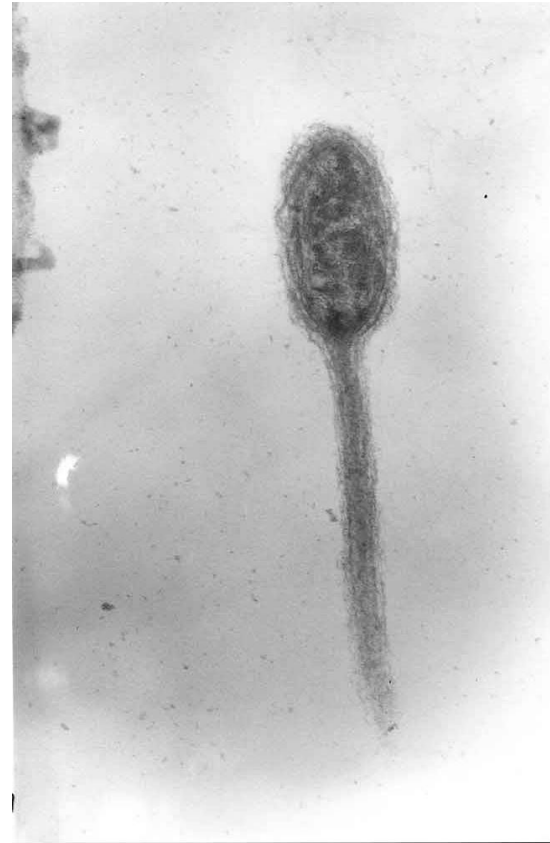
Head: 0.3 x 0.56 microns;
L = 1.7 microns

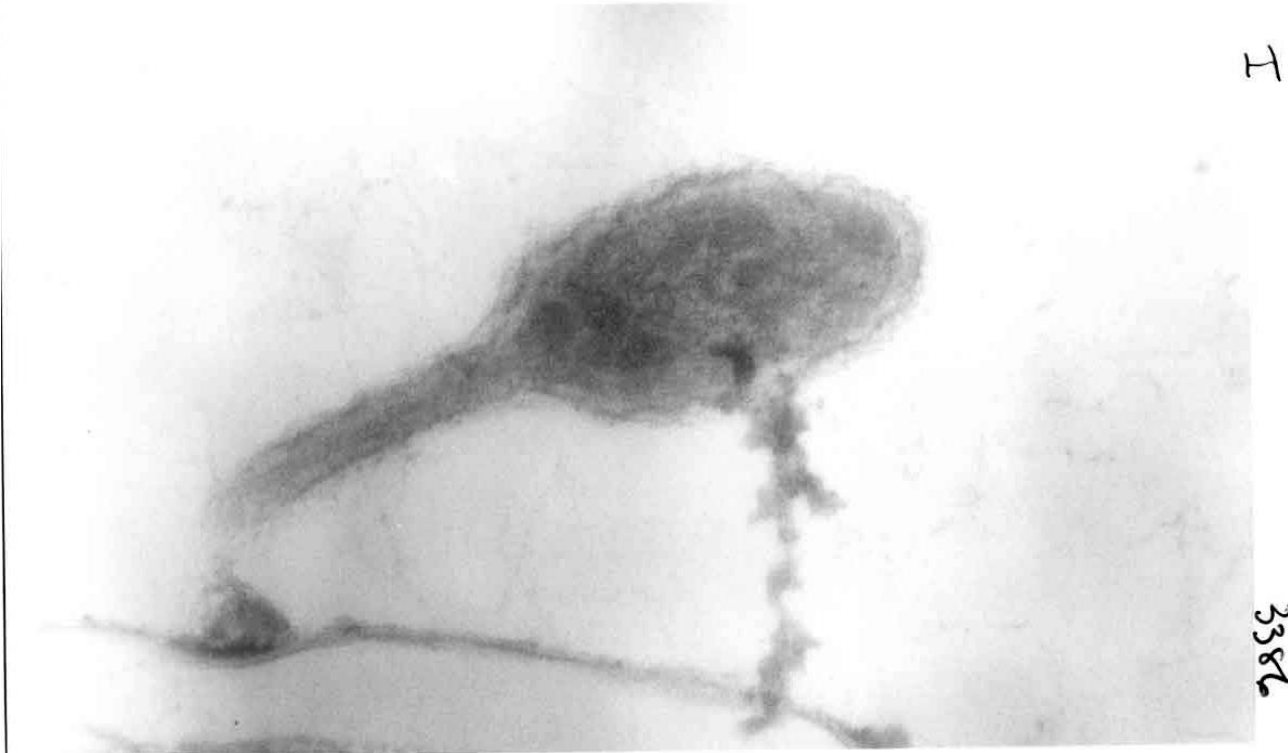
Pest attaching?

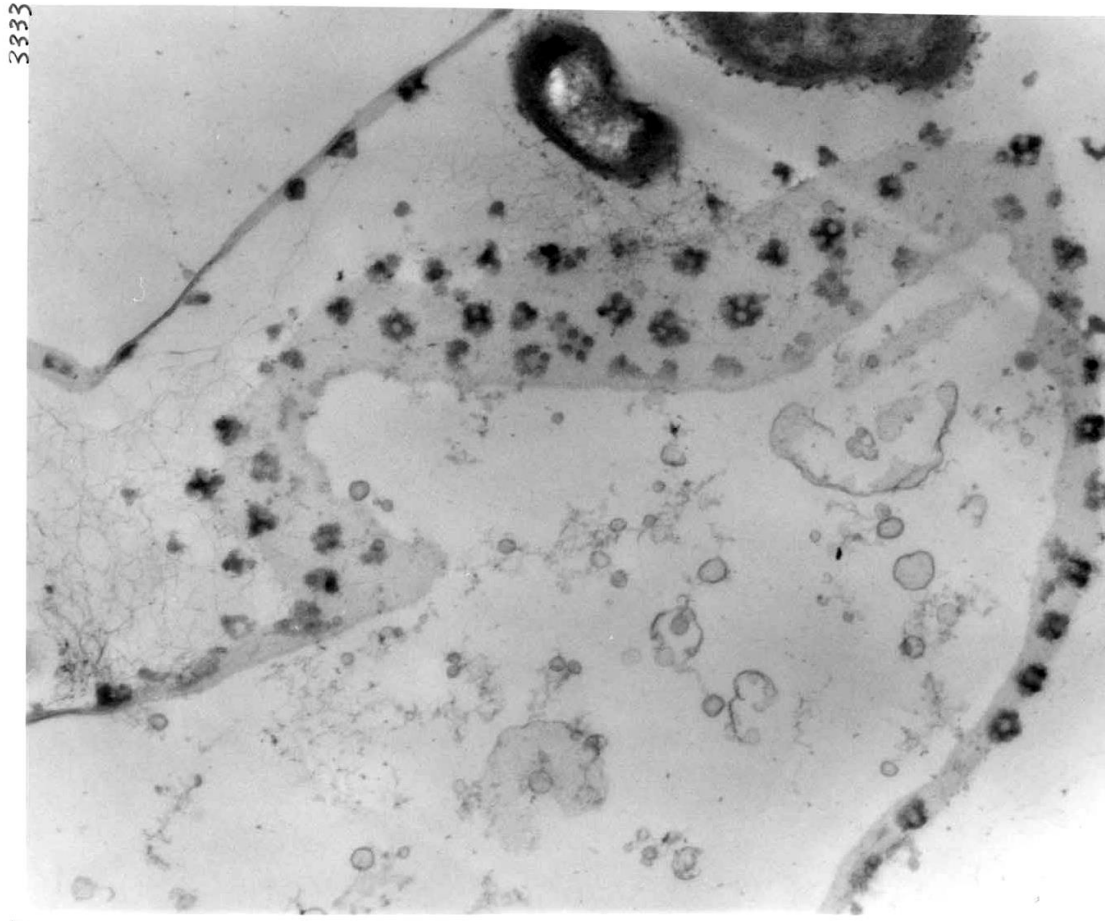
Virus?

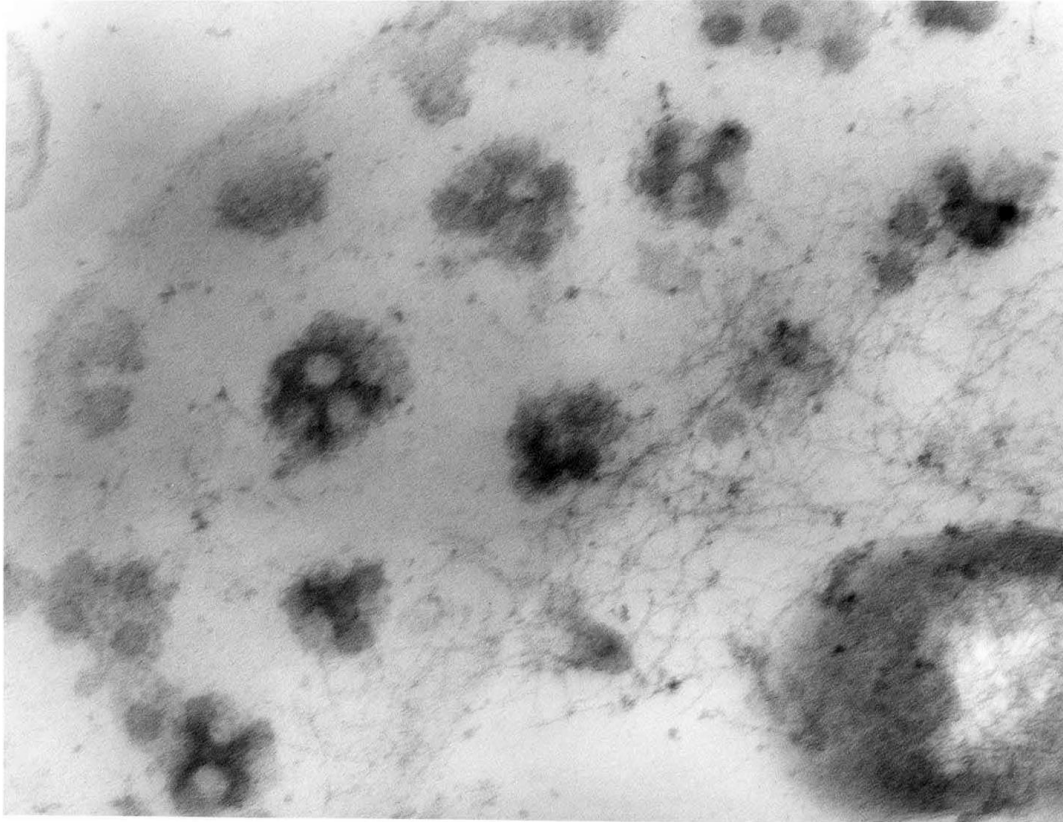
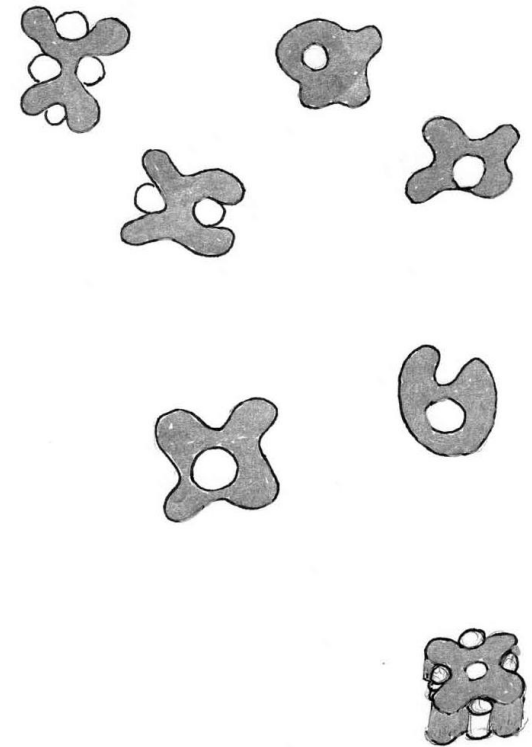
Virus (?) and schematic representation

Diam. = 0.087-0.125 microns;
Holes diam. = 0.025 microns
