GUTTER WITH STRAPS ANCHORED INTO STANDING SEAMS

MR E1.6

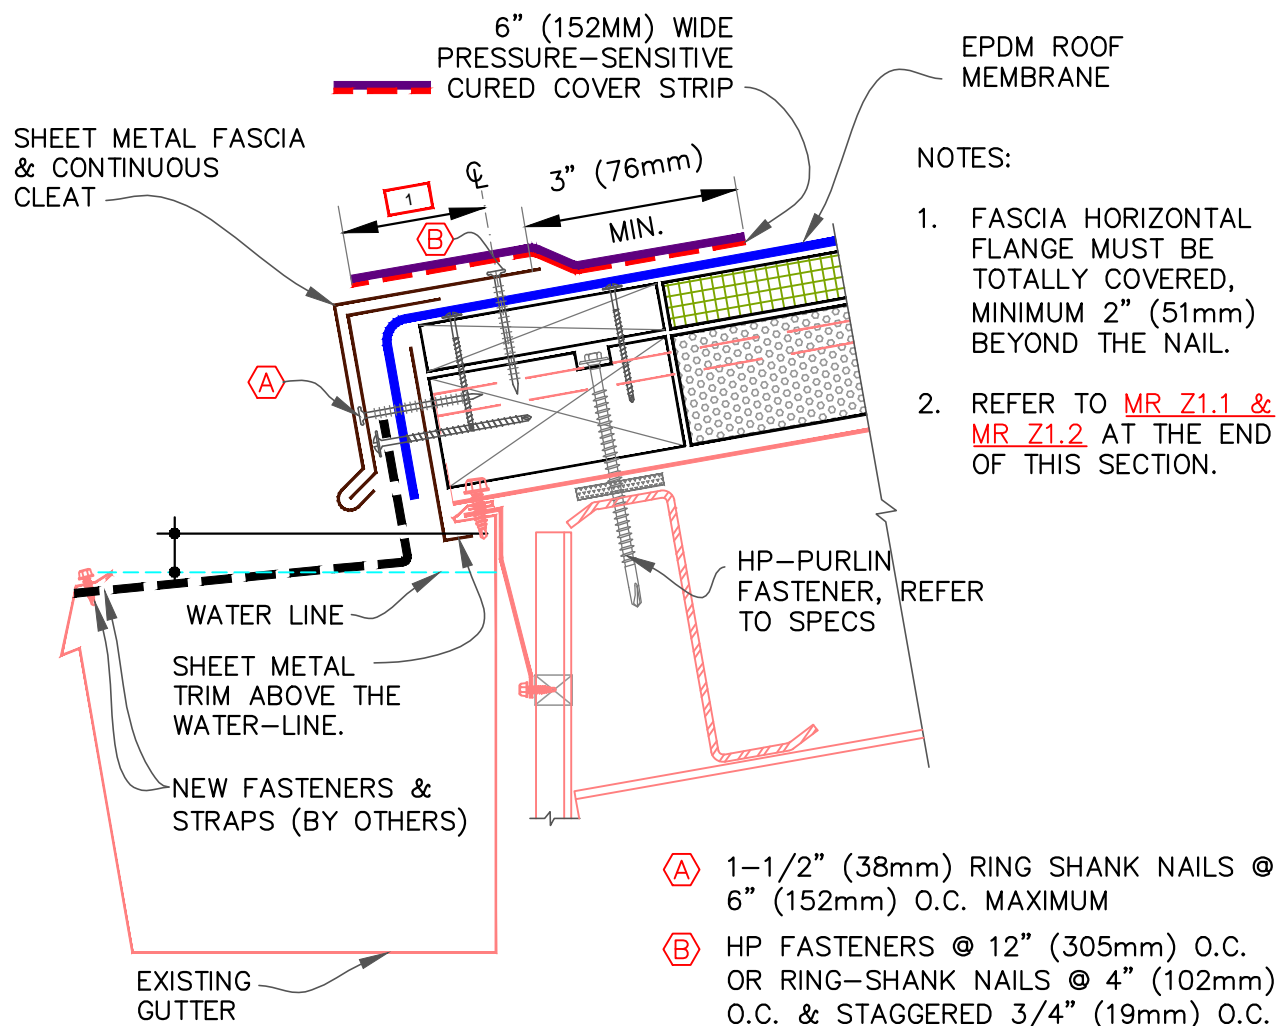
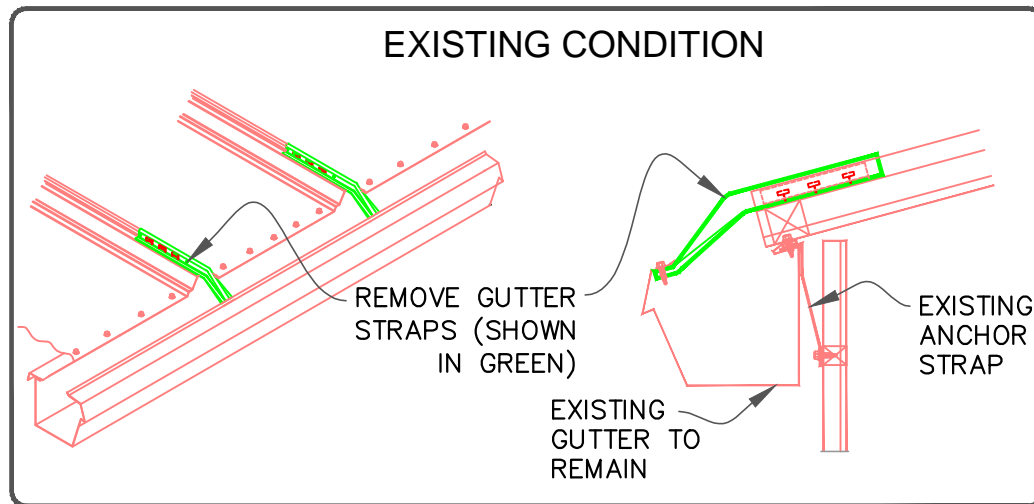
• HIGH DENSITY RECOVER BOARD		• ROOF MEMBRANE
	• IN-FILL INSULATION		• WOOD NAILER (BY OTHERS)
	• SEE DRAWING NOTE(S)
