1 ELEVATION - SECTION - SOUTH WALL  
S402

# KNOCK-OUT CMU BOND BEAMS

DIAGRAM 02.410.0141

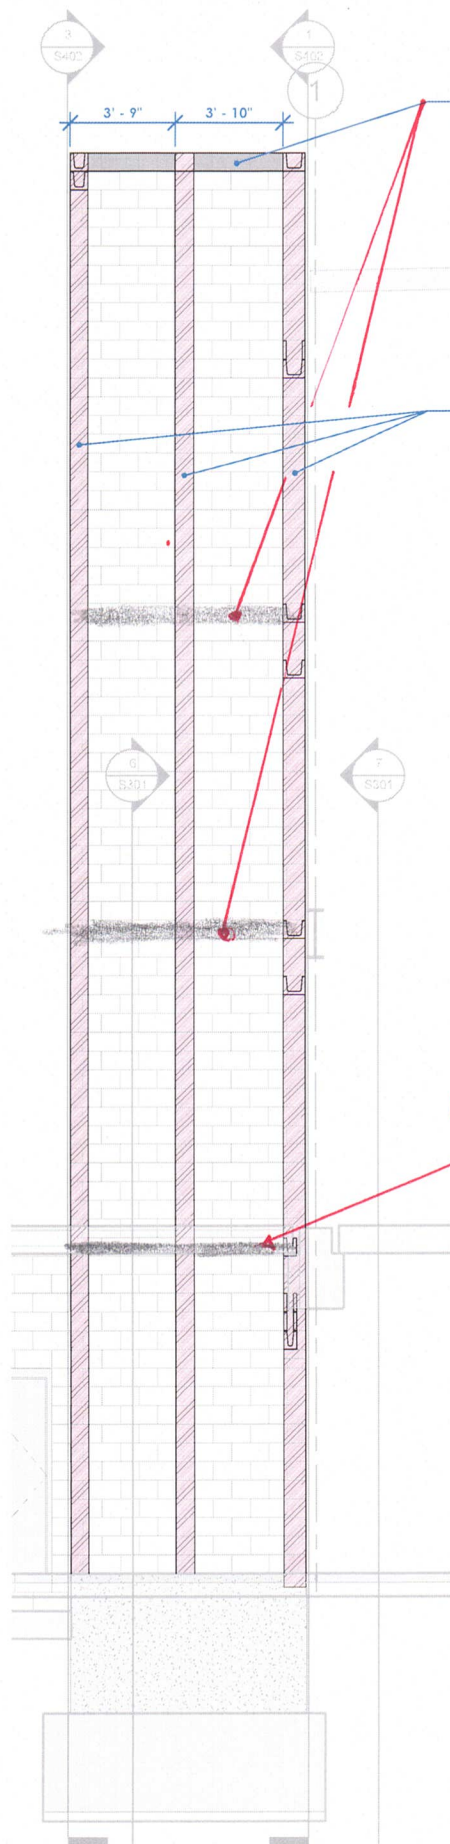
(7) GROUTED W/ (2) CONT.  
 8W X 8D BOND BEAM W/ (2) #5  
 (REBAR 3" FROM BOTTOM OF  
 BEAM) HORIZONTAL #4s

(8) SPACING BETWEEN  
 REINFORCED HOLLOW UNITS  
 = 32" O.C.

(12) 6W X 8D BOND BEAM  
 GROUTED W/ (1) #5
