Footscray Hospital Construction

Daily Construction Site Report

PROJECT	REPORT DATE	REPORT ID	STATUS
Footscray Hospital	11/14/2025	38ff358d	PROCESSING

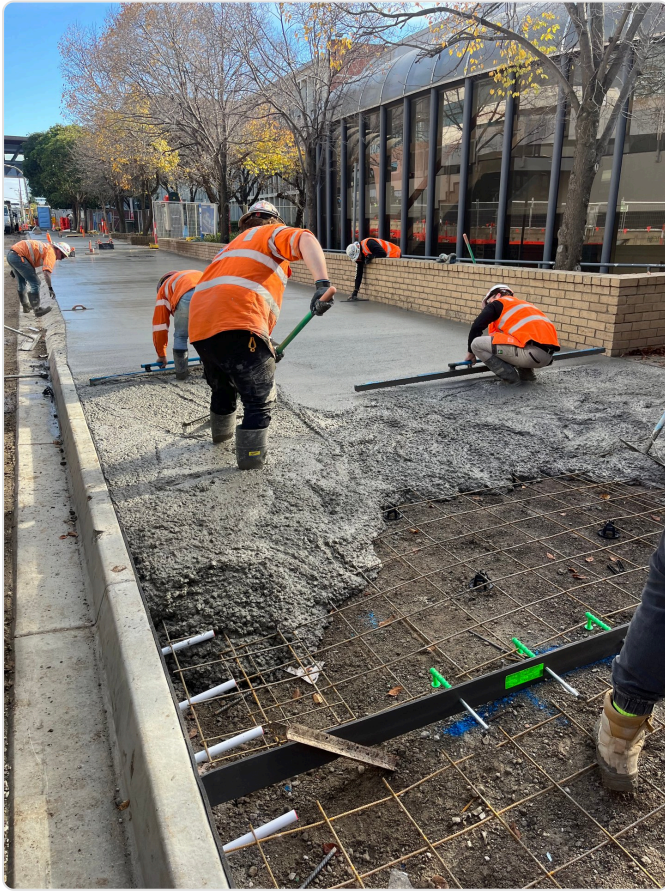
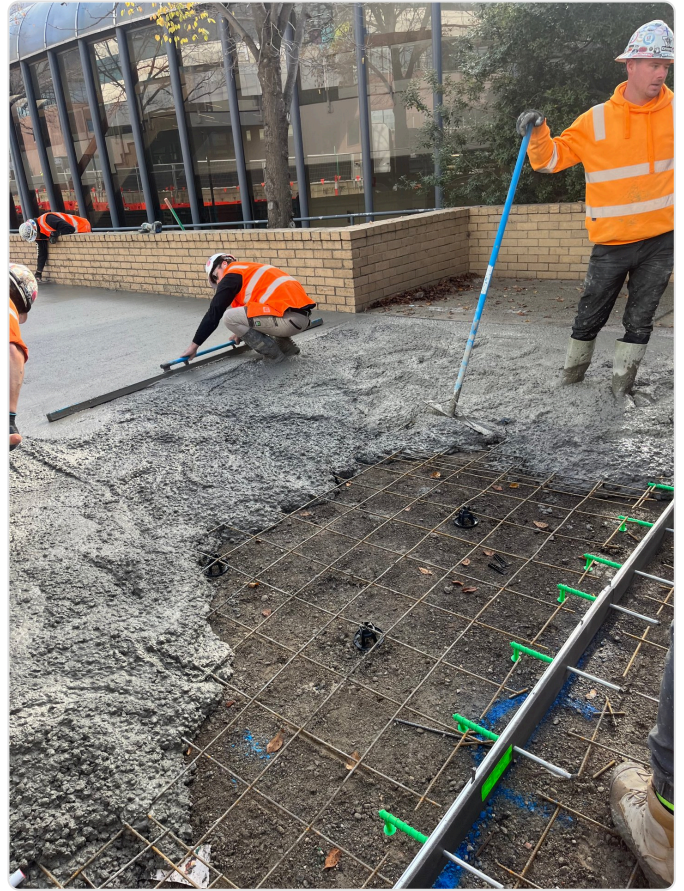
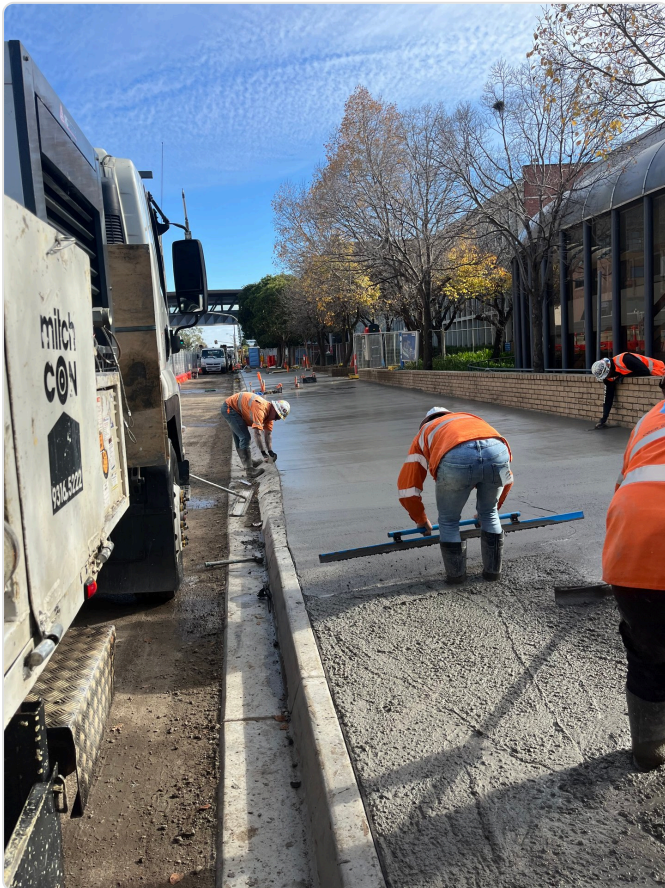
Site Photos

Completed concrete infill pour to previously prepared area adjacent to the western retaining wall. Reinforcement and formwork were verified prior to placement. 32 MPa concrete supplied by Holcim (49 m³ total) was placed via boom pump, vibrated, screeded, and finished to a smooth, level surface. Curing compound applied immediately post-finishing. Final levels checked with laser; tolerances within ± 5 mm as specified.
