**The Drowning Machine**  
Written by Kim A. Elverum and Tim Smalley  
Photos by Tim Smalley  
Layout & Design by Sharon Ketelsen

Boat and Water Safety  
Minnesota Department of  
Natural Resources  
500 Lafayette Road  
St. Paul, MN 55155-4046

# The Drowning Machine

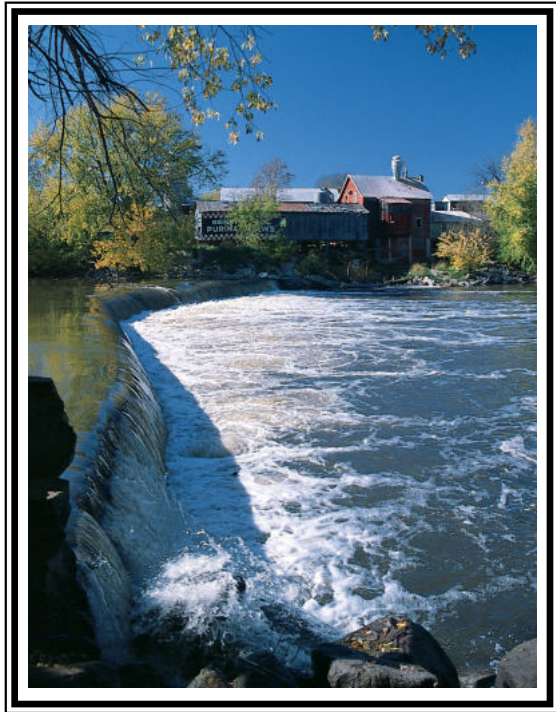
The Berning Mill Dam on the Crow River near St. Michael, Minnesota was typical of a lowhead dam. Water flowing over the top creates a recirculating current drawing objects back toward the face of the structure. Even boats with powerful engines have been trapped and capsized by lowhead dams such as this one. The dam has now been removed as part of a state dam safety program.

was located on the Crow River, which forms the boundary between Hennepin and Wright counties. In July 1979, events nearly as tragic as the Binghamton incident began with what was alleged to have been a dare.

A 25-year-old man wearing a boat cushion on his back plunged over the Berning Mill Dam on an air mattress. The river was unusually high for the summer and the man was trapped in the hydraulic.

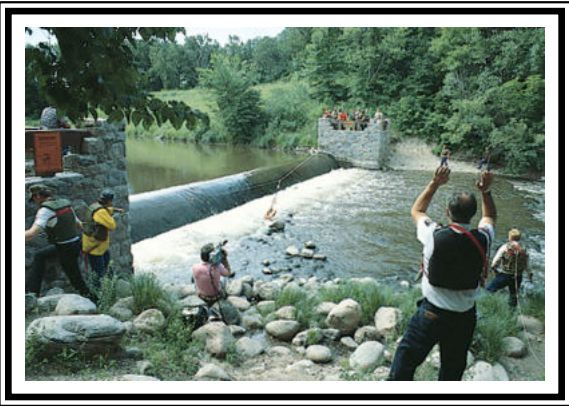
The Minnesota DNR teaches rescue techniques at a Fast-Water Rescue School. In a drill, a rescue team pulls a float through the boil. A victim caught in the boil could hang onto the float and be pulled free.

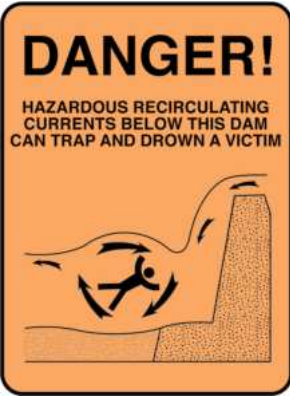
This sign, installed at many dam sites around the state, warns people of the potential danger of a lowhead dam.

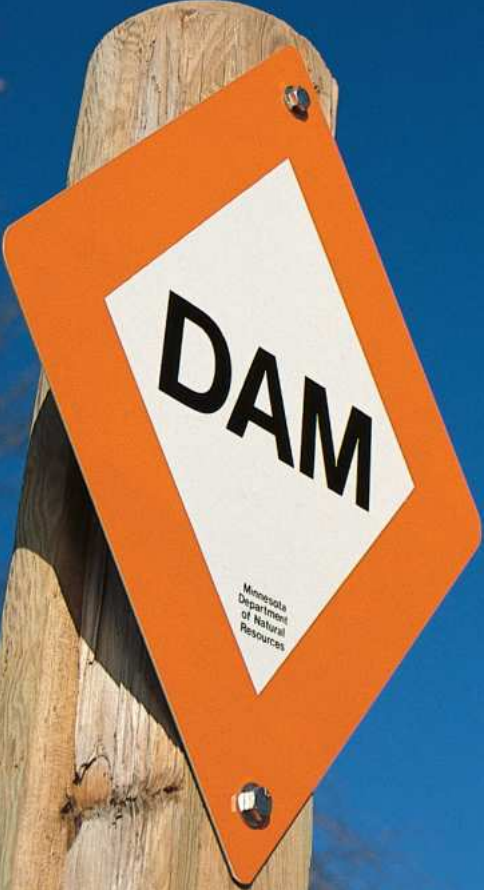
Front cover: This sign is placed along rivers across the U.S. To boaters, the sign's diamond shape indicates danger ahead.
