The Drowning Machine
Written by Kim A. Elverum and Tim Smalley
Photos by Tim Smalley
Layout & Design by Sharon Ketelsen

The Drowning Machine

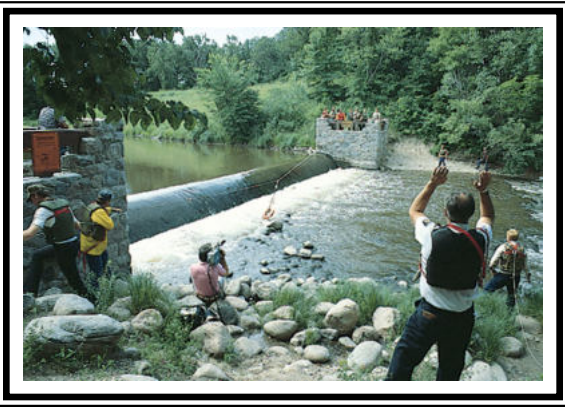
The Minnesota DNR teaches rescue techniques at a Fast-Water Rescue School. In a drill, a rescue team pulls a float through the boil. A victim caught in the boil could hang onto the float and be pulled free.

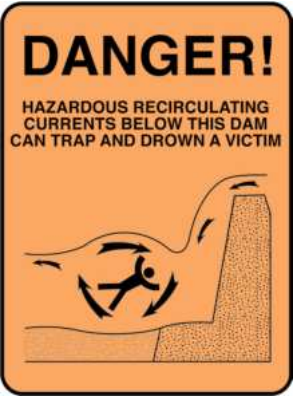
This sign, installed at many dam sites around the state, warns people of the potential danger of a lowhead dam.
