Car Damage Detector & Reporter

Damage Analysis Report

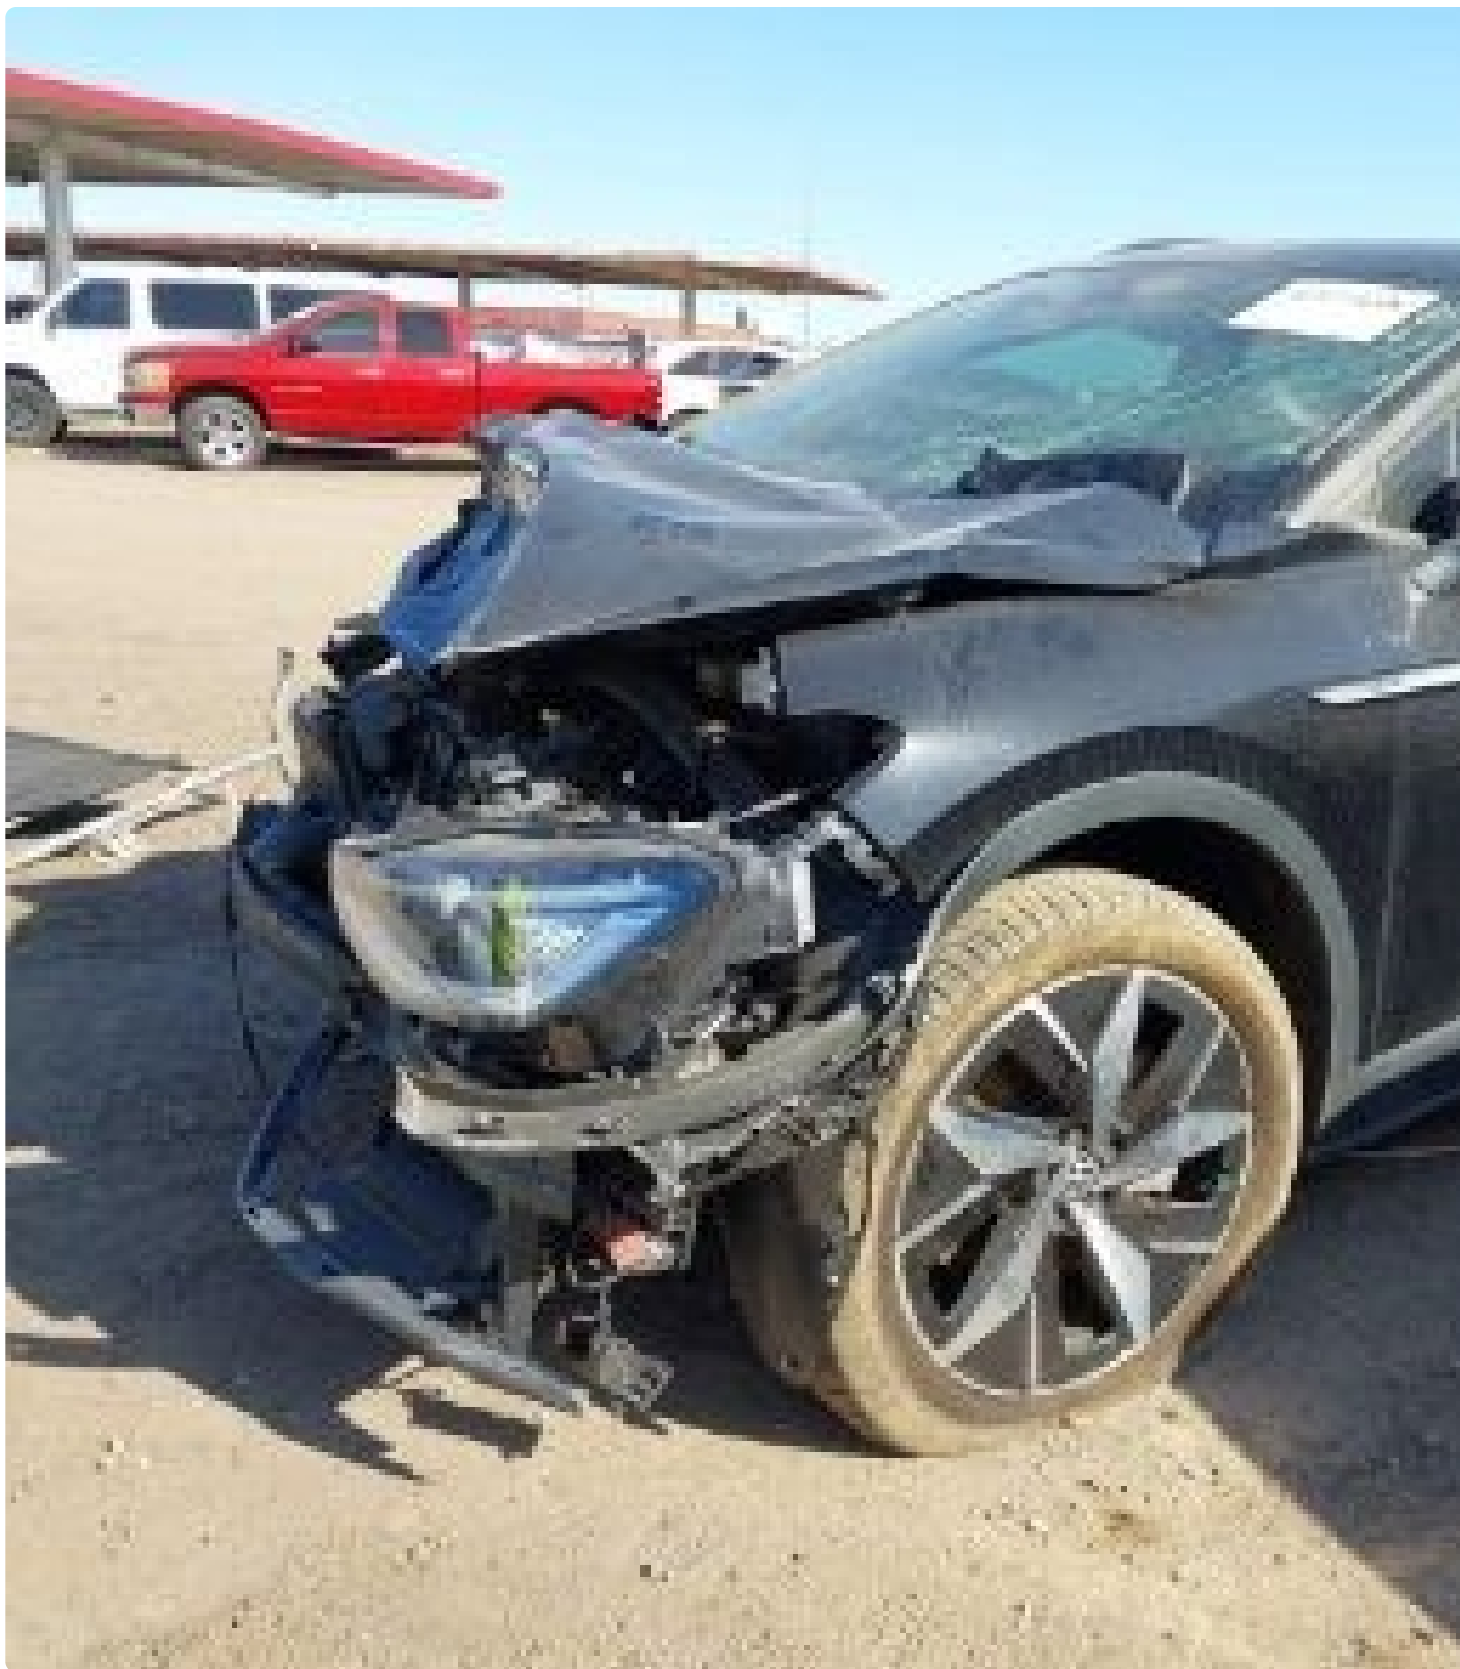
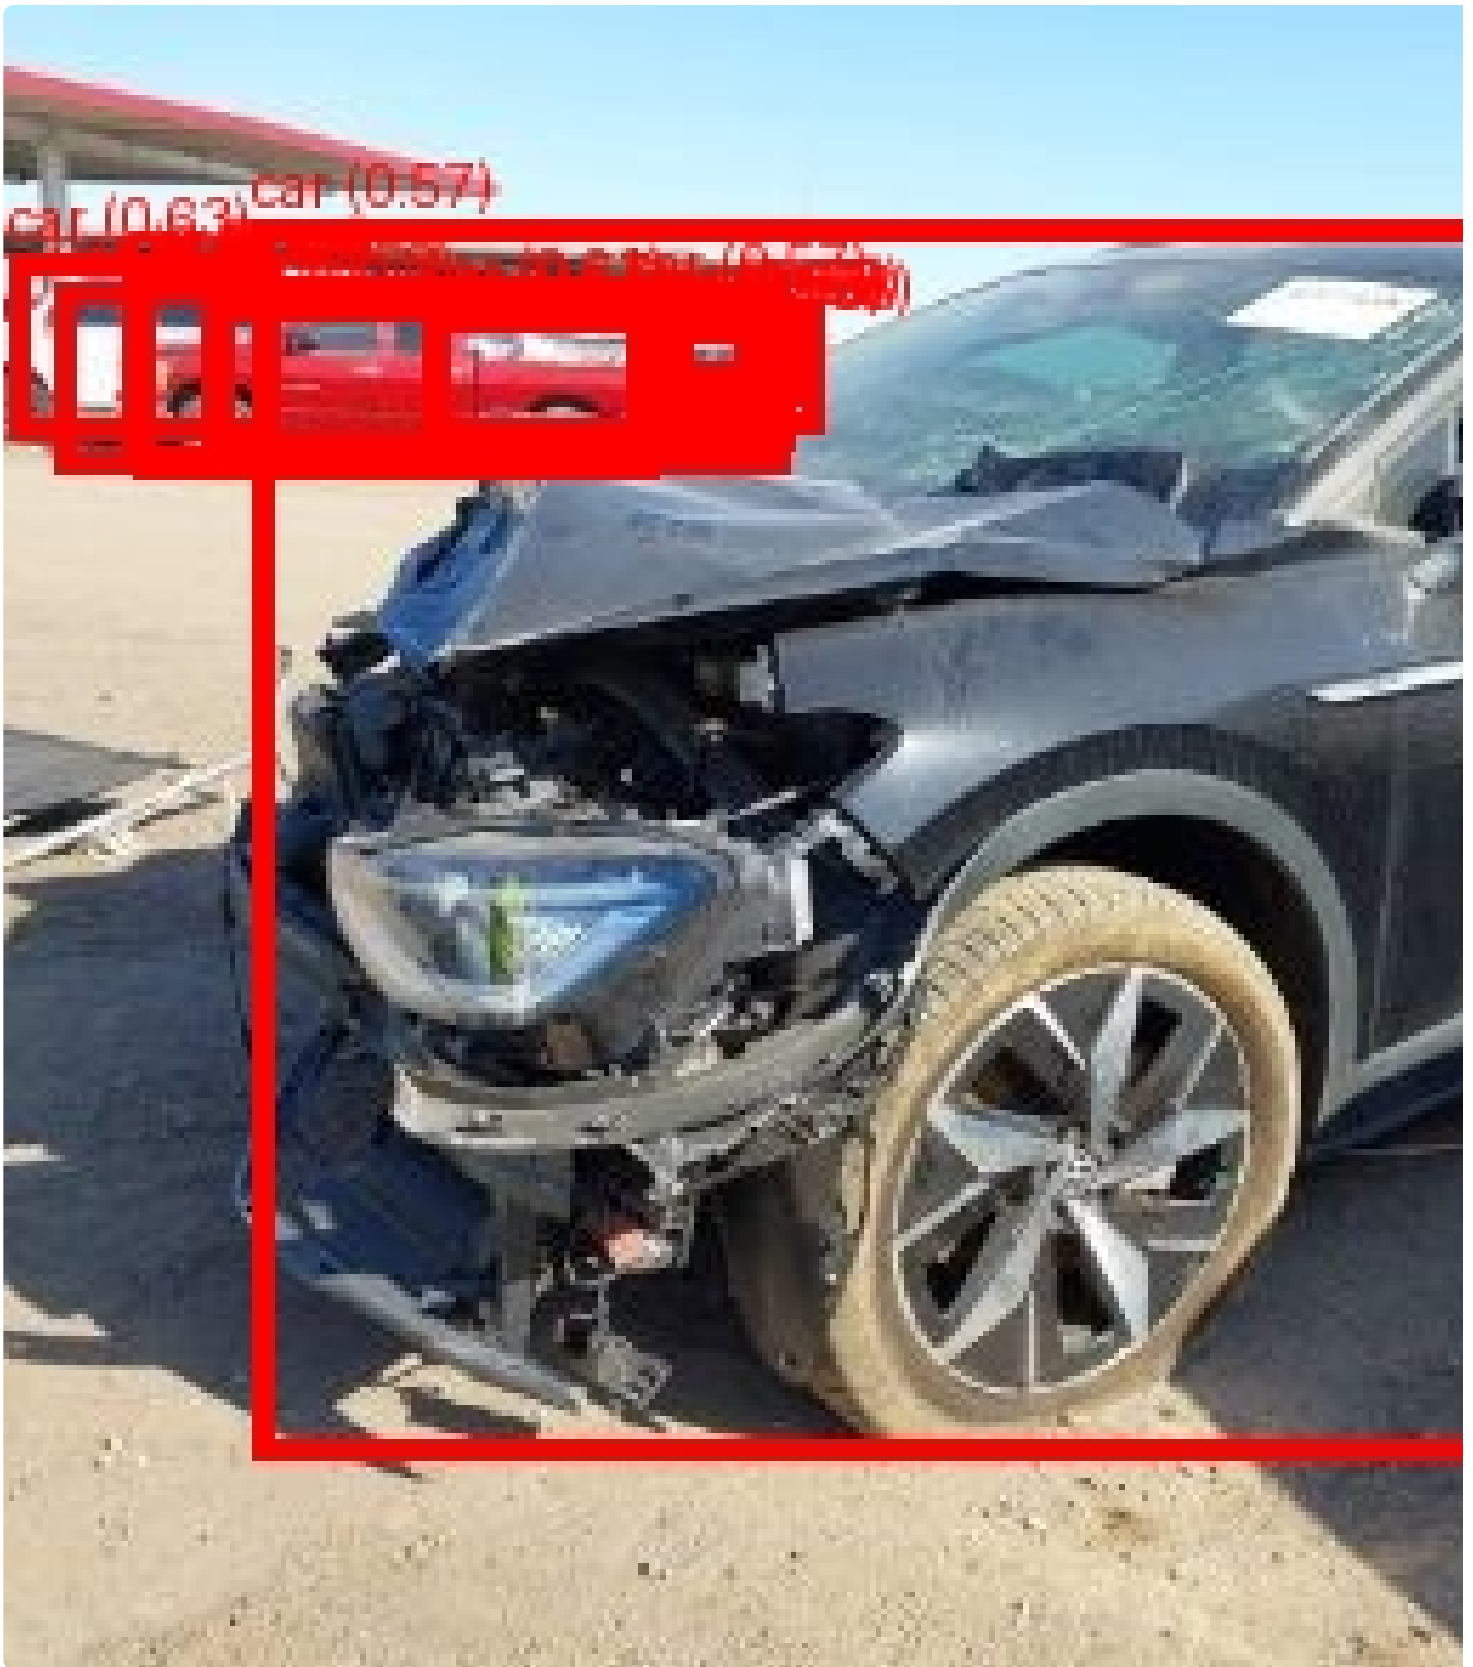
Original Image

Overall Impression: This vehicle has sustained a severe front-end collision. The front of the vehicle is heavily crumpled and damaged.

- **Headlight & Assembly:** The headlight assembly is completely detached and lying on the ground. The damage extends significantly into the front bumper.

- **Front Bumper:** The front bumper is severely crushed, torn, and detached from the vehicle's structure. It appears to be missing much of its upper portion.

- **Hood:** The hood is severely dented and crumpled, with possible damage to internal components.
- **Grille:** The grille is crumpled and likely damaged.

- **Front Wheel Well:** The front wheel well is crushed and impacted, possibly affecting suspension components.
- **Front Suspension:** It appears the damage extends to the front suspension components, given the extent of the wheel well damage.

- **Radiator:** The radiator is exposed and likely damaged, along with its support structure.
- **Wheel:** The front wheel is intact but sits at an abnormal angle, indicating possible damage to the hub and potentially suspension.

- **Severe:** This damage is categorized as severe due to the extensive structural damage, particularly to the front end. It will require significant repairs.
