## Assembling missing emergency pulling.

Edition Date: 13/03/17

Assembling of missing emergency pulling support can be fixed on already installed landing doors. To make easier please loosen or unscrew panel from the carriage.

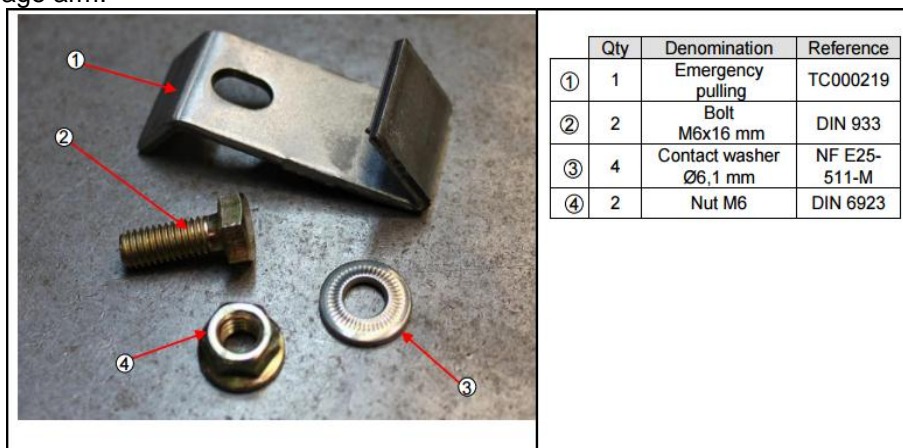
It will be easier to increase distance between mechanism base and carriage arm – pull a little bit arm to put nut behind the carriage arm.

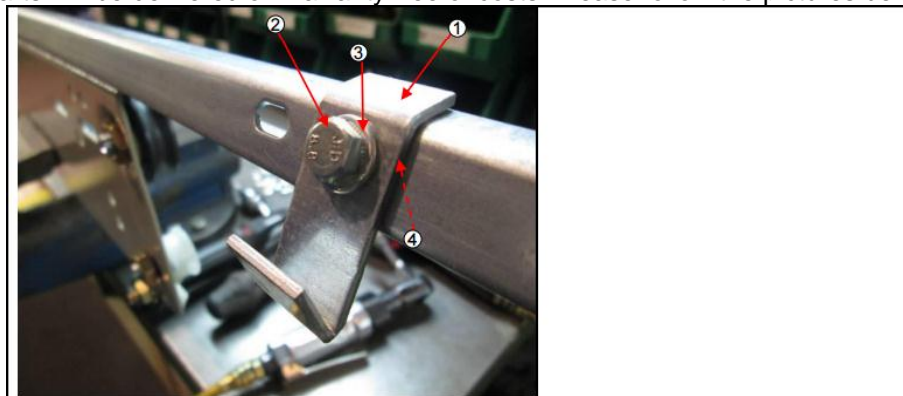
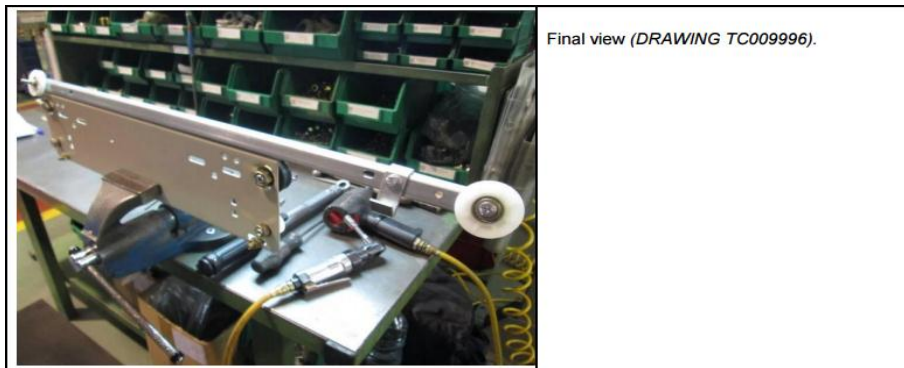
All necessary parts will be delivered on warranty free of costs. Please follow the pictures below :

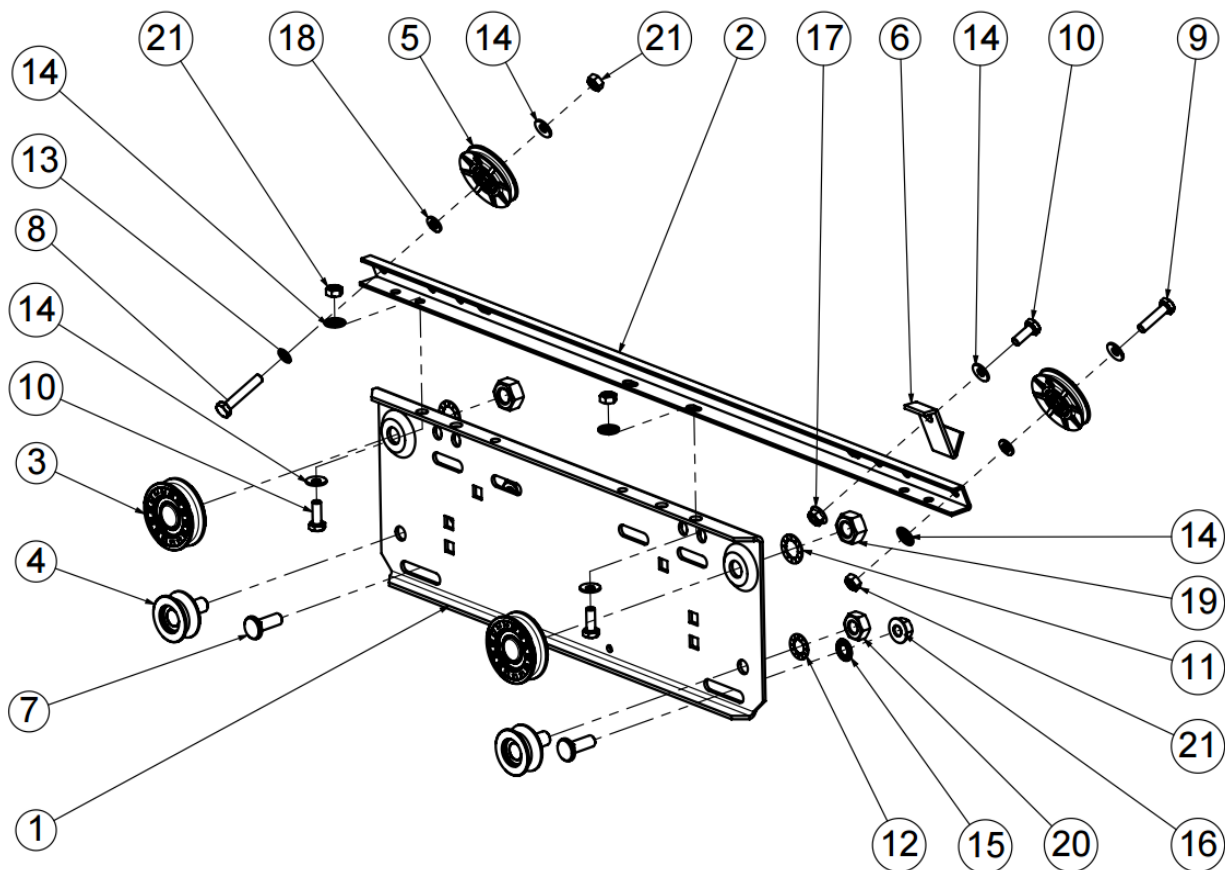
Additional drawing of assambled carriage.
